Correcting Windburn Injury Without Interrupting Play

by O. J. NOER

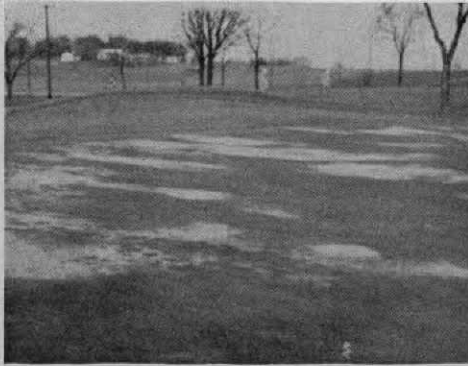
In the spring of 1949 the greens at Ozaukee Country Club suffered badly from windburn. Grass started growth, but began to wither and die in spots soon afterwards. Injury was mostly on the knobs and higher ridges, or on the greens facing the south. The prevailing winds are from that direction. Examination of the turf disclosed a shallow, meager root system, and a thick surface mat of grass.

1. Injured spots in spring on a windburned green, due to shallow rooted turf. The high spots were affected most. 2. The greens were drilled promptly in spring, and holes were left open to encourage deep root formation. 3. The green surfaces looked like this after drilling. 4. The small amount of soil around each drill hole was removed with a dandelion-type rake. 5. New white roots started to develop immediately. By midsummer they extended beyond the depth of the drill hole.
