Andy Wood, Course Manager at the Robin Hood Golf Club in Birmingham, chats to Laurence Pithie of Turf Master One about the results of his drainage work on the greens, most of which was completed in 2009/2010

Greens drainage ...a case study

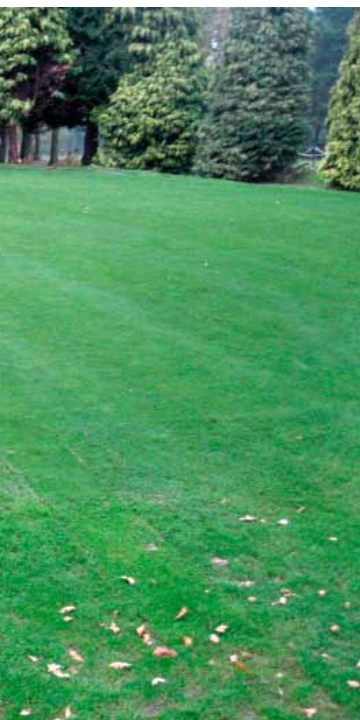
LEFT: Putting on 18th green 10 months after drainage
