Get Pumped!

Case Studies in Pump-Station Replacement

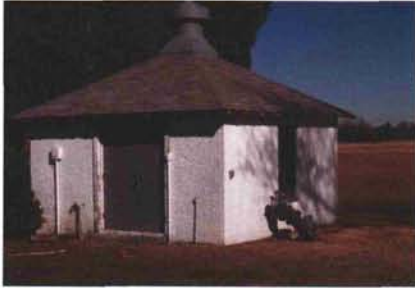
The building that housed the pump station measured 16' x 16'. The exterior was stucco painted white with a hip roof. The structure was constructed for a sum of \$600 in 1914. The building was accessible through two sets of doors. The floor was originally poured concrete and had deteriorated significantly over the last 88 years of its existence. Inside, the area was cramped and dimly lit. In order to service any part of the pump or electrical components, it was necessary to step over pipes and around motors or tanks to gain access. To open the primary power disconnect, the door would have to be removed due to a discharge pipe that prohibited it from swinging open. Abandoned electri-

cal components and wires littered the walls, making diagnostic tasks for system failures a nightmare. No components were clearly marked and old wires were intertwined with replacement wire. The interior was lit by one 100-watt light bulb in the center of the structure. A flashlight was almost always required for any type of inspection.

Chicago Golf Club's old pump house.

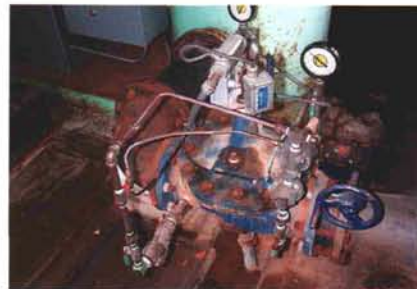
After studying our system in detail, the consultant made a number of recommendations. One of them included replacing the pump station. As was the case with Shoreacres, a primary concern was the integrity of the hydro-pneumatic tank. The pressurized tank displayed sections of rust and deterioration that could potentially result in the tank rupturing and injuring people in the building.

Inside CGC's old pump station.

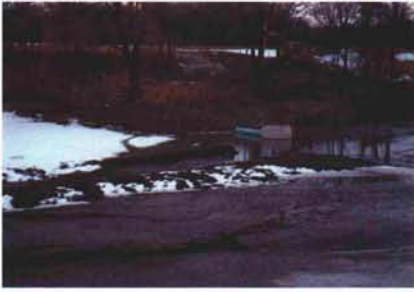
Many factors come under consideration when selecting any product. Service, reliability and peer recommendations are always very important. The designer builds the size and specifications into the station. Shoreacres required a station that would work with the present system and be able to meet the needs of the new system. Water quality was also an issue at Shoreacres. Water drawn from Lake Michigan will contain zebra mussels that clog pipes and pumps. Silt is also an issue. The cleaner the water source, the less wear there will be on the pumps. To assist in cleaning the water, a secondary wet well was installed in the pond.

Shoreacres' secondary wet well.

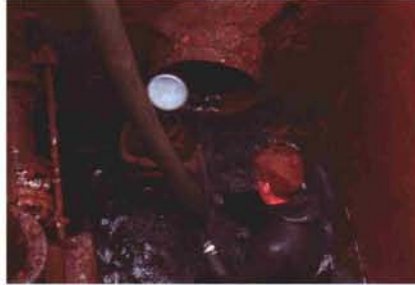
pressure maintenance pump and two 60-hp pumps are able to provide 1,200 gpm. The water source is a pond fed by two wells. Upon inspection, we found very little silt in the flume and none within the wet well, so water quality was very high, eliminating the need for additional filtering systems.

Cleaning out the wet well at CGC.

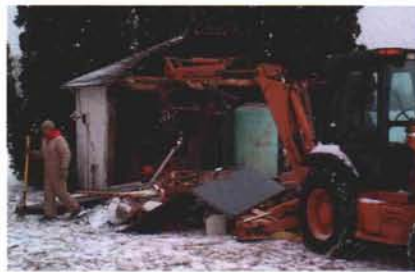
Demolition of old pump station at CGC.

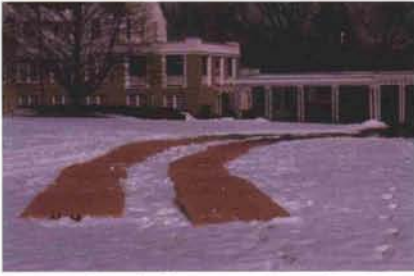
Plywood path for cement trucks to traverse to minimize golf course damage.

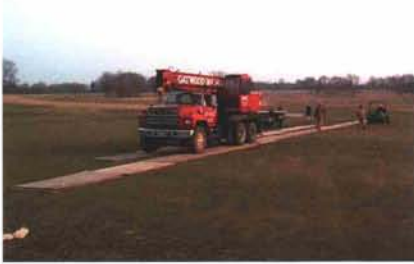
Truck traveling across plywood at CGC.

1 fairways and the driving-range tee. The gross weight of the truck full of cement was 79,000 pounds. The result of our diligence was evident when the truck reached the pump-house area and exited the plywood to turn into position. The wheels immediately sank 8" into the turf. The truck made all of its turns within a designated area of disturbance surrounding the pump house. After emptying the concrete, the truck was much lighter, making the return trip easier. We used single sheets of plywood in the rough and double-sheeted the driving-range tee and fairway crossings. The remaining section of the floor necessitated bringing out only a small amount of concrete. Again, we used utility vehicles. When all of the cement had been transferred from the truck to the pump house, the sun was setting and the temperature was dropping. The floor was completed at 8:30 p.m. using the lights of a skid steer and a pickup truck. The forms came off the foundation walls on Monday, March 11 and the concrete block walls started to go up Tuesday, March 12.

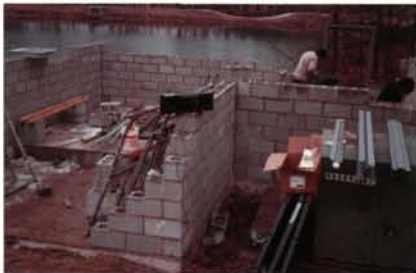
The building at Shoreacres, meanwhile, is very elaborate. Measuring 24' x 24' less an 8-1/2' x 8-1/2' section to accommodate the electrical transformer, the total area for the building is 504 square feet. The cost and difficulty of relocating the transformer called for the building to surround the existing transformer.

Shoreacres' building goes up around existing transformer.

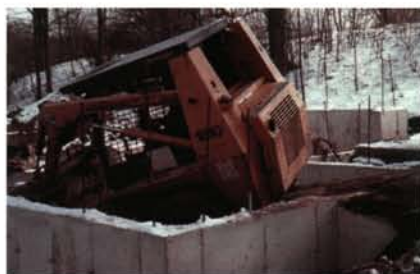
Even with the best planning, "things will go wrong," as this episode at Shoreacres testifies.

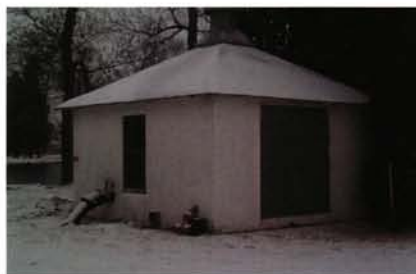
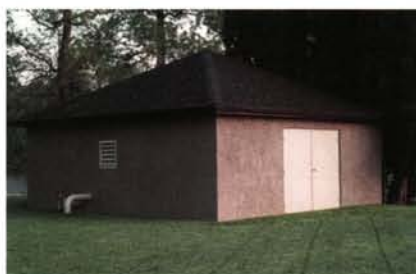
Chicago Golf Club's pump house: before and after.
