It's all in the Details

Ted Soenksen, *Wilmette Golf Course*

Fixes are Easy Once the Problem is Found

Glenn Peters, *Sunset Ridge Country Club*

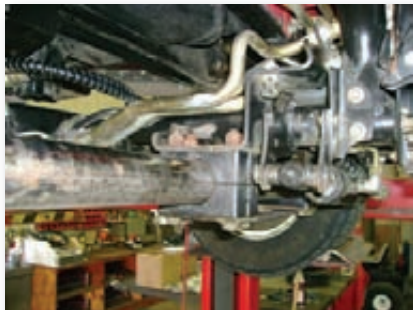
The slide mechanism that allows the cutting units to move left to right. The bearing caps that support the entire lift of the cutting units are made of plastic and run on steel. After looking into this, I found there are no specifications or wear limits to these plastic bearing caps. I decided to see how much play this wear had caused the cutting units to move. With the cutting units off the machine and in the lift I was able to teeter the assembly over 1 1/2" in the furthest right position. Visually I could see the gaps between the bearing caps and the round steel axle!

Naturally I ordered a set of bearing caps and slides right away. Upon closer inspection I found the solid hydraulic tubing that is mounted on this assembly was very close to rubbing against traction unit frame because of the slop in the bearing cap slides.

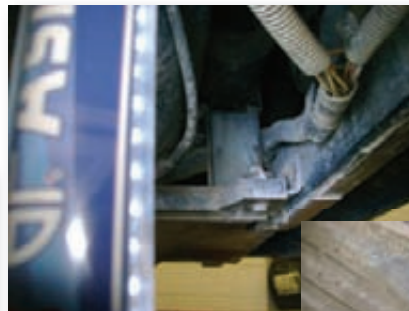
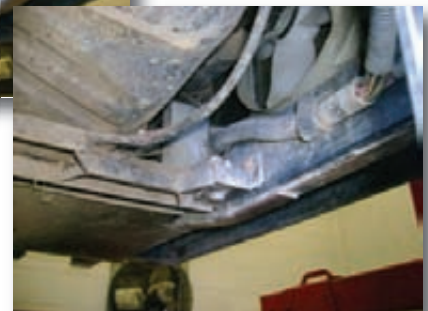
The Problem: the engine starts, and runs, but acts as though is running out of fuel.

Eventual Solution: I peeled back the covering to discover the wires had been cut by the frame of the vehicle. (*See photos for location*) The wire for the ignition run position broke when I put the loom back in its proper position. In addition, the wire to the carburetor fuel valve was grounding intermittently causing the hesitation and the perception that it was starved for fuel. The repair of the wiring was simple and corrected the problem completely. -OC
