Remedial Investigation at Faribault Golf & Country Club

By **DALE WYSOCKI**
Golf Course Superintendent

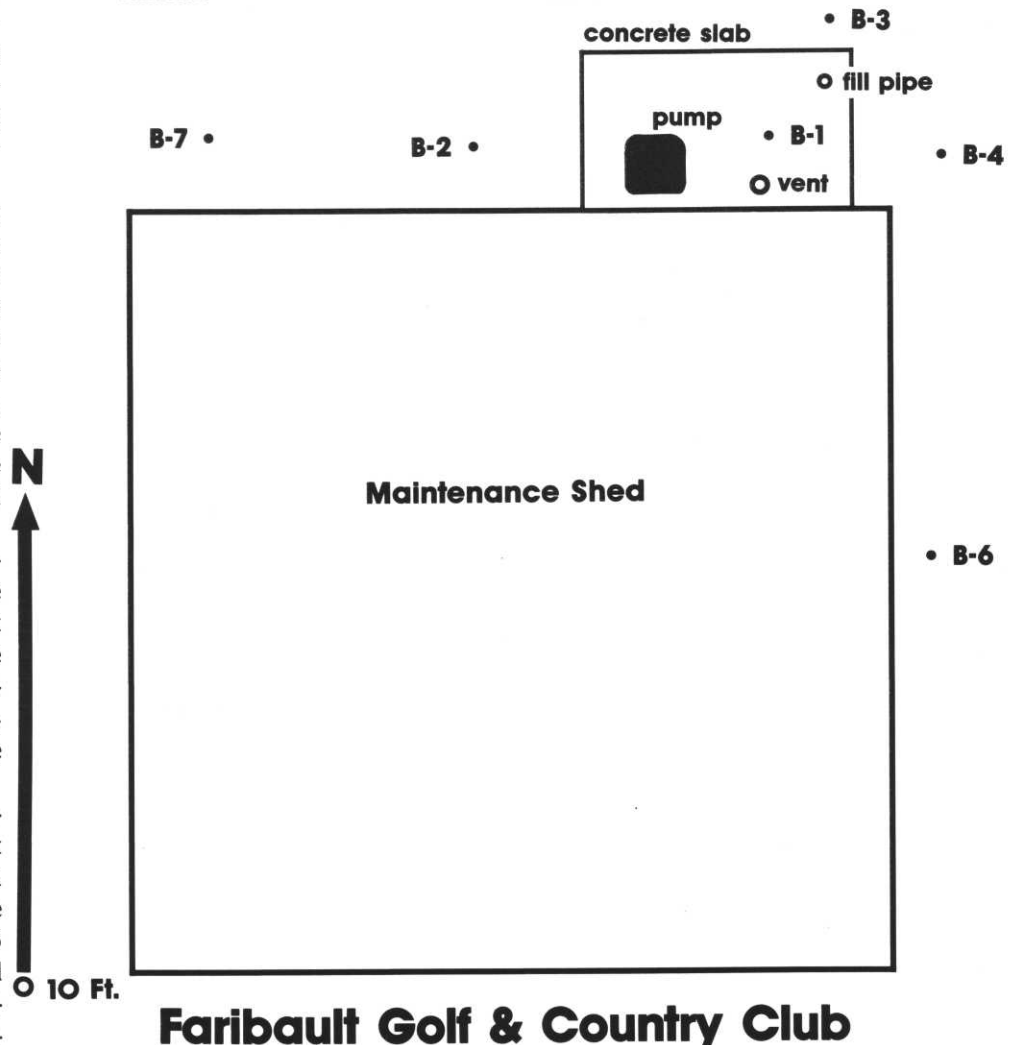
Barr Engineering had proposed drilling seven wells over and around where the UST was buried (*see map*), down to either the water table or to five feet below the base of contaminated soil. However, before this or anything else could take place, we had to give locations of rescue squads, hospital, and of course, call Gopher State for any underground wires, oil lines (we have two running under the 10th tee) and telephone wires.

Now what did we find? Of the seven borings made, four turned up clean, but the other three—B-1, B-2, B-3—show us that there is a definite problem—a problem that extends down to 30-35 feet. The jar head space analyses indicated 48-28 ppm at 30'-32'. The maximum allowable rate set by the MPCA is 10 ppm, so now the petroleum tank release investigation suggests that the release may have impacted shallow groundwater at the site. A groundwater investigation is going to take place following this work, and a final remedial investigation report will be submitted to the MPCA for approval of recommended corrective action and site closure.

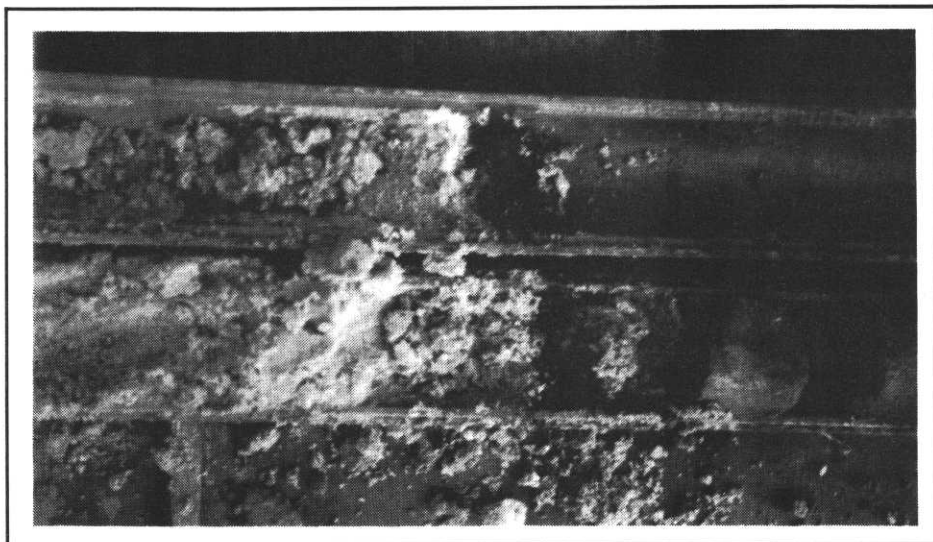
THE BLACK LAYER on the top half of the split spoon was extremely high in soil contaminants, located right above groundwater.

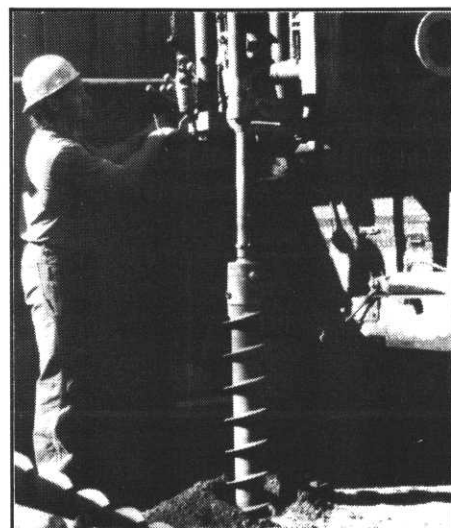
OPERATING a CME-55 is Jerry Scallin of Exploration Technologies.

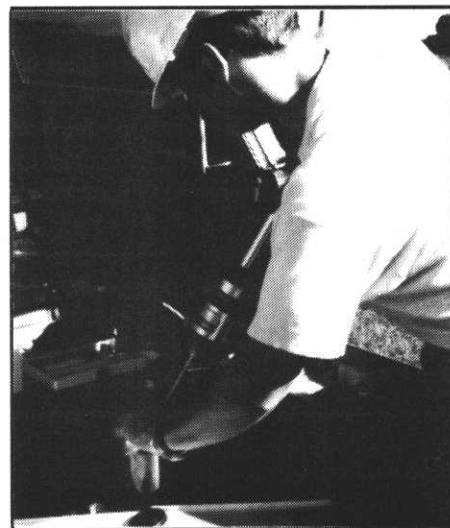
PERFORMING jar headspace test is Dave Dahlstrom of Barr Engineering Co.

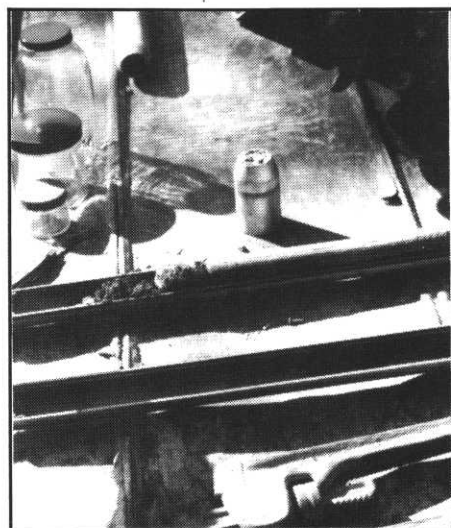
A SPLIT-SPOON SAMPLER with a sample of soil that later would be checked for contaminants.

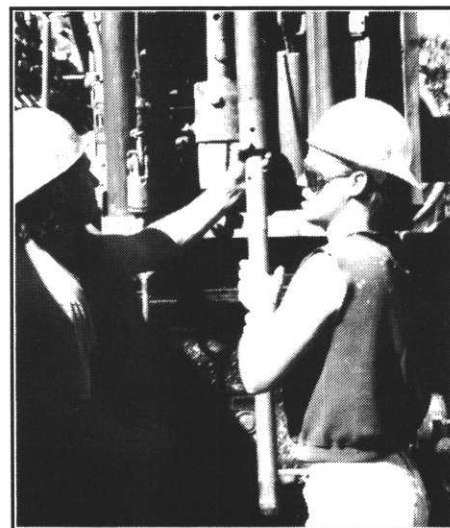
TECHNICIANS from Exploratory Technologies attach a "split-spoon" sampler.
