# OTS Conference Highlights

## Sportsfield Drainage: Learning from Mistakes (Case 2)

DR. BOB SHEARD, P. AG., AGRONOMIST, GUELPH TURFGRASS INSTITUTE

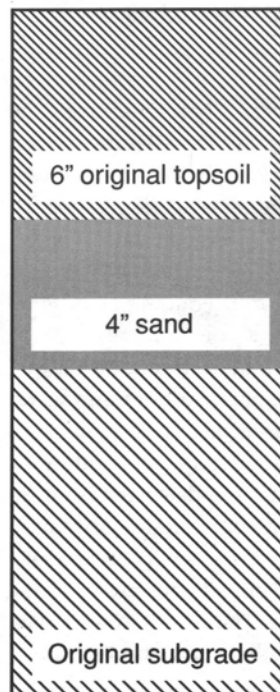
The architect suggested removal of the surface 15 cm of topsoil, which was a clay loam, shaping the field to 2.0% grade at centre field for drainage, placing a 10 cm layer of sand over the entire field, and then replacing the topsoil (Figure 1).

There were two major errors in design and construction. The major problem was the sand layer below the topsoil which created two zones of pore size discontinuity. The first zone was between the subgrade and the sand layer. At the interface of the subgrade and the sand there is a change from relatively large pores in the sand to very small pores in the subgrade. As often happens in sports field construction, the earth moving was done in the fall under wet conditions with large-size, earth moving machinery. This operation resulted in a compacted subgrade with further reduction in porosity through which one would expect a very low rate of water movement. Thus, winter snows and spring rains would keep the sand layer saturated for a long time in the spring. In turn, the water in the saturated sand layer would rise into the topsoil by capillary action, keeping the surface soft and resulting in the observed rutting by the tractors.

interface between the sand layer and the topsoil. Here the discontinuity is in the reverse direction where relatively fine pores in the topsoil overlay large pores in the sand. Initially in the spring, drying out would be delayed because a perched water table would develop in the topsoil at this interface, adding to the wetness of the surface. When the system finally dried out during midsummer, capillary flow of water from the subgrade upwards through the sand to the topsoil would be interrupted resulting in the turf having to rely only on the available water stored in the 15 cm of topsoil.

The second error in the design was the use of an excessive crown as a substitute for drainage. Although a 2.0% grade would effectively shed most of the water if the field were a bare parking lot, a dense turf, the prime prerequisite of a good soccer field, is the best system known to soil conservationists to prevent run-off. If run-off is prevented through the turf cover, the water which falls on the surface must infiltrate the soil surface and be removed by natural or artificial internal drainage systems. While a crown may be of value in a parking lot, it adds little to the drainage of a sports field.

**Figure 1: A schematic drawing of the soil profile of the soccer field.**
