ONE WOULD ordinarily think that copper fittings on an underground plastic piping system would not corrode; there is much experience to back this up. This was not the situation, however, in an automatic sprinkler system installed several years ago in the community center of a major city in Michigan where an abnormal situation resulted in leaking at the copper fittings.

When the investigation of the cause of corrosion started, three threaded copper adaptor pieces were received. The pieces may be described as follows:

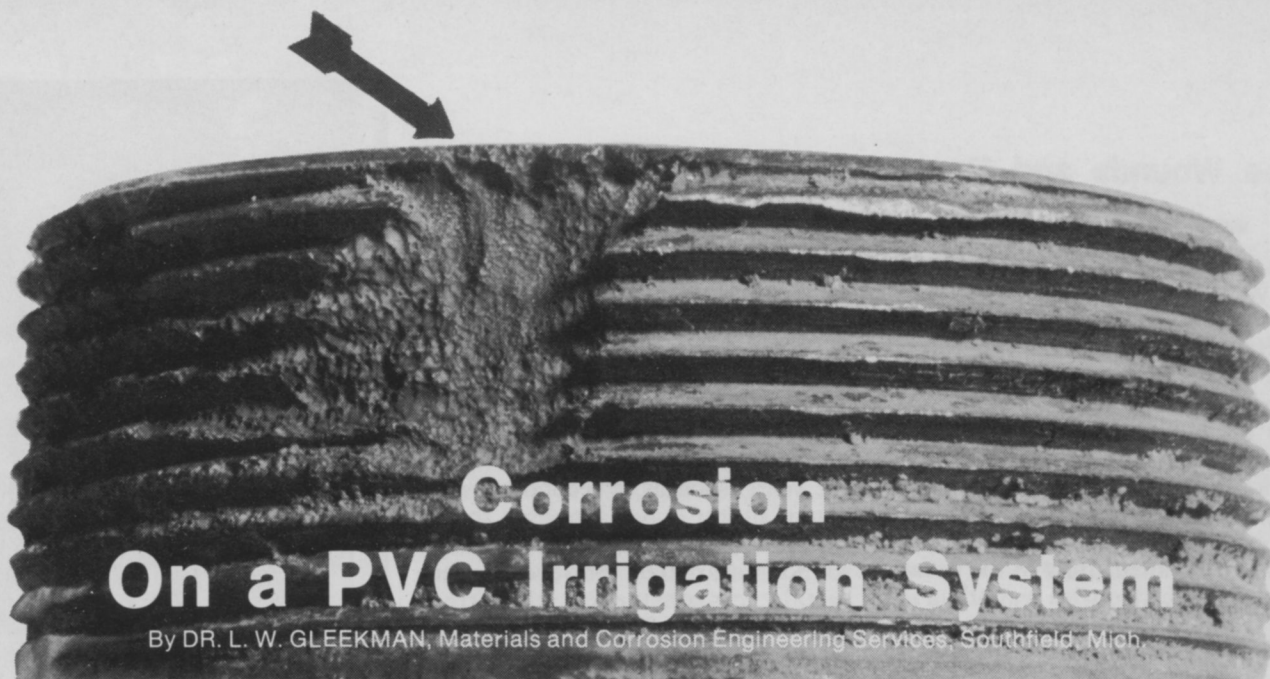
A two and one-half inch ips male thread-to-tubing nipple.

The small piece showed attack at only one area in the threads; this was located three threads back and was slightly oval in shape. Sand was present in the threads on most of the piece, indicating that no more than three threads had been properly engaged.

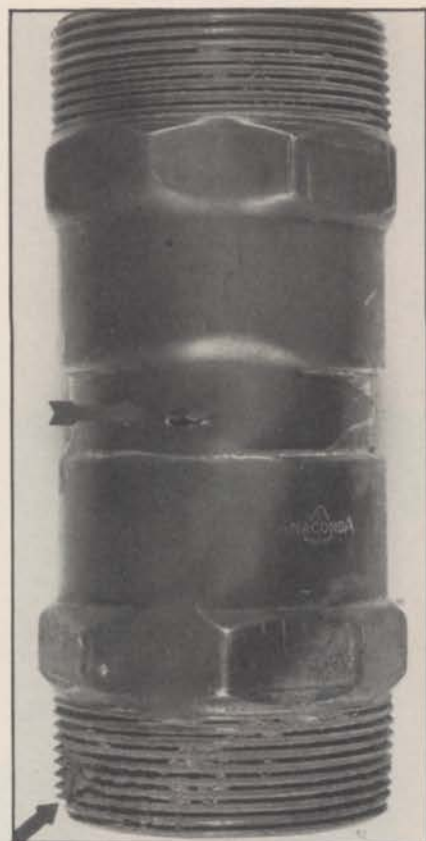
The medium piece showed the largest amount of attack. There was a large section chewed out of the threads on one end with the adjacent threads attached. The octagonal shanks of the fitting were worn smooth right down to the solder in one area. The other threaded end was perfect, with the first four threads clean and shiny showing full engagement; the remaining six threads had a visible trace of a blue compound plus very definite grains of sand in many of these threads. On the attached end, from the color of the threads and the location of the sand in the threads, it was very evident that no more than two threads had been fully engaged.

Examination at low magnifications (three to 15 times) clearly showed the nature of the attack. The medium piece showed the greatest attack and the clearest differentiation of the mechanism. The maximum attack in the threads started at the inner end of the thread and progressed back six threads at one location. The attack was characterized by overlapping shallow depressions in both the root and the top of the threads as well as along the sides of the thread. There was a definite clockwise orientation to the attack in the direction of the right-

hand thread. This was characteristic of the attack on all threaded joints. Downstream of the attack area there was no attack. The hole in the medium piece, which was elongated transversely to the length of the tubing and nipples, was in direct line with the eroded portion of the shank of the two nipples.

There was no sign of attack on the interior of the tubing or fitting and the hole clearly proceeded from the inside outward. The surface of the tubing and the nipples showed an exceptionally smooth wear pattern and with no grooves or scratch marks. Obviously, the copper wall of the tubing had been worn by external erosion of escaping water to the point where it could no longer withstand the internal pressure; the tubing then ruptured.

This is the medium piece — a two inch ips male thread-to-tubing nipples joined together to a short length of two inch copper tubing by soldered joints.

The corrosion of the copper fittings is traced to cavitation corrosion in the threads, followed by erosion-corrosion of the exterior of the shank of the two nipples and the tubing joining the nipples ("medium" piece).

In the case of the medium piece, when water wore a big enough path through the threads, its jet action then caused erosion of the shank and the tubing joining the nipples. When the tubing was worn down to a thickness less than 1/64 of an inch, rupture of the tubing occurred due to insufficient wall thickness to resist pressure. Reference to the "Piping Handbook" indicates that joint sealants such as litharge and glycerine or glypton are preferred for tight joints. In addition, the Handbook points out that for two-inch pipe size, five threads should be engaged for a hand-tight connection. For two and one-half inch pipe size, approximately five and one-half threads should be used. The Handbook further states that Teflon thread lubricant should be used in assembling threaded PVC plastic piping. This obviously applies to joints that may have to be disassembled subsequently, since threaded joints of PVC pipe may be permanently joined using a thread cement such as PVC cement. This material uses a solvent such as tetrahydrofuran. This solvent is often pigmented blue.

copper fittings to the mating PVC threaded pipe used the blue PVC cement as the thread sealant. PVC cement is just that — an excellent cement and solvent for PVC but certainly not a thread sealant. Perhaps the convenience of the PVC cement being available in a can with a half-inch wide brush and applicator was too tempting to certain of the trades, and this cement was used rather than the conventional joint sealants, such as litharge or glycerine or preferably Teflon tape.

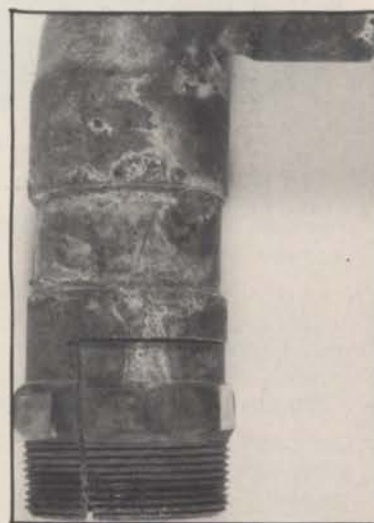
The large piece had been coated after removal with a blue PVC joints cement over a large part of the threads. Thus, the presence of sand and gradations in color would not be clearly differentiated. However, the location of attack was, at one

point, in the threaded portions of the nipples.

This is the two-inch ips male thread-to-tubing nipple soldered to a piece of two-inch tubing, in turn soldered to a two-inch to one and one-half inch reducing bushing, soldered to a piece of one and one-half inch tubing.
