# ADVENTURES IN WATER STRESS

Drought conditions and failure of the irrigation system produce interesting findings on an experimental green in the Midwest.

by Don Taylor, Ph.D., University of Wisconsin, River Falls

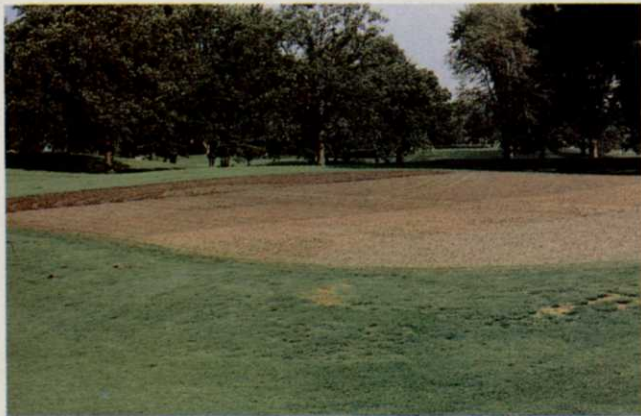
Figure 1. Experimental golf green at the University of Minnesota Golf Course following topdressing. Sections of different soils are evident from color of topdressing material.

The green was constructed according to U.S.G.A. guidelines, save one. It was divided into five sections, and five different soil mixtures were used in the rootzone layer (Figure 1). The five soil mixtures used on the green

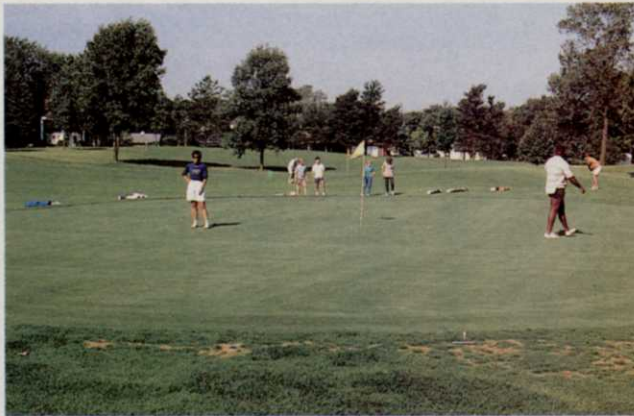
Figure 2. Experimental golf green in August 1986, when bentgrass on all soil mixtures was in excellent condition.

During 1986, the first year turfgrass growth was carefully monitored, bentgrass growth on all five soil mixtures was superb with no differences between plots. Figure 2 shows the golf green as it appeared in August, 1986.

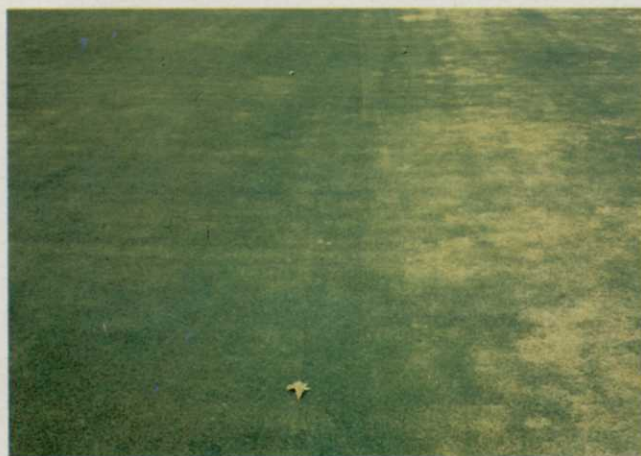
Figure 3. Damaged turf growing in soil mixture No. 5 (right half of photo) compared to the relatively undamaged turf growing in soil mixture No.3 in April 1987.

In mid-April, before the irrigation system had been turned on for the season, bentgrass growing on soil mixture No. 5 started going into water stress. Despite running hoses from the clubhouse to water the green while the irrigation system was being checked, turf loss occurred on soil mixture No. 5. Figure 3, taken on April 22, shows the damaged turf on soil mixture No. 5 (right half of photo) along with the undamaged turf on soil mixture No. 3 (left half of photo). The lines dividing soil mixture No. 5 and the two bordering plots were distinct and obvious with the damaged plants restricted to soil mixture No. 5. Once

the irrigation system was fully operational, the turf on soil mixture No. 5 gradually recovered until there were no more differences observed between plots for the rest of the season.
