ASK THE "EXPERT" Julius Albaugh, CGCS, and Frank Heery Westmoreland Country Club

# Aggressive Green Aerification: A Case Study

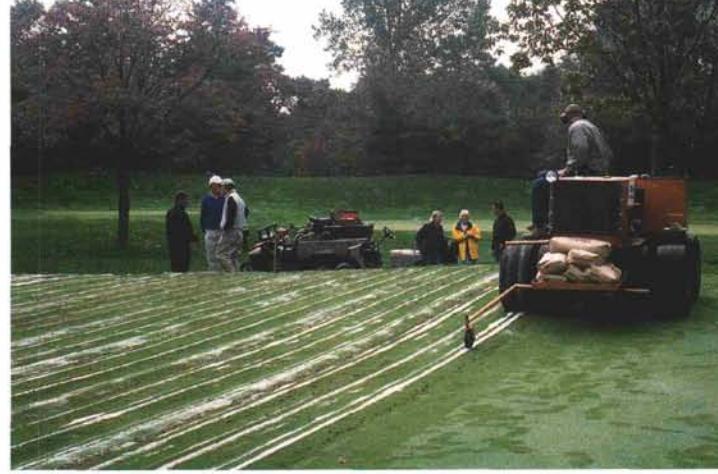
Waterwick on no. 15 green.

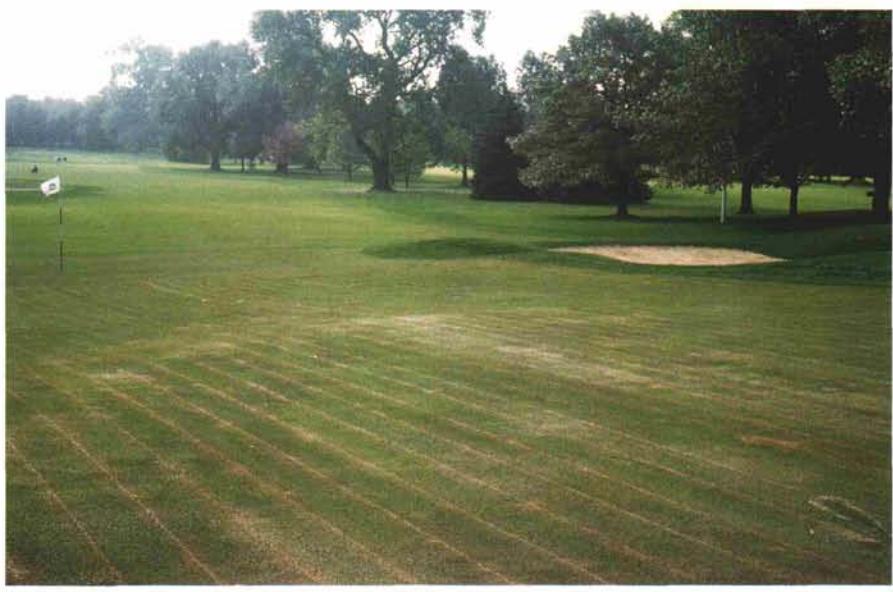
No. 18 green after completion of the Waterwick. (Note scarring in bottom-right corner.)

Organic matter on average had dropped one full percentage point. The 2003 season was difficult at Westmoreland because of the cosmetic "scarring" that remained after the Waterwick process. Even though we had incorporated a tremendous amount of sand, the playing surfaces remained bumpy and there were areas on the heavier-soiled greens that remained "heaved" despite countless rollings with the one-and-a-half-ton vibratory roller and Salscos. Frequent topdressings (60 tons of sand applied on a three-week average) were used in an effort to smooth the playing surfaces. To eliminate the "scarred" areas, we used A-4/T-2 plugs from our nursery, in addition to an increased overseeding practice. The Waterwick is an aggressive machine, and not for the faint of heart. Any greens that had a poor root structure prior to the process (less than 3'') were at the complete mercy of the machine and received the highest percentage of damage. High-percentage Poa and shaded areas were the most susceptible. "Scarring" in these areas remained until the spring of 2004. From an observational standpoint, there are several encouraging observations that have been made on the greens this season.

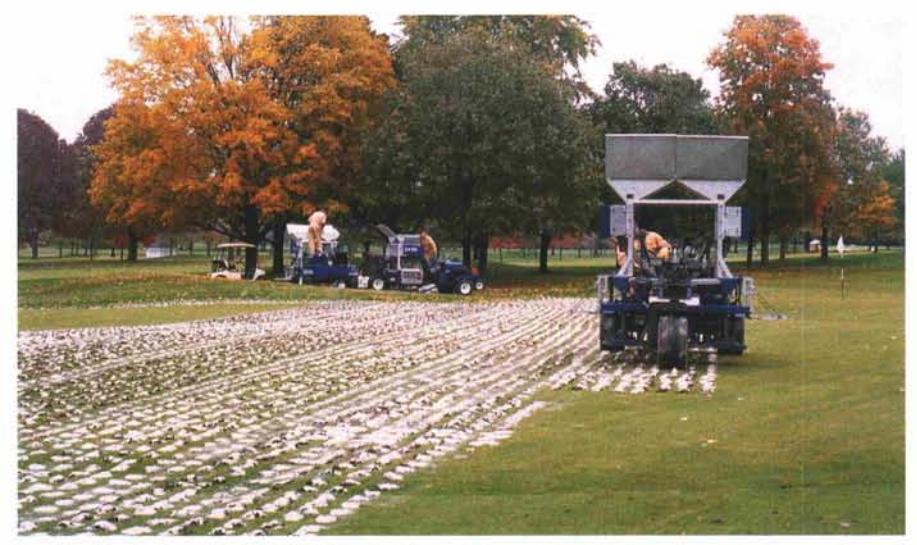
Drill-and-fill machines in action.

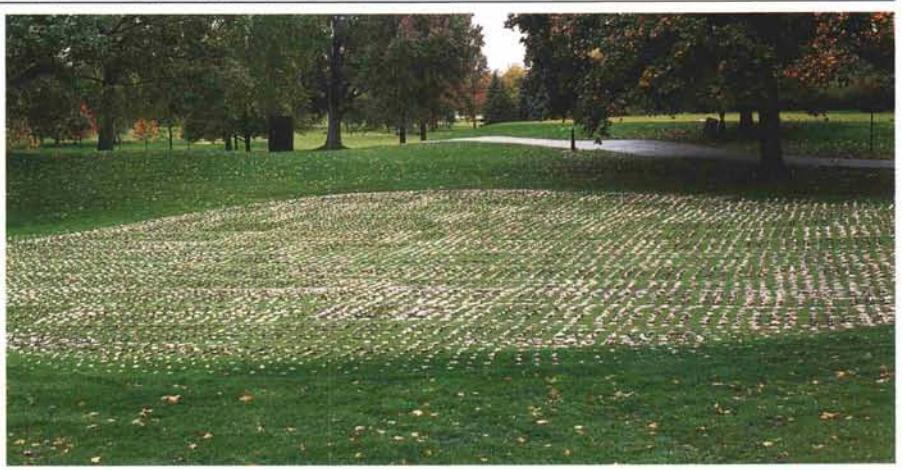
Completed green.

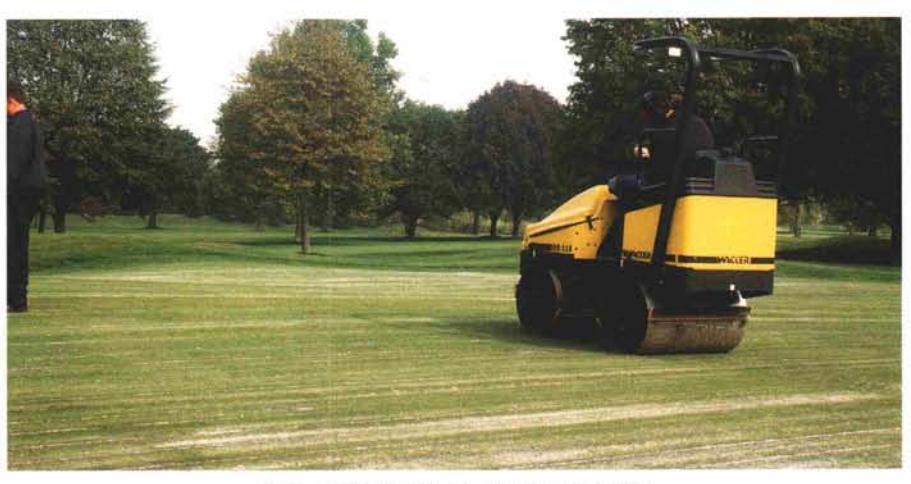
One-and-a-half-ton vibratory roller.

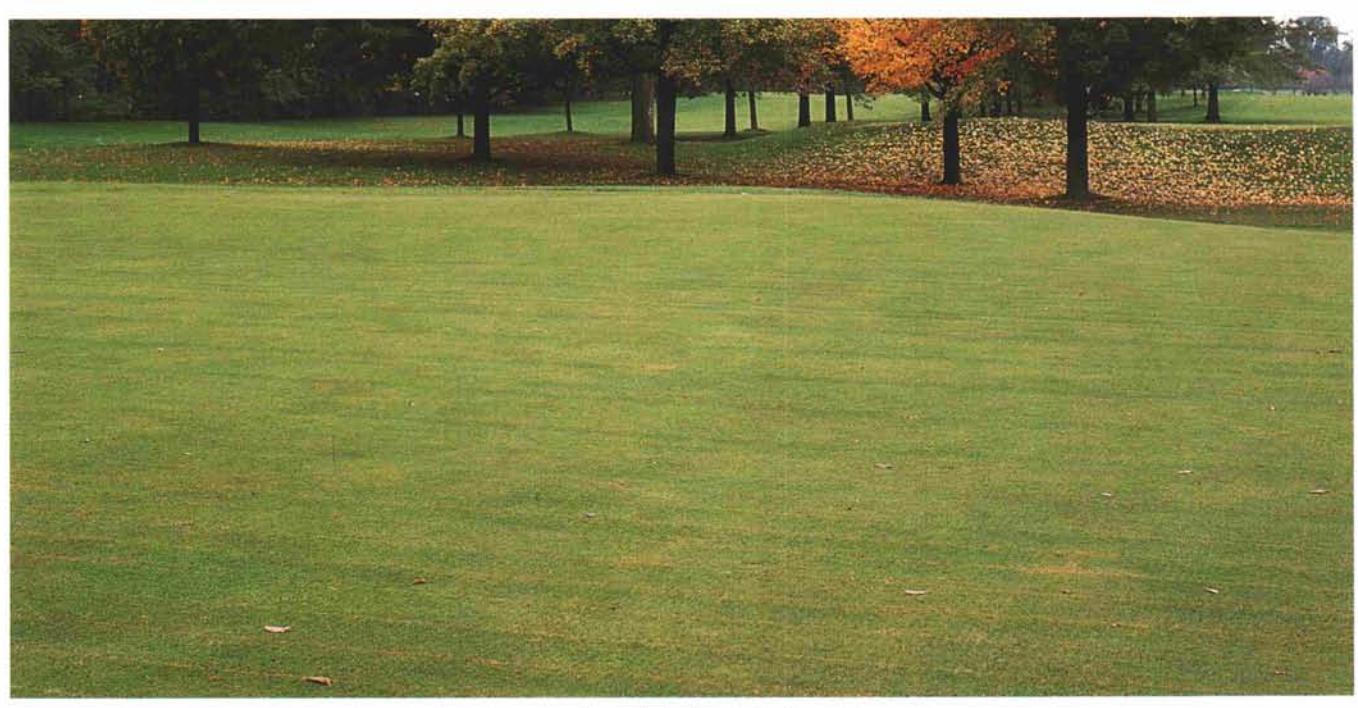
Completed product.
