## ASSESSING SOIL PHYSICAL PROPERTIES HELPS DETERMINE STRATEGIES FOR IMPROVING GREENS

# by DR. NORMAN HUMMEL

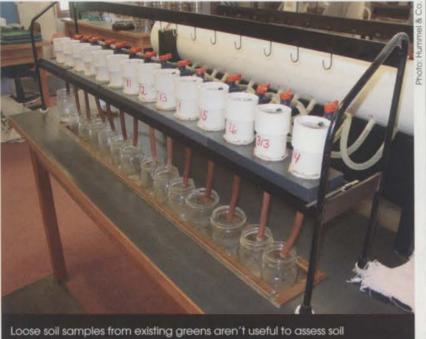
Loose soil samples from existing greens aren't useful to assess soil physical properties such as infiltration rate and porosity.

If a new green was built, a loose sample of mix would be sent to the lab, where the mix would be evaluated on laboratory-compacted samples. One shouldn't send loose samples from existing greens to labs to assess soil physical properties such as infiltration rate and porosity. Doing so won't provide any pertinent information about the greens because the sample won't be tested at the density it exists in the green. A good assessment of soils from existing greens should be done on undisturbed samples.

Using special sampling equipment or techniques, samples are removed from greens as cores that are shipped to the lab intact. This enables the lab to test the samples with the soil or mix as it exists in the field, providing a better evaluation of the physical properties.

While there's special equipment available for pulling undisturbed soil samples, these generally aren't cost effective for superintendents to purchase and involve some technique to pull a good sample. Instead, there's been good experience having samples pulled with PVC pipe, which should be beveled on the forward edge so that soil is displaced to the outside as the pipe is driven into the ground. Drilling holes in the top to insert a metal rod assists in pulling the sample out.

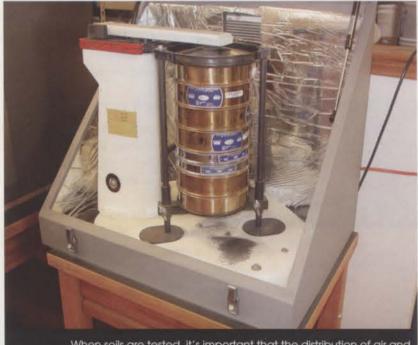
When soils are tested, it's important that the distribution of air and water filled pores are determined because they relate to soil health.

When soils or sand-based mixes from greens are tested, it's important that the distribution of air and water filled pores are determined because they also relate to soil health.
