Mechanical Matters

Contributed by Chad Braun, Equipment Manager, Prestwick Golf

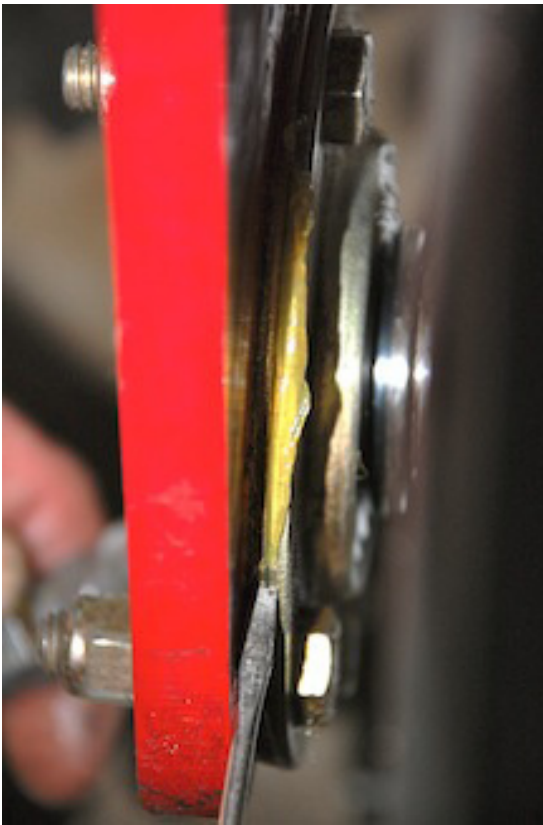
To the right observe the black marker line which indicates where a bead of silicone is to be placed insuring the stoppage of leakage and the redirection of grease to the bearing.

Solution: Place a small bead of RTU silicone between the flanges prior to assembly. This forces grease into bearing instead of leaking between flanges. Silicone easily comes apart when replacing the bearing during the next service.

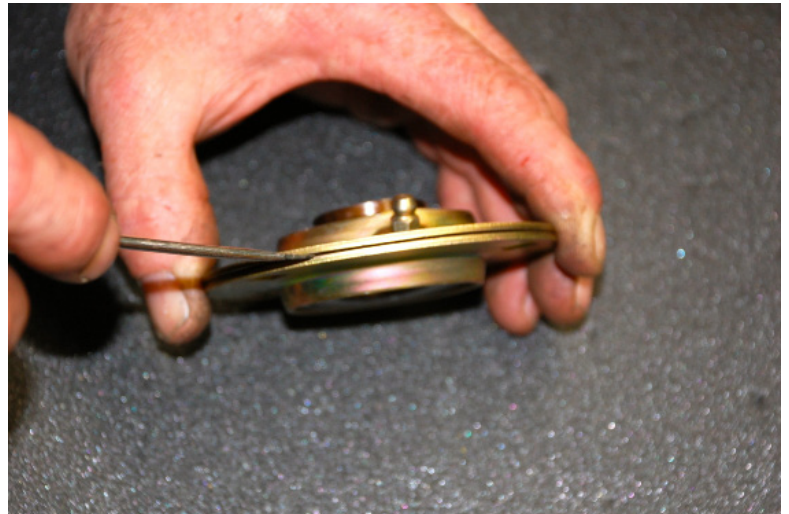
Above, now off the machine you can see the gap and problem in the bearing.
