December 21, 2017

# Golf Course Habitat Restoration Pilot Program: A Project Between the US Golf Association and The Nature Conservancy Final Report

Andrew J. Peck, PhD  
FRESHWATER PROJECT MANAGER

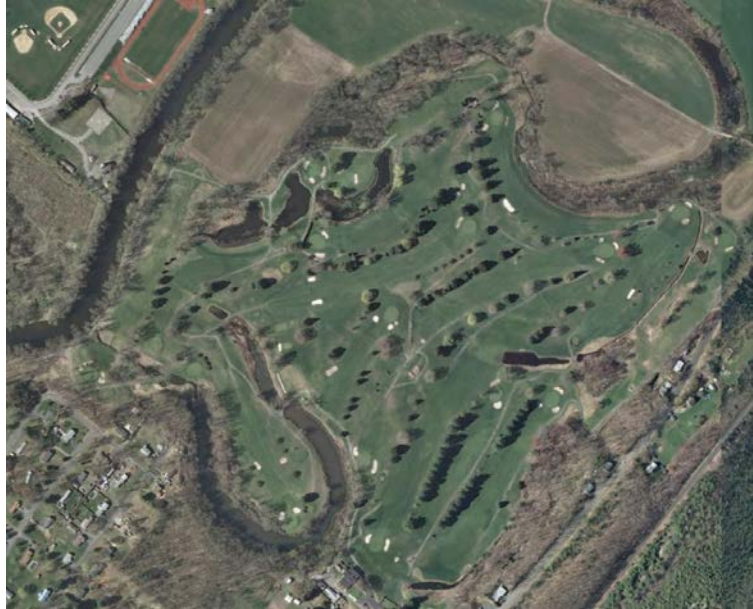
Figure 1. Aerial image of the 124 acres parcel that comprises The Lynx at Riverbend in Port Jervis, NY.

The Lynx at Riverbend, a privately-owned golf course but open to the general public, is situated on a 124 acre parcel (Figure 1) in the last, largely undeveloped, floodplain complex along the Neversink River before it joins the Delaware River. The course contains several natural oxbow pond complexes developed as the Neversink channel shifted its course over thousands of years. The course also receives significant run-off from the Shawangunk Ridge which runs along the southern border of the golf course property. The soils located on the course are quite permeable and allow water to percolate into the groundwater quickly. However, when the groundwater table is high, the Neversink River is generally approaching bank-full flow or flood stage. The natural function of the floodplain is to store water during these kinds of events and then slowly release it as the mainstem falls back within its banks. Receiving both flood water from the Neversink and surface run-off from the Shawangunk Ridge, means The Lynx at Riverbend is highly vulnerable to flooding with “worst case scenario” events occurring three times in the past 15 years. As precipitation events are expected to intensify in the future, significant flooding impacting the course is expected to become more frequent.

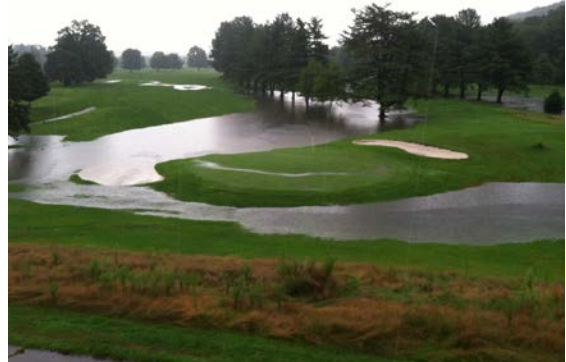
Figure 2. Moderate Flooding around the 18<sup>th</sup> hole of The Lynx at Riverbend. All areas left of the pine trees and inundated in the photo were naturalized in the Fall, 2017.

becomes unplayable and unsafe (Figure 2.). During an event of this magnitude, all of the existing waterbodies become inundated and begin accessing the floodplain and cover approximately 50% of the course. A 10-year flood event, with a 90% chance of occurring in any given year, practically impacts the entire course. The highest elevations likely become super-saturated while the lowest elevations may be inundated by nearly 12 feet of standing water or more.

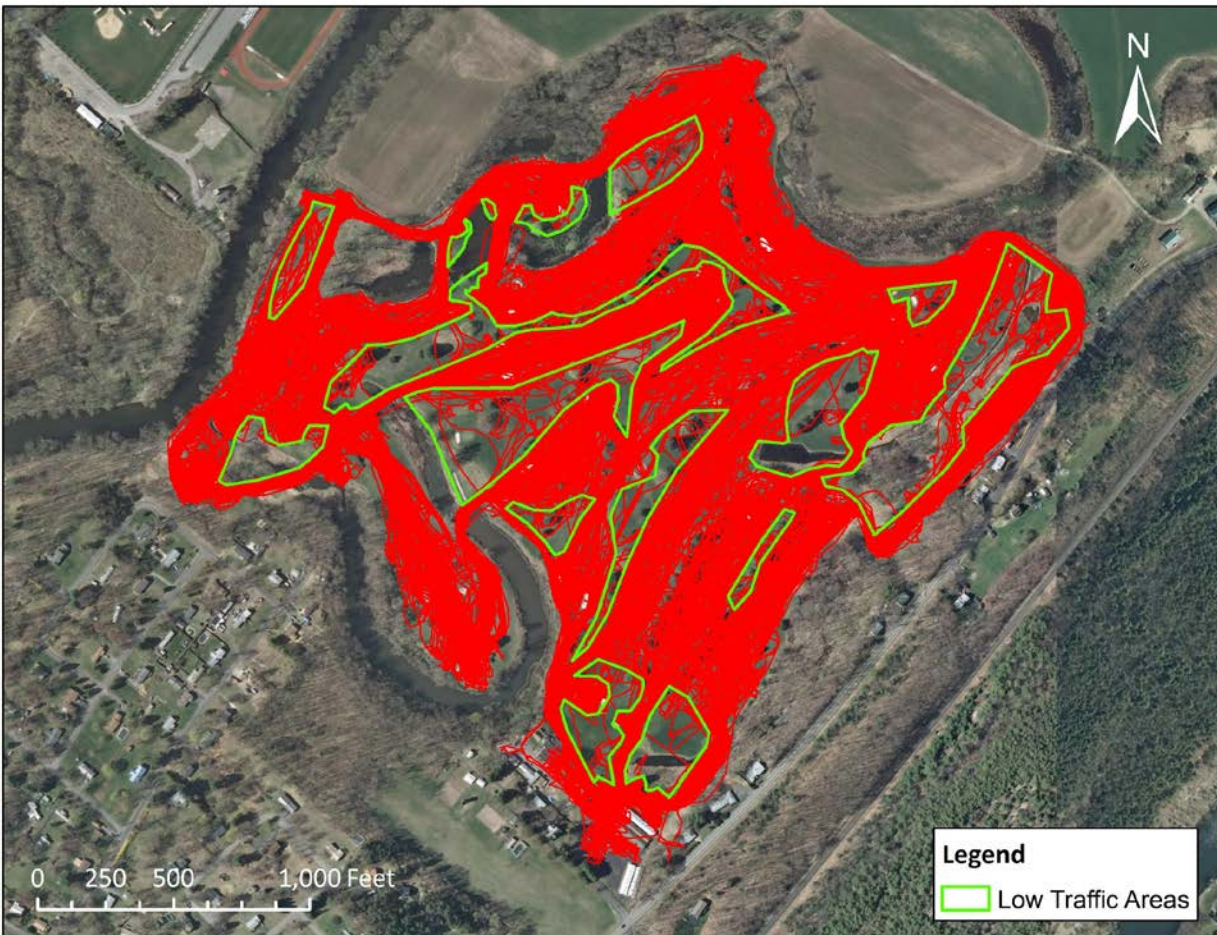
Figure 4. Areas in red represent the 90 tracks used by golfers that were fitted with Global Positioning Systems tracking devices provided by USGA Green Section. Areas inside of the areas with green borders were identified as possible naturalization areas. In total these 16 plots represent 35 acres and more than 25% of the course property.

In order to identify where actively managed areas with low intensity use by golfers existed, we deployed Global Positioning System (GPS) technology provided by the Green Section of the US Golf Association. The GPS Transmitters were deployed over two-month period during the 2015 Season and tracked 90 rounds of play. This user tracking exercise resulted in the identification of 16 areas suitable for naturalization throughout the course and comprised of more than 35 acres (Appendix 1); more than 25% of the entire course property. It wasn't feasible to tackle all 35 acres with the allocated budget, so, in collaboration with course management, we prioritized four areas to be completed with US Golf Association resources, totaling approximately 3.75 acres, based on their likelihood to become inundated, improve course management efficiencies, improve water quality and improve the overall course experience.

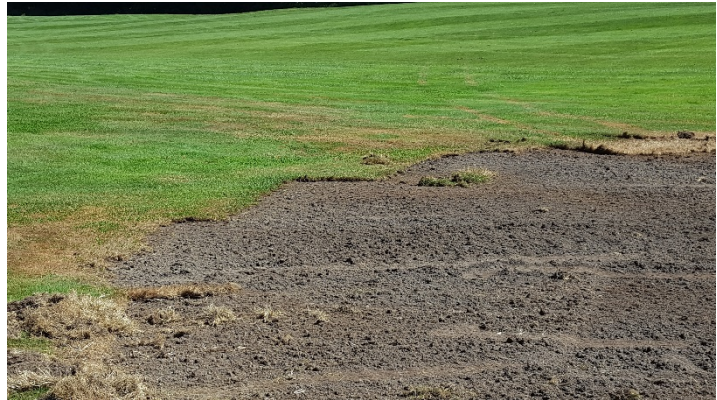
Figure 6. Resulting planting area conditions following removal of turf by “Harley Rake.”

In early September 2017, during the regions typical drought period, the course superintendent, a certified and licensed herbicide applicator, applied glyphosate to all the areas identified for naturalization. The herbicide areas were rested for roughly three weeks to ensure all existing turf and other plant material had been neutralized. We broke ground on the naturalization areas on September 25, 2017. The glyphosate treated turf was pulled up using a “Harley Rake” attachment on a wheeled mini-excavator (Figure 7). This not only pulled up the turf but also loosened the ¼” of remaining soil (Figure 6). The resulting turf material was then incorporated into new tee boxes or otherwise incorporated on-site.

In preparing the sites to be naturalized, we opted to try a new technique to The Nature Conservancy. The contractor recommended the use of a “Harley Rake” attachment for a mini-excavator. This was expected to save a tremendous amount of time and effort in turf removal. However, the maintenance crew failed to mow the areas, which had been allowed to grow, uncontrolled, for nearly 3 months, before glyphosate application. This produced a significant amount of turf material that needed to be managed. Although the “Harley Rake” worked extremely well, the areas should have been mowed first with a brush hog and then again with a mower prior to glyphosate treatment to reduce the amount of material requiring disposal management. We were able to develop a “beneficial use” plan for this material, as well as the pond dredge material, by incorporating both into new tee boxes.

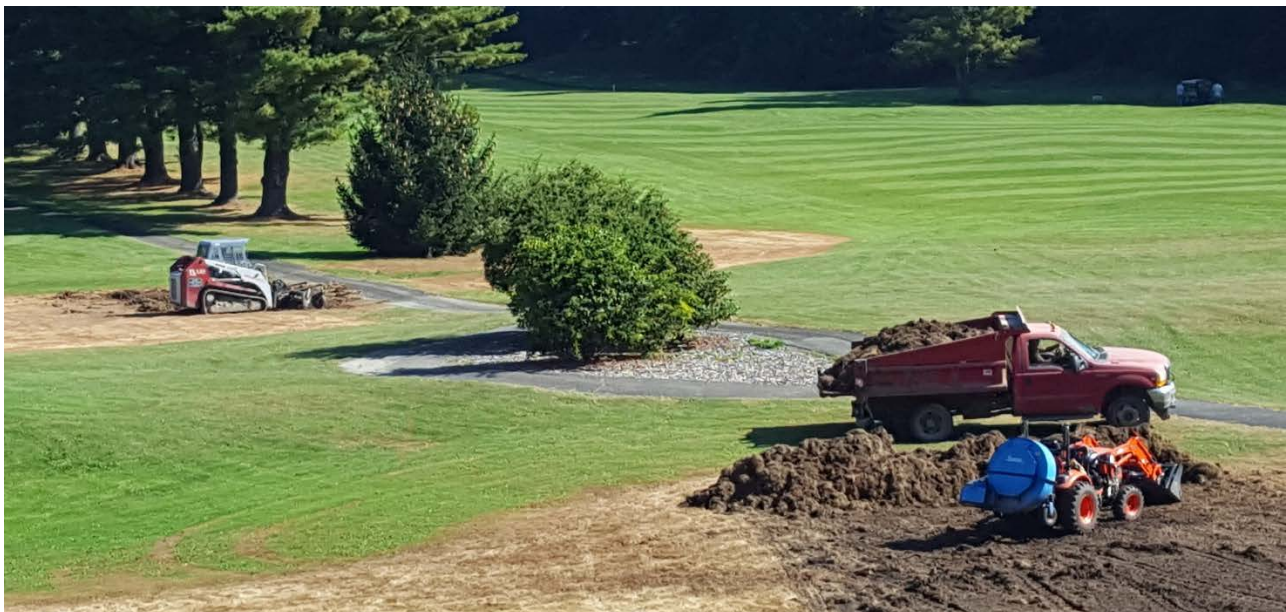
Figure 7. All equipment used in the turf removal and disposal process. Light brown areas have been treated with glyphosate, but not yet “Harley Raked.” Mini-excavator and “Harley Rake” used to remove turf (upper left corner). Dump truck and front-end loader used to transport removed turf to final destination.

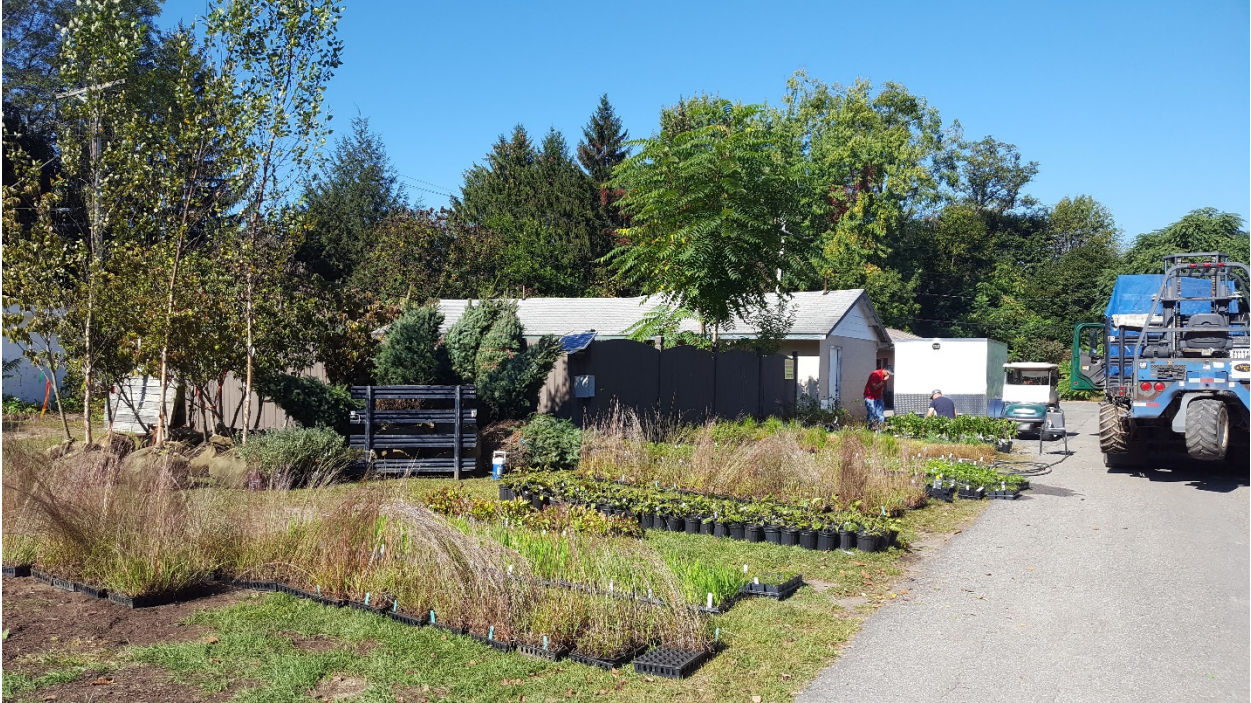
Figure 8. Plug, shrub and Tree staging area following delivery on September 27, 2017.

Plant material was delivered to the course on September 27, 2017. An inventory of delivered material was taken and condition of the plants were checked. The majority of plugs and plants were delivered in very good condition, but not all. A reconciliation was made with supplier to our satisfaction and replacement plants were delivered within three days. Seeding began immediately using both native seed mix for the appropriate moisture conditions and oats as an erosion and sediment control measure. All seeded areas were then drug using a steel mesh mat to ensure good soil to seed to contact conducive to seed germination.

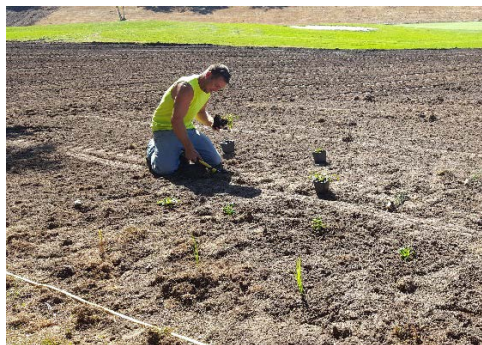
Figure 9. Contractor planting plugs in naturalization area in front of 18<sup>th</sup> Hole using an approximately 24-inch layout scheme.

Appropriate species and seed mixtures were selected for the appropriate moisture and anticipated inundation conditions and positioned to accentuate species diversity while not interfering with play. This was accomplished using 24" spacing between plugs and shrubs with shorter species around the perimeter and taller species being more concentrated toward the interior of each area. Additionally, course management agreed to adjust out-of-bounds markers and lines to ensure the naturalized areas are not impacted by cart or foot traffic following project completion. Shifting boundaries was not insignificant, but did not result in changes to hole par ratings. Tee boxes were also shifted on at least two holes, which was done largely to improve pace-of-play and used materials excavated from the naturalized areas and pond dredging.

Planting of plugs occurred over two periods, September 28 – October 3 and November 2 - November 6. A third-party contractor and a volunteer group from the Albany Pine Bush assisted in planting more than 12,000 plugs along with 117 shrubs and trees on nearly 4 acres.

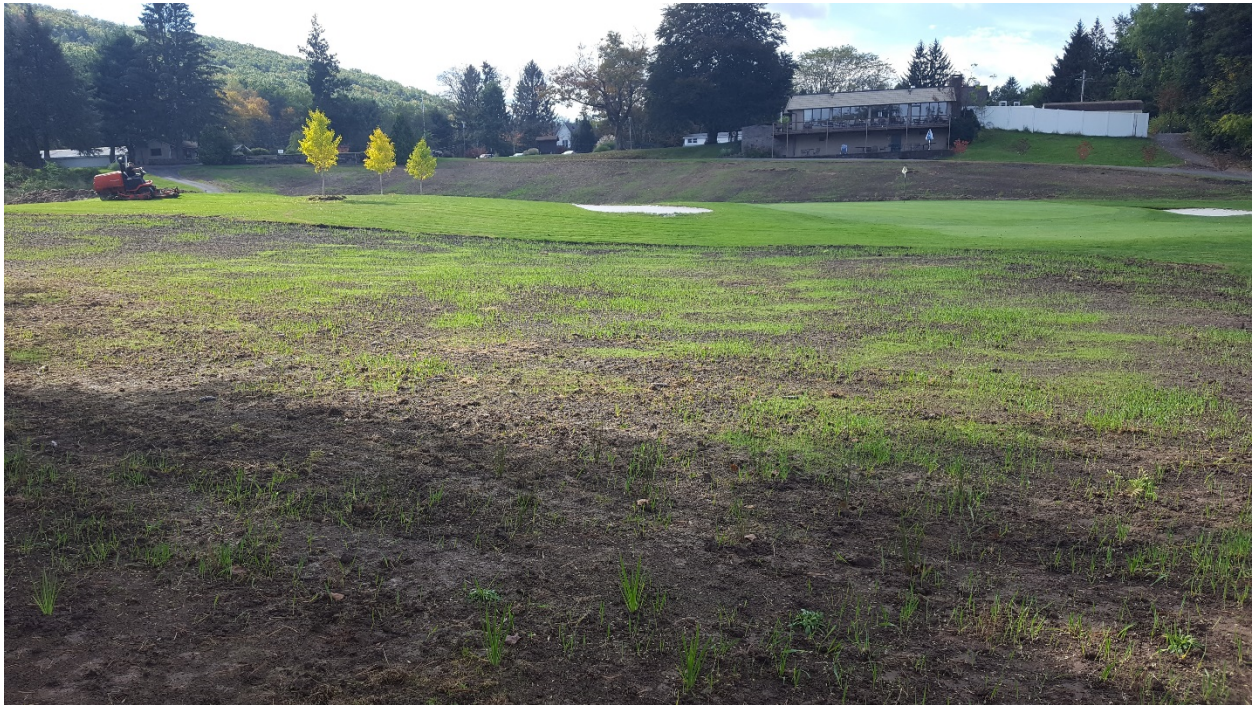
Figure 10. Initial germination of oats on October 10,2017 in front of the 18<sup>th</sup> green (foreground) and on a steep slope in front of the clubhouse (background). Plant plug material is interspersed, but difficult to identify.

Although soils were dry during the initial planting period, we received moderate precipitation shortly after which allowed for initial germination to be observed on October 10, 2017. The Erosion and Sediment Control inspections identified good germination rates across all sites with some small areas benefiting from additional seeding. In these small areas, a supplemental mix of winter rye and oats were seeded. Germination continued to be observed through mid-November as weather conditions were very favorable.
