Restoring Lake Banks Reduces Labor Costs

Peridia Golf and Country Club Ray Bartels, CGCS, superintendent

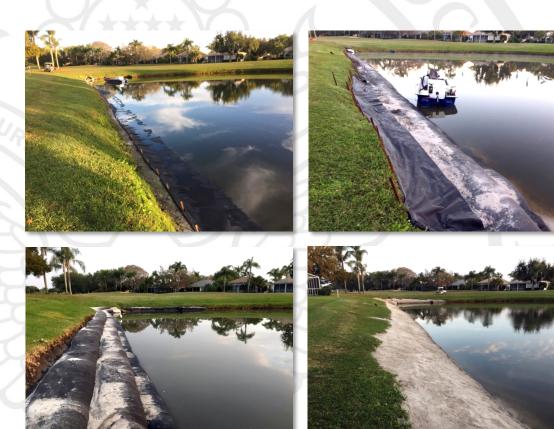
Figure 2 - The shoreline stabilization process involves placing a series of geotextile tubes along the shoreline (upper left), filling them with sediment from the bottom of the pond (upper right, lower left), covering the tubes with soil (lower right) and eventually sodding the slope.

The goal was to create gradually sloping lake banks that would be more manageable for golfers and maintenance practices. The club decided that a 4:1 slope—i.e., 25-percent slope—or less was their target. Peridia Golf and Country Club began restoring several eroded lake banks and installing geotextile tubes to stabilize shorelines and prevent future erosion. The process costs \$35 per foot and, with more than 13,600 feet of shoreline to stabilize, it is going to take a few years to complete the entire project.
