Creek Restoration To Reduce Erosion And Preserve Habitats

St. Thomas Golf And Country Club
Wade Beaudoin, superintendent

London, Ontario

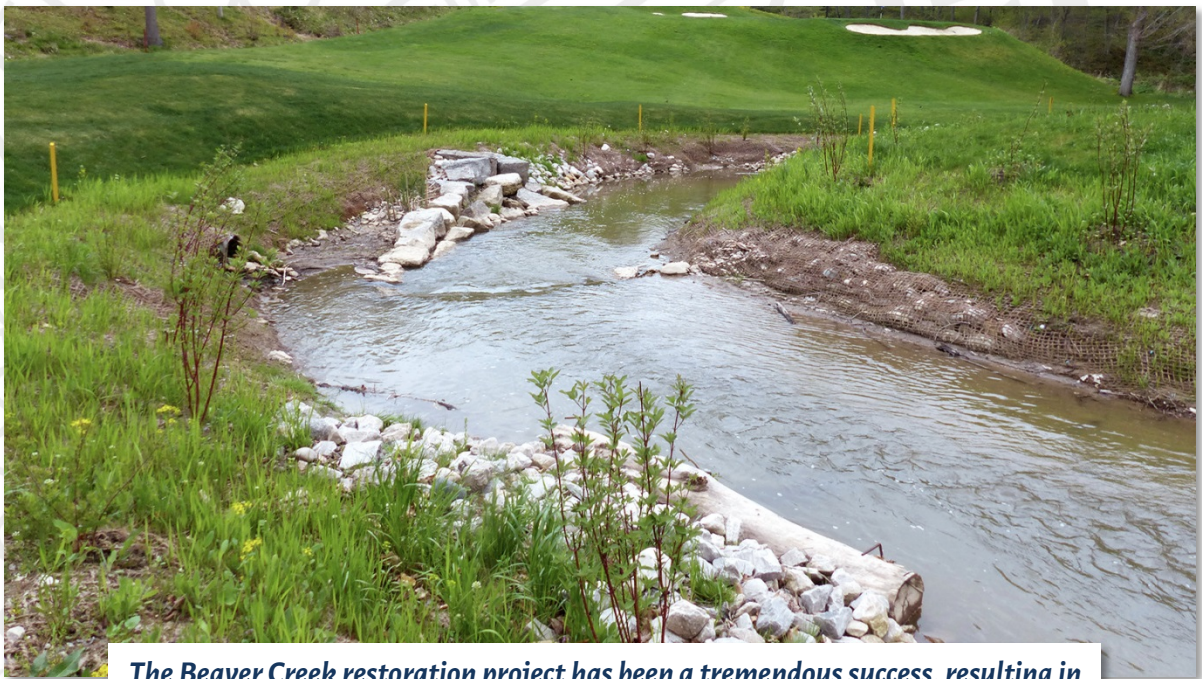
The Beaver Creek restoration project has been a tremendous success, resulting in stabilized creek banks, improved water quality and enhanced wildlife habitat.
