Enhancing Playability With Improved Drainage

Westmoreland Country Club
Todd Fyffe, superintendent

Wilmette, Ill. 60091

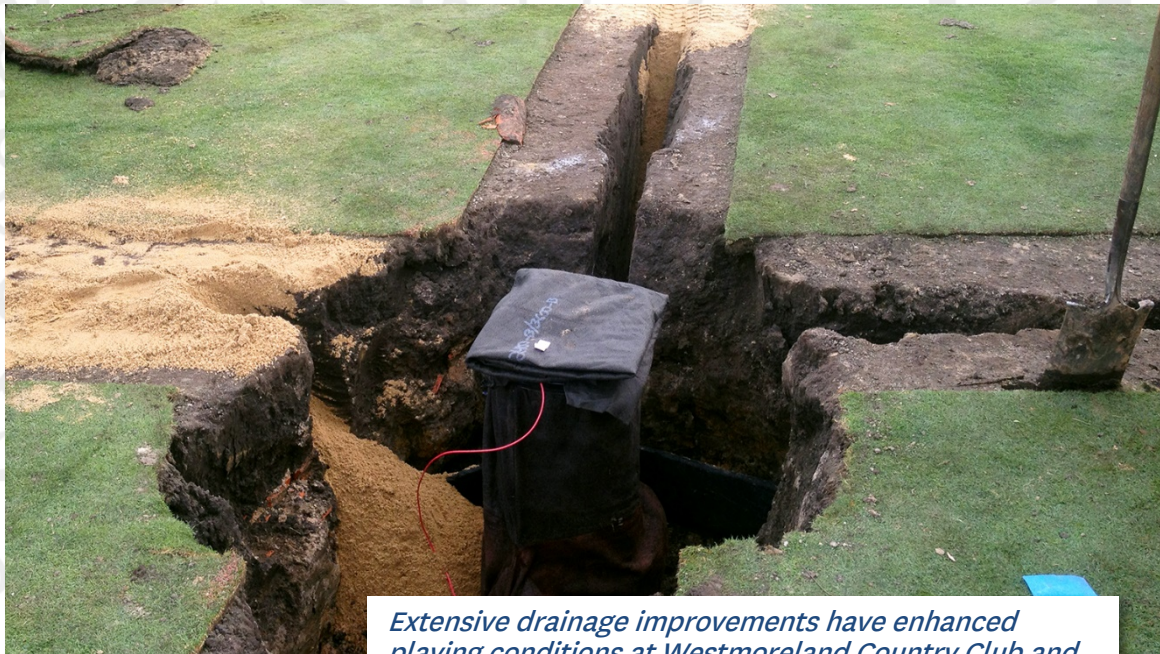
Extensive drainage improvements have enhanced playing conditions at Westmoreland Country Club and help the course reopen quickly following rain events.

The new drainage system includes 11 miles of “waffle” drainage pipe that was backfilled with coarse sand. There are also 11 pumps, both electric and irrigation driven, that move water to retention ponds on the property. A transfer pump was installed to move water from the retention ponds to the irrigation reservoir, helping Westmoreland utilize more stormwater for irrigation. Lastly, a pipe was installed to move water from the irrigation reservoir to another storage pond at a higher elevation, increasing the facility’s total water storage capacity.
