Improved Water Storage Yields More Consistent Playing Conditions

Wilmington Country Club
Dan Pierson, director of grounds

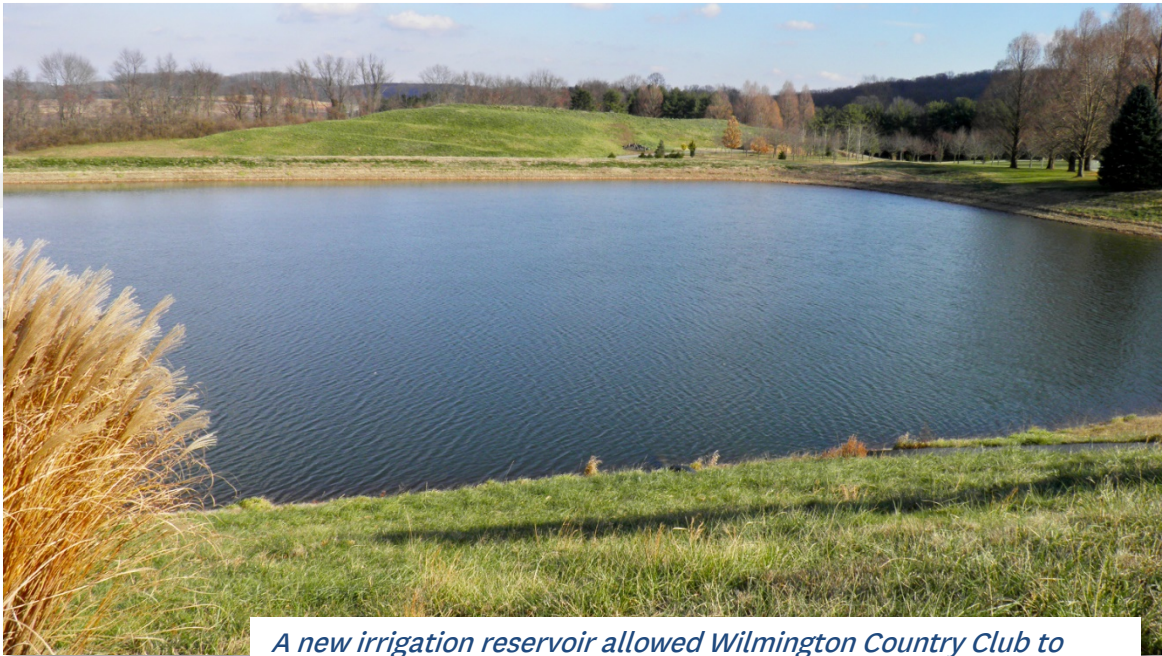
A new irrigation reservoir allowed Wilmington Country Club to store enough water to properly irrigate both of its golf courses, even during extended dry periods.

After reviewing several options it was decided that an additional reservoir would be built adjacent to the existing reservoir, increasing the facility's total water storage capacity to approximately 35 million gallons. Construction started during the summer of 2011 and finished in early 2012.

Water is transferred from the new reservoir to the distribution reservoir by an 8-inch HDPE pipe that is connected to a pump mounted on a custom platform at the bottom of the new reservoir. When the pump requires service, an air compressor is connected to a valve on the transfer line to force all of the water from the pipe. This causes the pipe and pump to float to the surface where service can be performed.
