# SAND CHANNEL DRAINAGE IMPROVES FAIRWAY CONDITIONS

Idle Hour Country Club | Lexington, Ky. 40502

Clay Stewart, superintendent

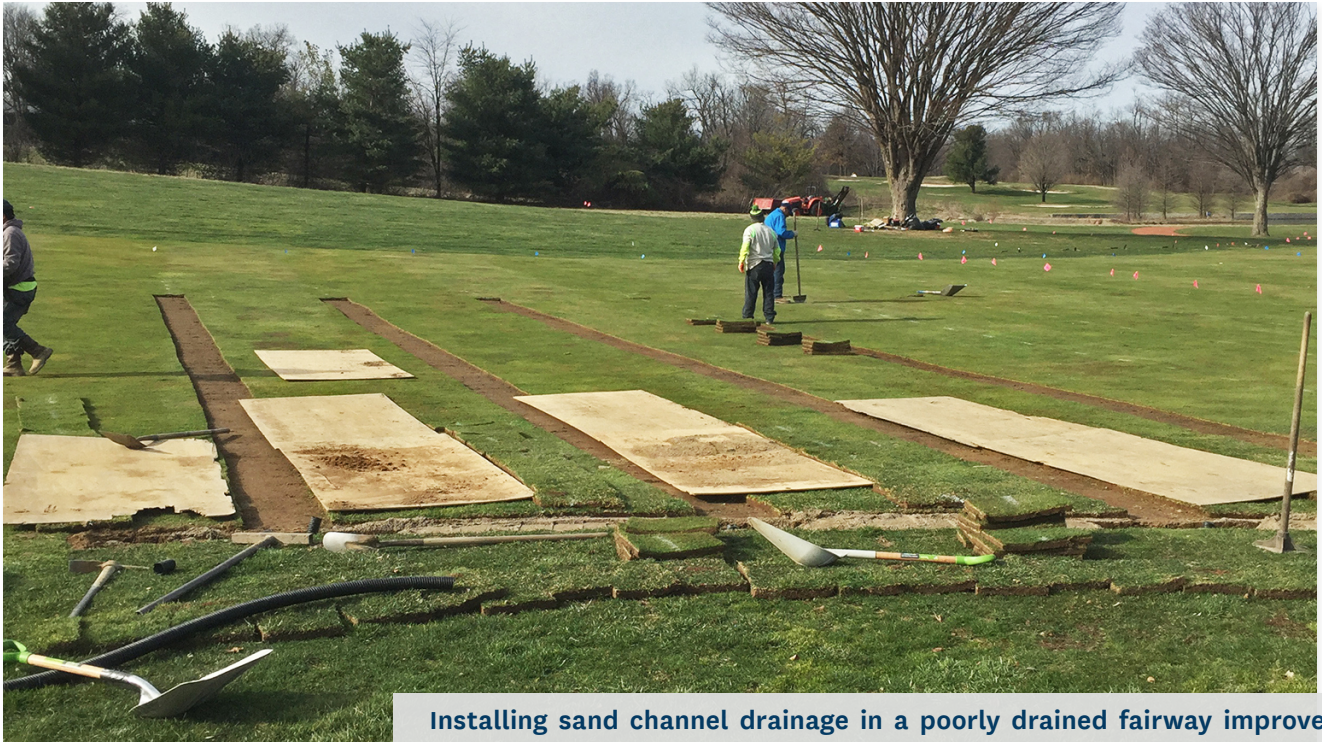
Installing sand channel drainage in a poorly drained fairway improved playing conditions and turf health and greatly reduced cart restrictions.

Favorable weather during February of 2017 provided an opportunity to complete the project without disrupting play. Lateral drain lines were installed throughout the fairway using 2-inch perforated pipe on 10-foot centers. Each lateral was connected to a 4-inch trunk line which outflows into the pond adjacent to the fairway. Lateral drain lines were backfilled with a free-draining sand and the sod that was removed to install the drain lines was replaced in its original location.
