BEST MANAGEMENT PRACTICES CASE STUDY

HYBRID IRRIGATION PIPING FACILITATES OFF-SEASON INSTALLATION

The Ohio State University Golf Club | Columbus, Ohio 43221

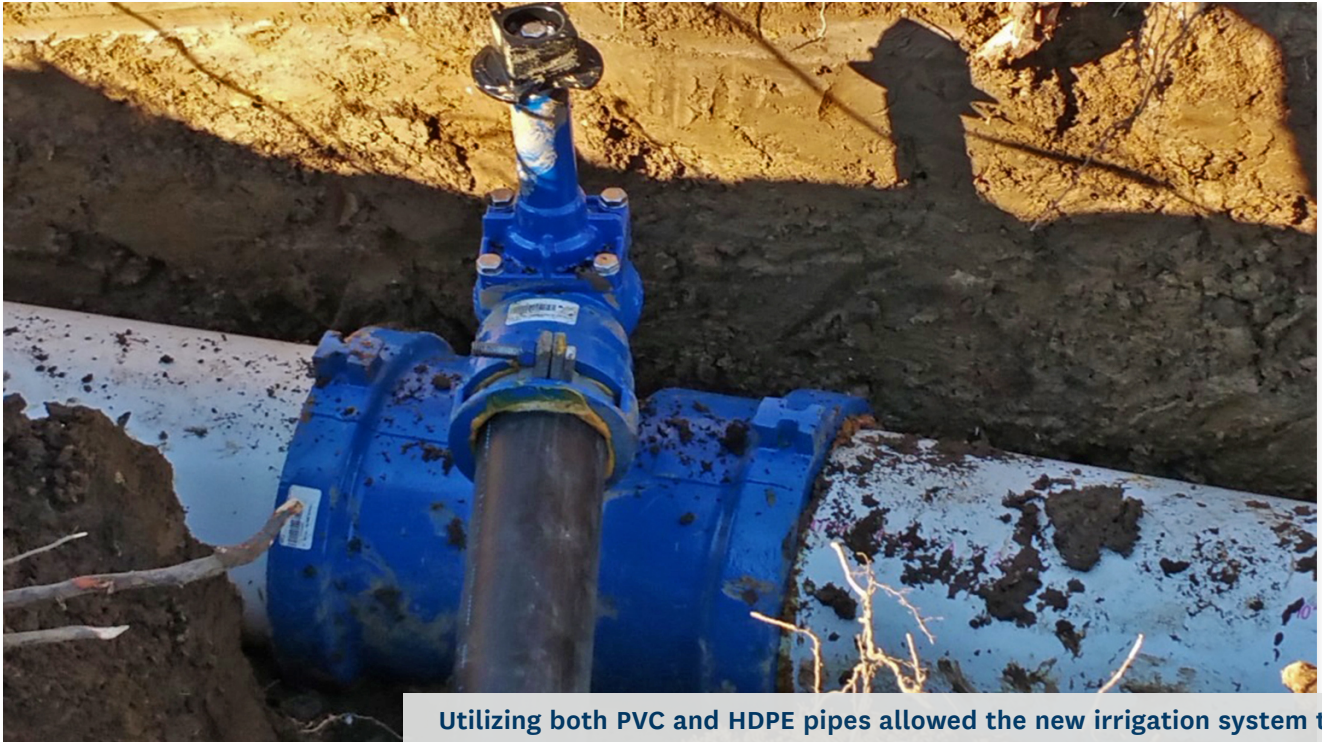
Utilizing both PVC and HDPE pipes allowed the new irrigation system to be installed during winter when there would be less disruption to play.

For all of the mainline pipes – i.e., 4-inch pipes and larger – PVC pipe would be installed by digging open trenches. For all lateral lines – i.e., 3-inch pipes and smaller – HDPE pipe would be pulled in with a vibratory plow. The decision to install HDPE pipe for the laterals made it possible for the project to continue during winter. Work would otherwise have been suspended during cold weather because the solvent weld cement used to connect PVC pipes has temperature restrictions for when it can be used effectively.
