The National Mall and Putting Greens

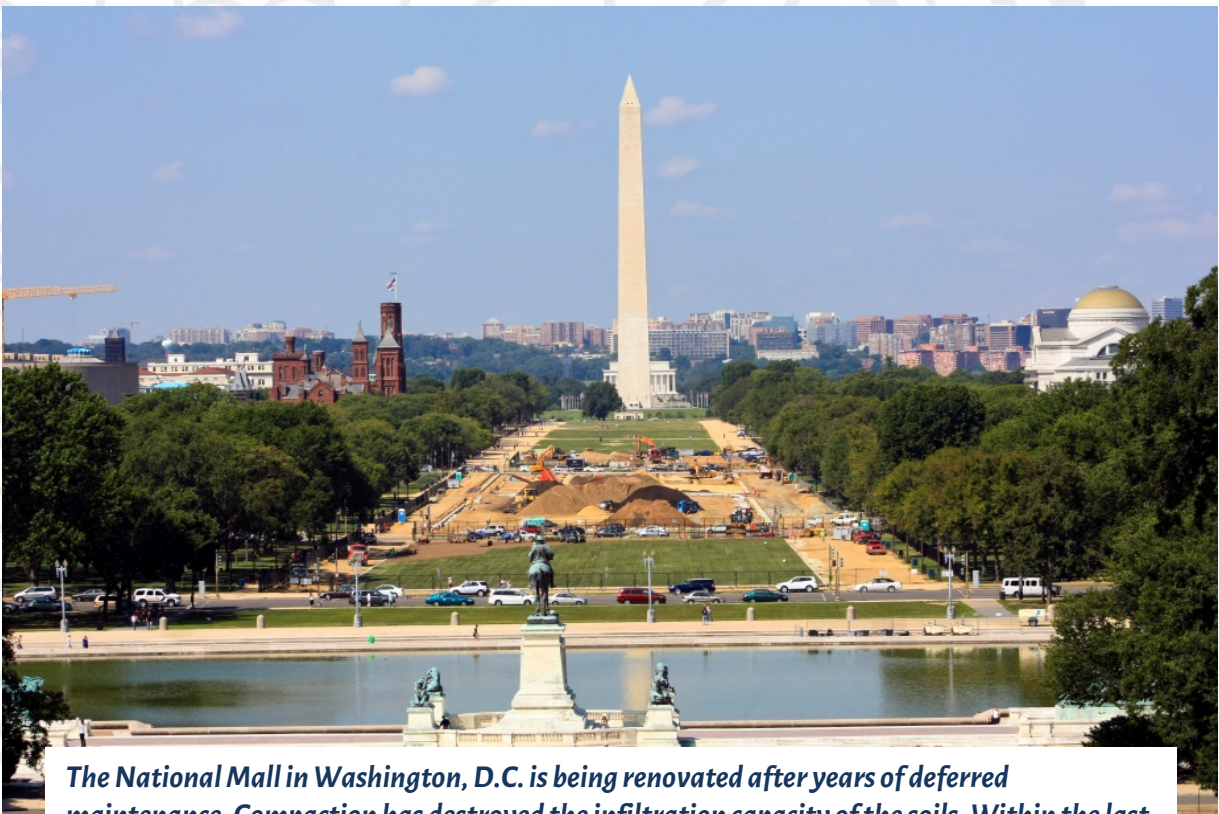
The National Mall in Washington, D.C. is being renovated after years of deferred maintenance. Compaction has destroyed the infiltration capacity of the soils. Within the last few years, the Trust for the National Mall has jump-started a major, multiyear renovation, which includes the restoration of the turfgrass, soils and drainage on the National Mall.

The soils and turf areas near the Capitol building were restored in 2012. An irrigation system, drainage lines and large underground cisterns that collect reusable stormwater were installed. The soil profile is like a USGA putting green – an amended, sand rootzone over a gravel layer with drain lines. Developed in the 1960s, this type of engineered rootzone withstands the high amount of traffic that putting greens receive each year. Periodic adjustments to the USGA Recommendations for a Method of Putting Green Construction by the USGA and soil scientists have occurred to improve performance and reduce construction costs of USGA putting greens.
