King Tides: A Concern For Coastal Courses In The Southeast

By John Foy, regional director, Southeast Region

November 6, 2015

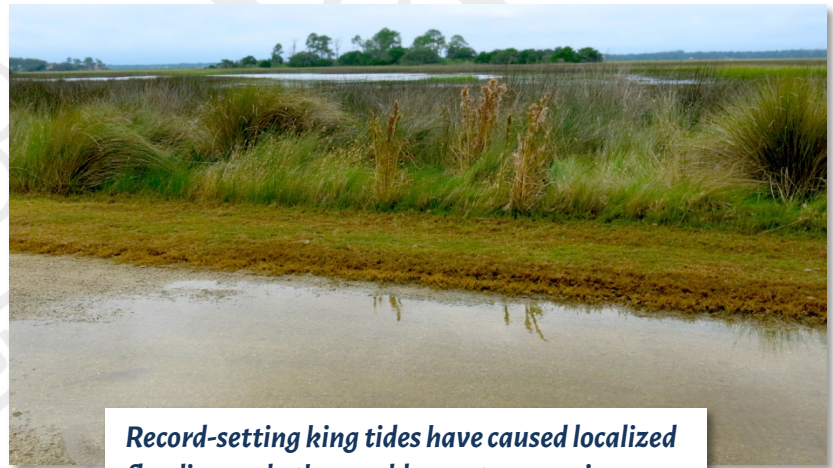
Record-setting king tides have caused localized flooding and other problems at courses in coastal areas of the Southeast Region.

At all of the courses visited, varying degrees of localized saltwater flooding had been experienced in low-lying fairways, roughs and bunkers. With the subsequent normal decline of the king tides and lowering of the groundwater table, the localized flooding problems will diminish. However, in some locations

turf damage and loss still can be a problem due to salt accumulation in the soil. Naturally, before recovery and sod repair work can be undertaken, it will be necessary to leach/flush salt accumulations out of the upper rootzone. At other golf courses in Southeast Florida where repeated flooding problems have been experienced due to normal high tides during fall, reconstruction work to raise low-lying areas has been included in capital improvement plans.
