THE WALLER'S TALE

By Paul Worster, Course Manager, Minchinhampton GC

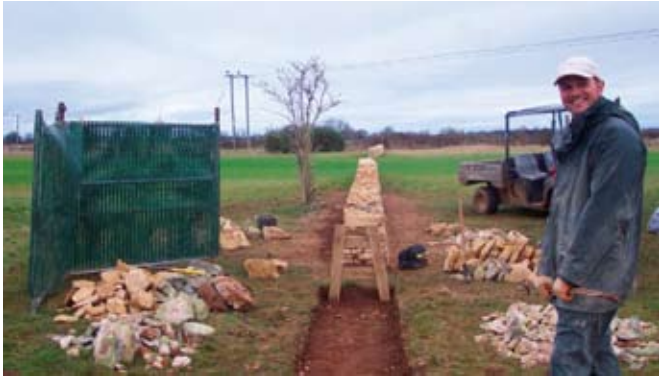
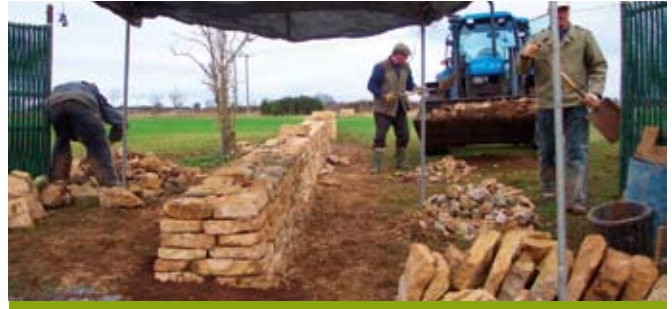
Large stones are put into the foundation and base courses, followed by progressively thinner stones for the uppermost courses.

The rest of the material is removed, and a firm foundation trench dug. A specially shaped frame and lines are used to make sure that all walls are of standard dimensions and follow straight lines. Charlie makes it look easy, but this is an illusion – there is a lot more involved than placing one stone on top of two more. All stones must be level and firm with no rocking. Charlie actually walks on the foundation stones to make sure they are firm.

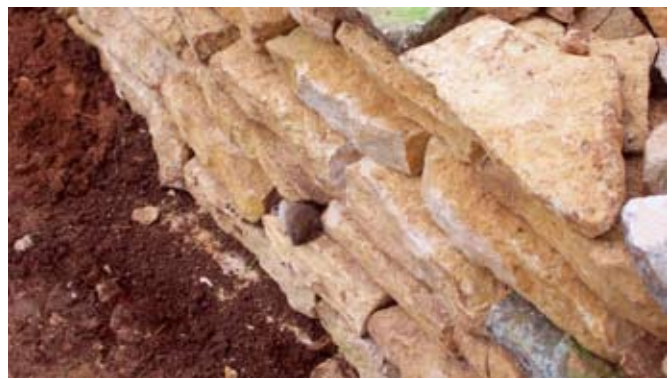
The local wildlife is already showing a strong interest in the walls which provide a habitat for small mammals which in turn benefits the local bird of prey population. The walls are therefore a critical part of the various ongoing ecology initiatives here at Minchinhampton.

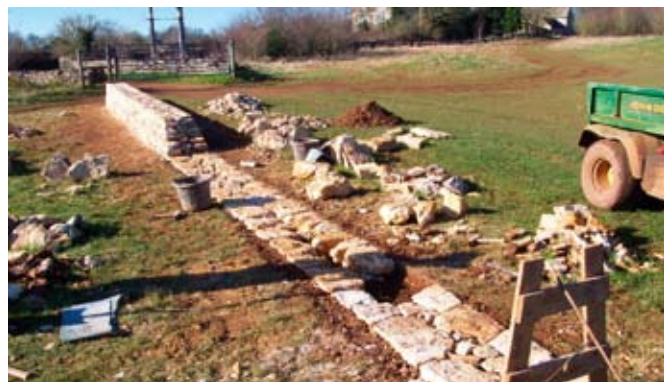
New stone – (as dug from the ground during a recent lake excavation), is sorted from a stock-pile, faced, and delivered on pallets to the wall site. All staff are involved in this sorting & facing process, while Charlie and the two other skilled “wallers” do the rebuilding. Most of the stone needs to be “worked” with hammers & chisels to get rid of any protrusions, allowing it to lie firmly within the new wall. The internal walls are known as feature walls and their construction differs quite significantly from boundary walls. Charlie pays great attention to detail whilst building these feature walls and uses large stones which virtually meet in the centre of the wall to produce a solid structure that uses the weight of the stones to hold the wall together. A boundary wall would be built much quicker than a feature wall and less work would be done to face and prepare the stone.
