# Golf course drainage: Short term pain, long term gain

David Shelton describes the extensive drainage work that has been carried out at Loch Lomond Golf Club

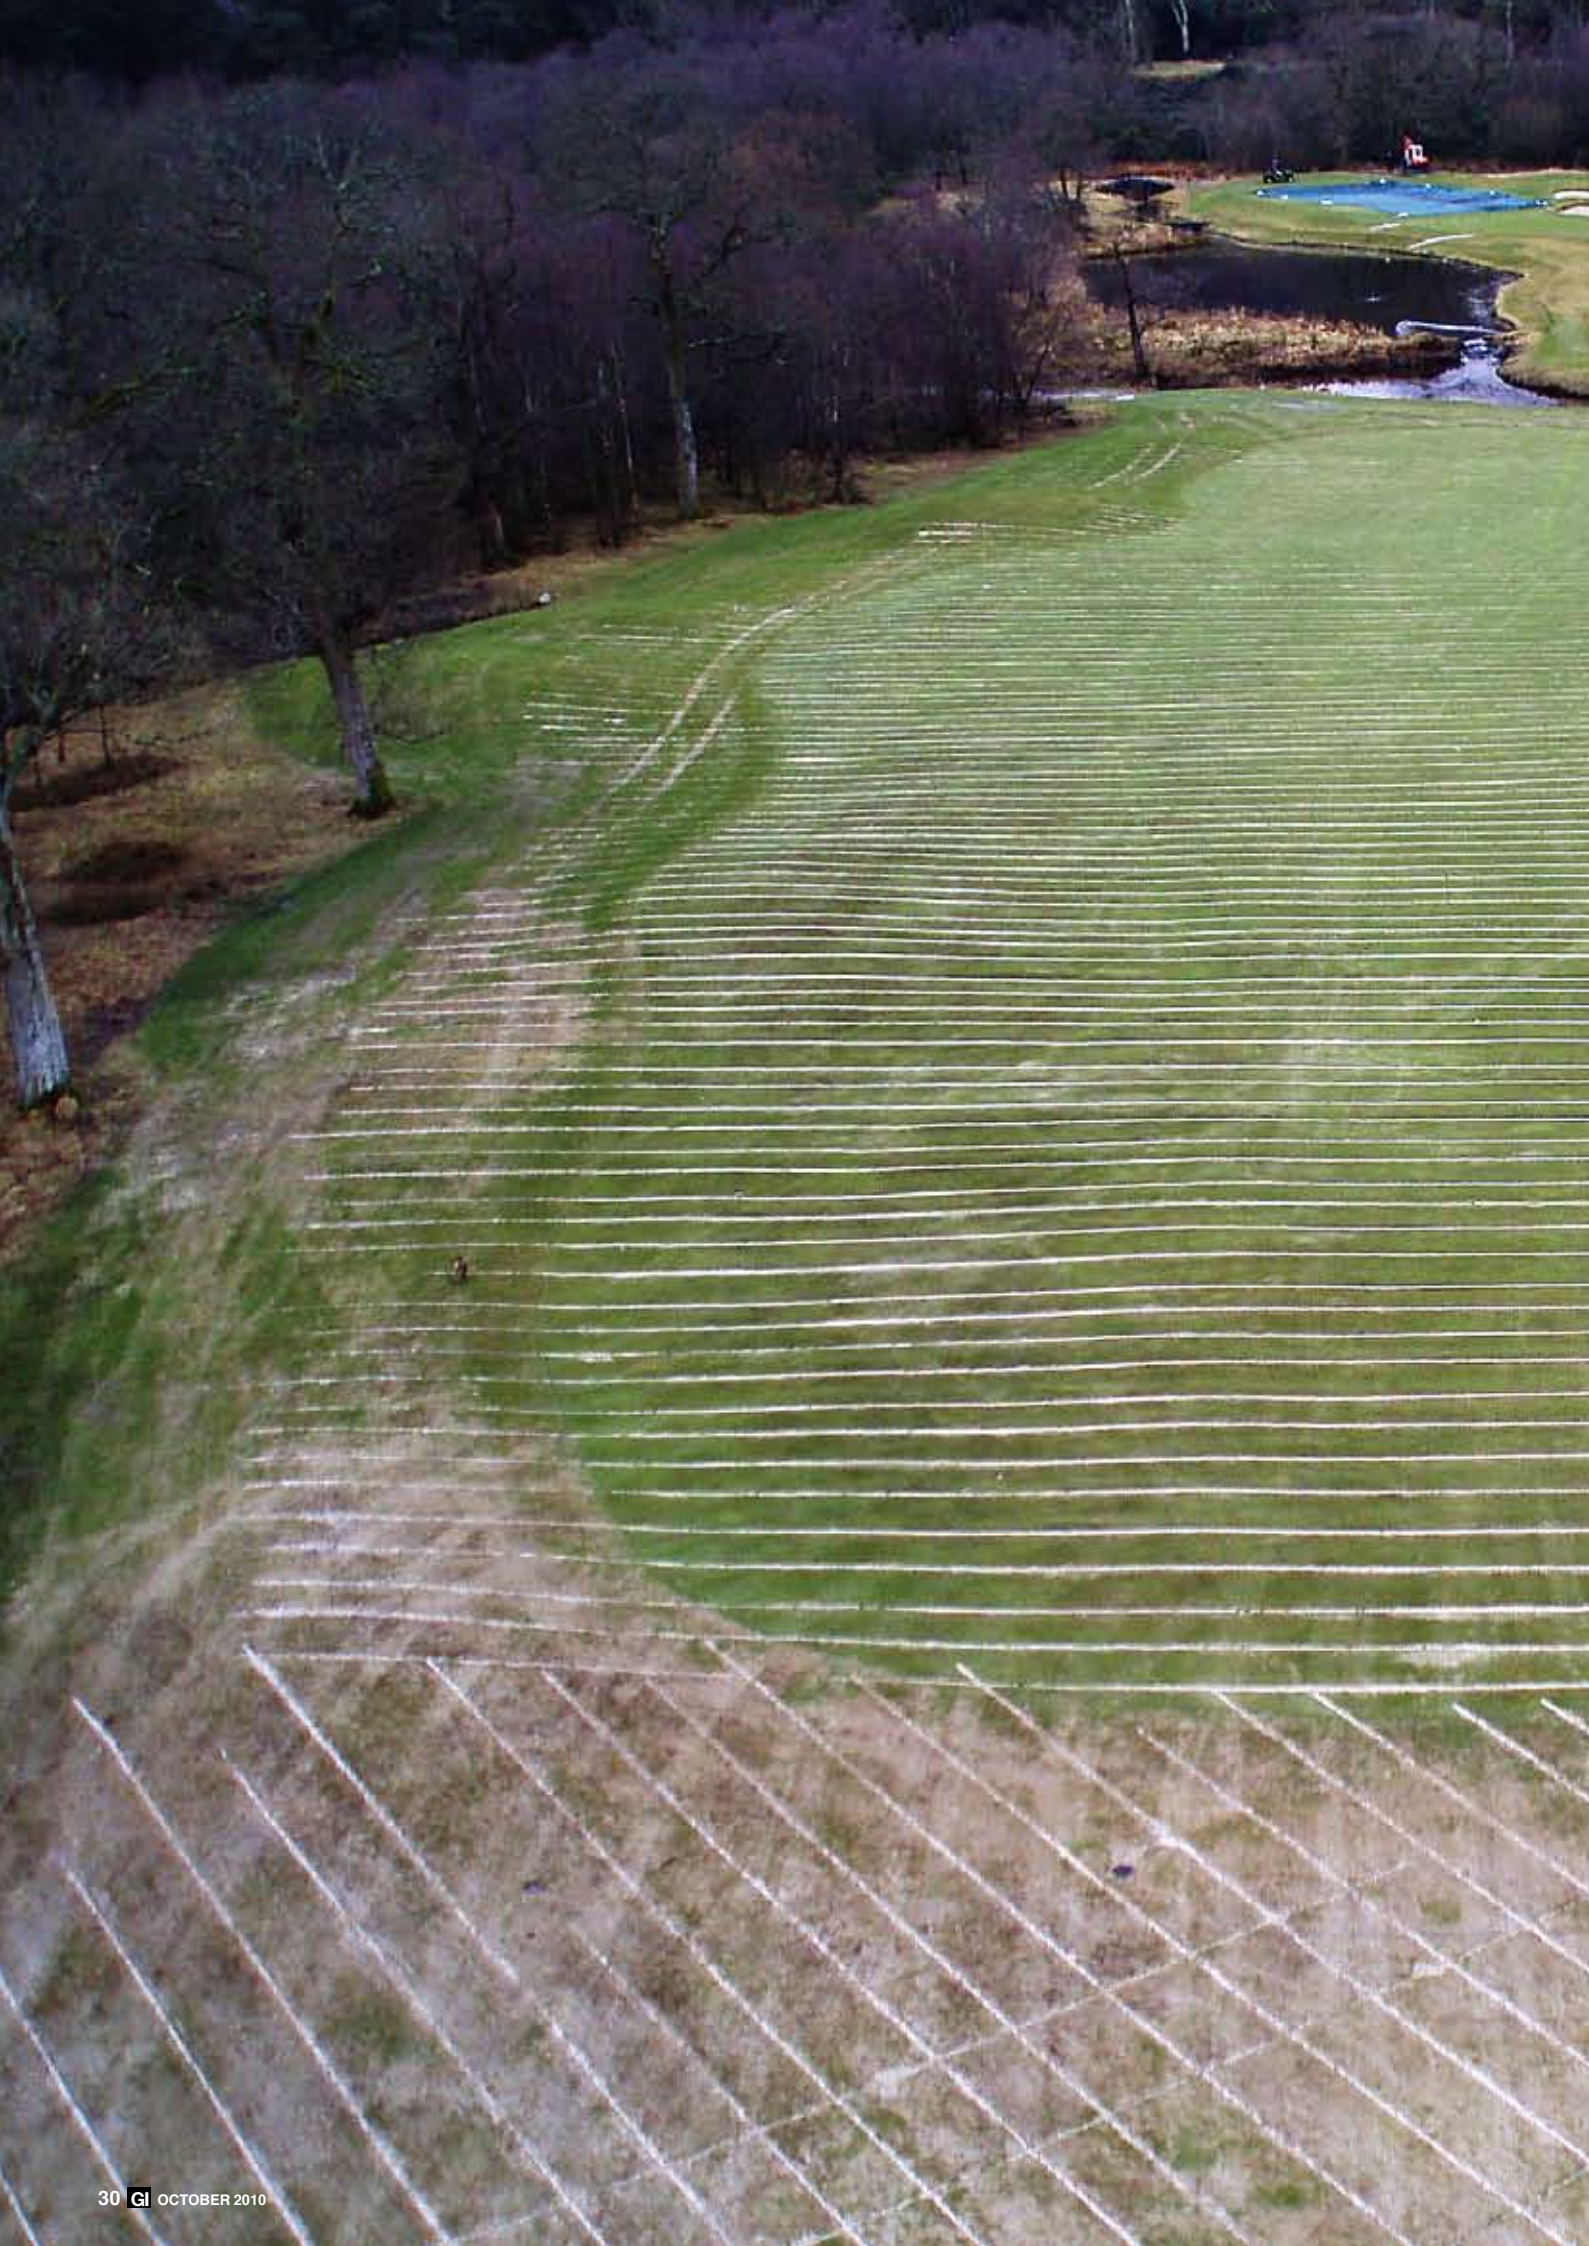
An aerial photograph of a golf course. The foreground and middle ground are dominated by a large area of green grass with a grid of white lines, indicating extensive drainage work. A single, large, leafless tree stands prominently in the middle ground. In the background, there is a sand trap and a small stream or drainage ditch. The overall scene is set against a backdrop of dark, dense trees.

A total of 74½ kilometres of phase two drainage with trenches dug 55mm wide and 225mm deep spaced at 1 metre intervals speed excess soil water to the piped system. The same Tillicoultry sand is used in back-filling these drainage channels, also.

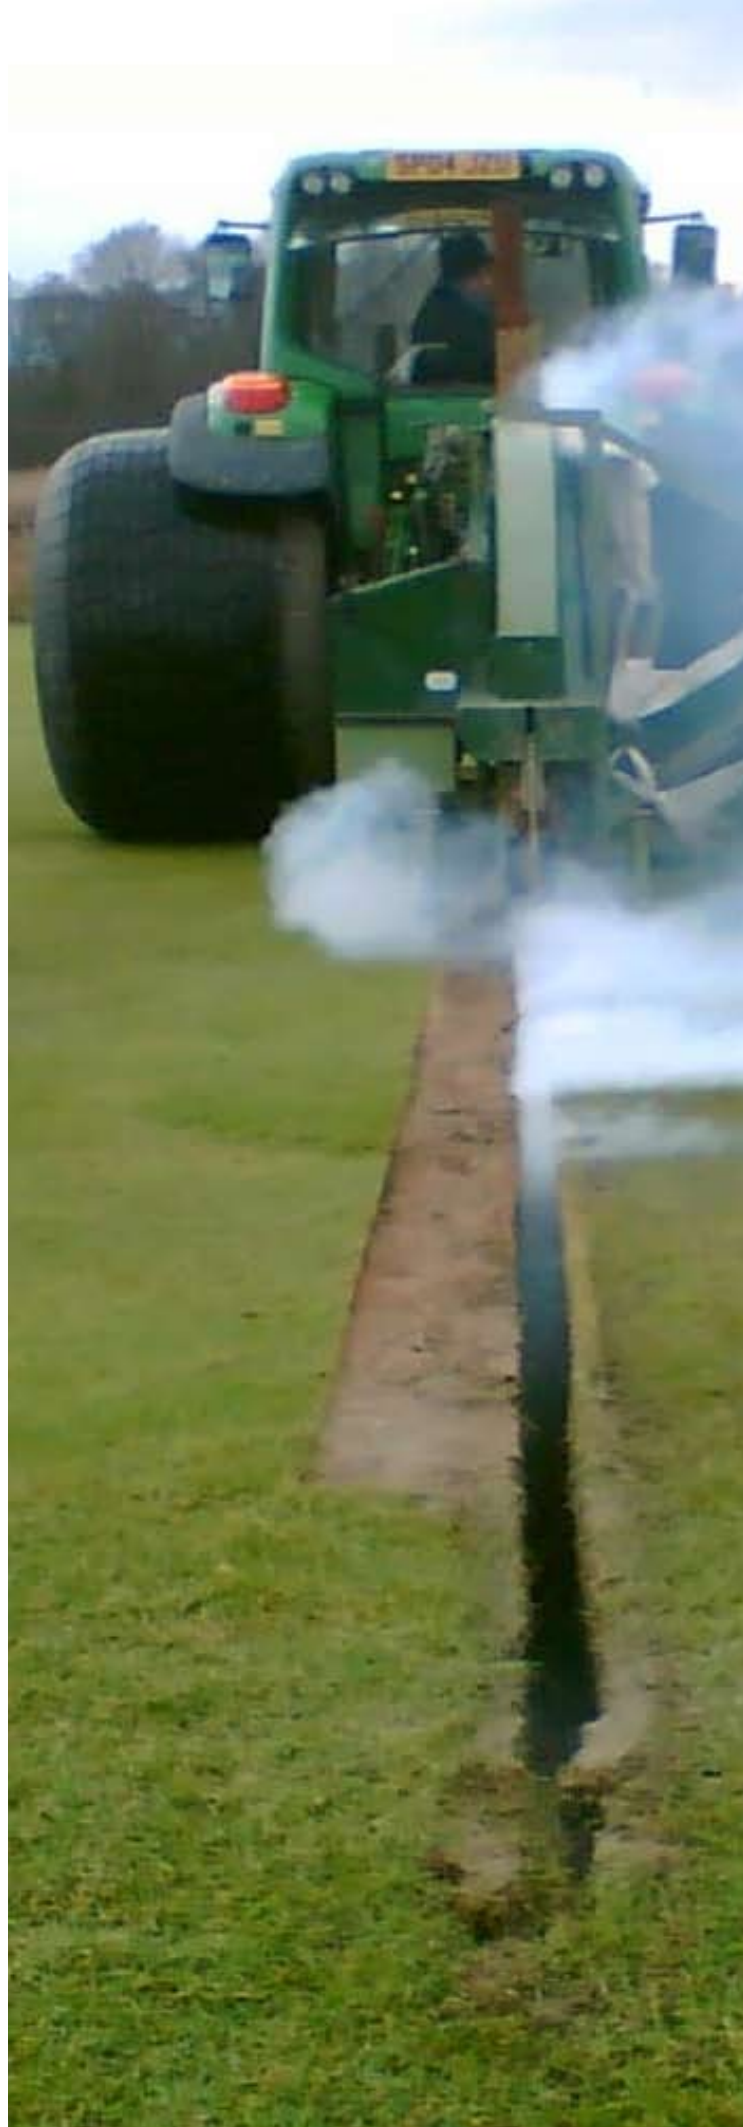
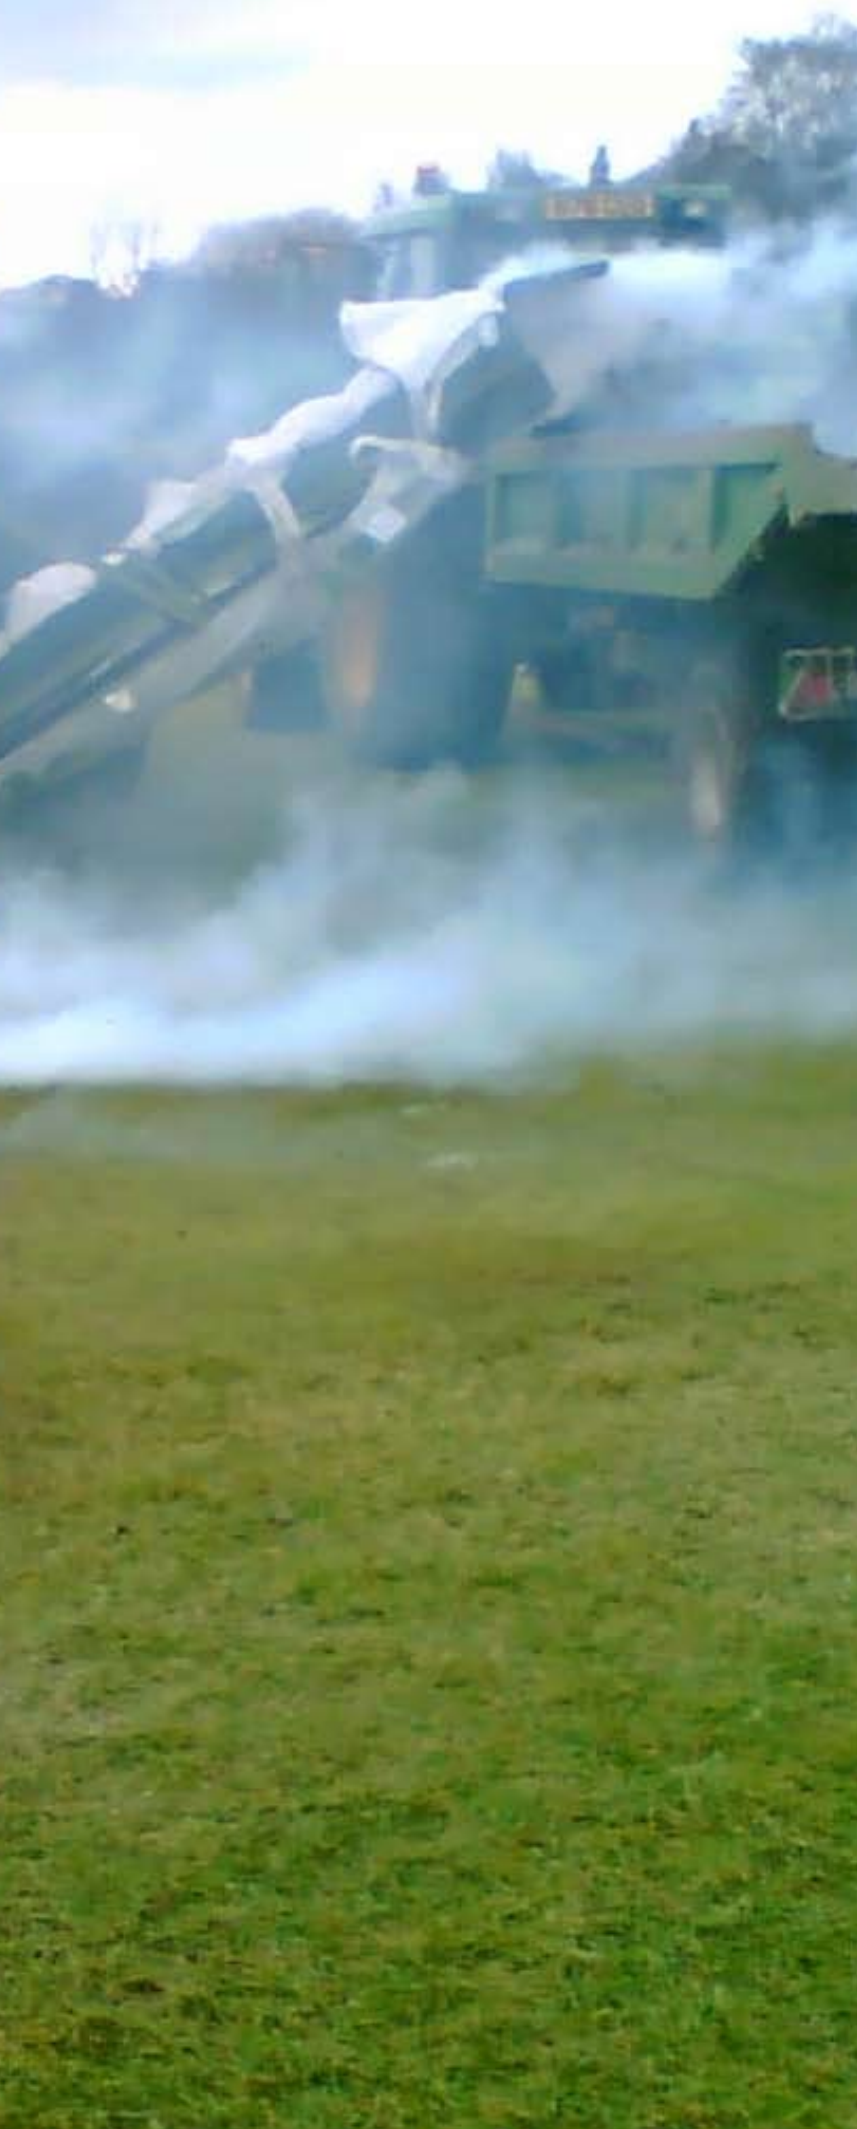
The accompanying pictures show the exceptionally high standards of operations undertaken by the eight strong drainage team. In all but extreme weather conditions this course should be able to host the most prestigious competitions for the enjoyment of players and spectators alike.
