An Eye for Quality: A New Methodology for Quality Control During USGA Putting Green Construction

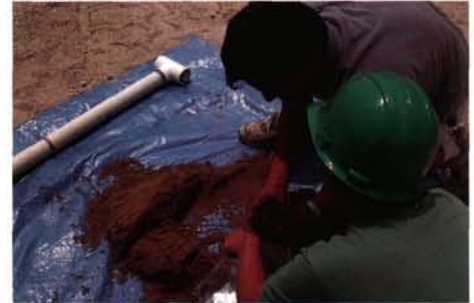
Preparing a representative sample from a large stockpile of sand requires hand-mixing a minimum of eight subsamples. After thorough mixing, a one-gallon sample is sent to a certified physical soil-testing laboratory.

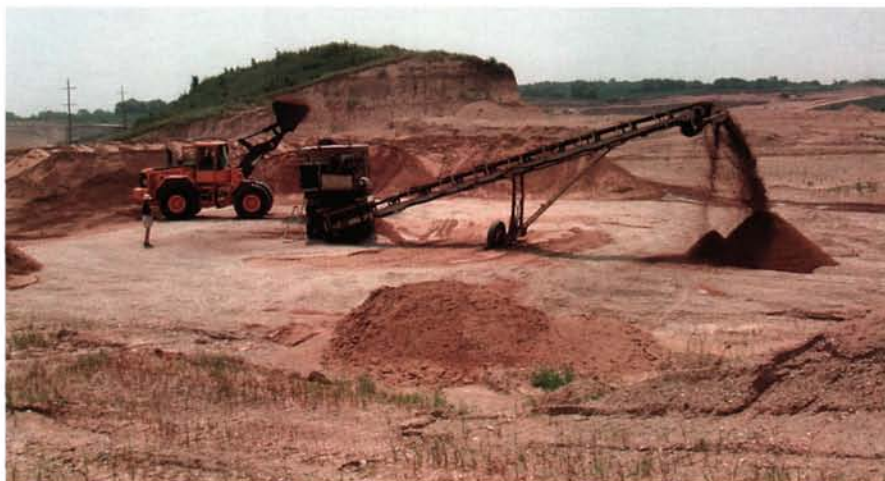
Inspecting the blending site for a hard surface during prequalifying visits to local sand suppliers is necessary to prevent contamination of the root-zone stockpiles once produced.

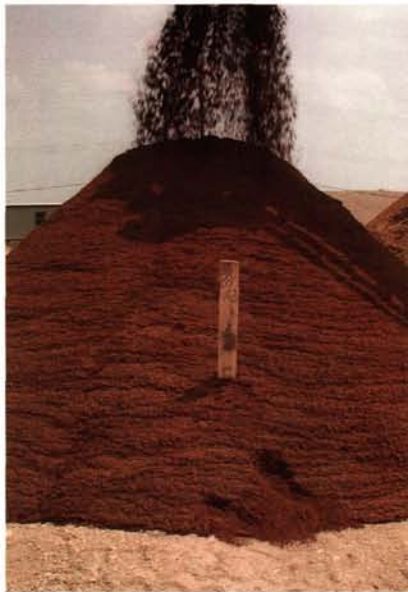
To monitor the consistency of root-zone production using confidence intervals published by the USGA, a standard set of data was obtained by first testing a small 100-yd³ stockpile consisting of 88% sand and 12% Canadian peat moss.

In August of 2002, several return visits were made to Supplier A to monitor the actual production of the root-zone mix. During the first return visit, Tom, his assistant and I met with Greensmix (the root-zone blender for the project) while they were calibrating their equipment. This calibration entailed mixing three 75-yd³ stockpiles of sand and peat in 88/12, 90/10 and 92/8 ratios. From these small stockpiles, samples were collected using the new USGA sampling procedure and submitted for laboratory analysis. The results of this analysis showed that the 88/12 sand-to-peat mixture had the best

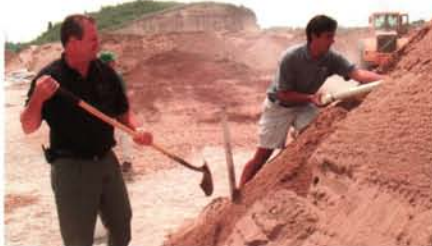
Using the new stockpile-sampling procedure written by Jim Moore, USGA Green Section, Tom Lively and his Course No. 1 assistant collect a sand sample during a visit to a local sand supplier.

In early June of 2002, the next step in the program was to visit two prominent sand and gravel suppliers in the Chicago area to prequalify construction materials. During each visit, Tom, his assistant in charge of the No. 1 course and I collected sand and pea gravel samples using the new sampling protocol written by Jim Moore. These samples were then labeled and sent to Turf Diagnostics & Design, one of several accredited laboratories, for analysis. The initial results of this analysis are summarized in Tables 1 and 2.

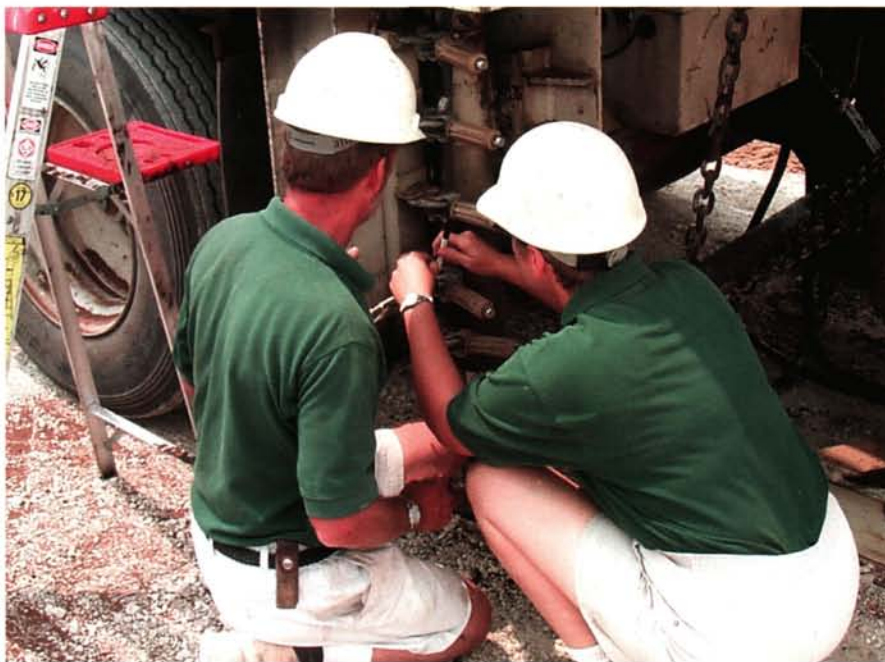
Proper calibration of the blending equipment is a key component of producing a high-quality, consistent root-zone blend.
