# The Use of Ultrasound to Control Algae

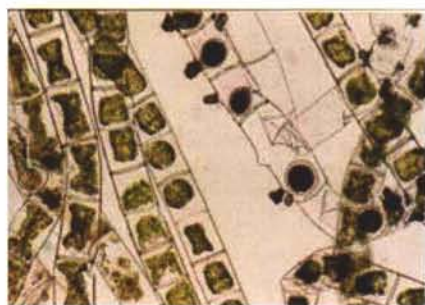
Figure 4.

Figure 4 was taken after 14 days' exposure. The cells have continued to shrink, with some forming denser, circular, brown agglomerations in the center of the cell. There is some evidence of cytoplasm leakage from the cells, indicating further damage to the cell walls.

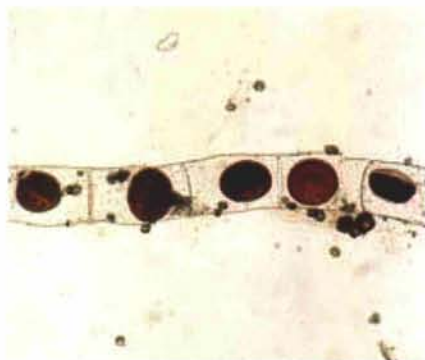
Figure 5.

Figure 5 was taken after 21 days, and shows complete breakdown of cell structure.

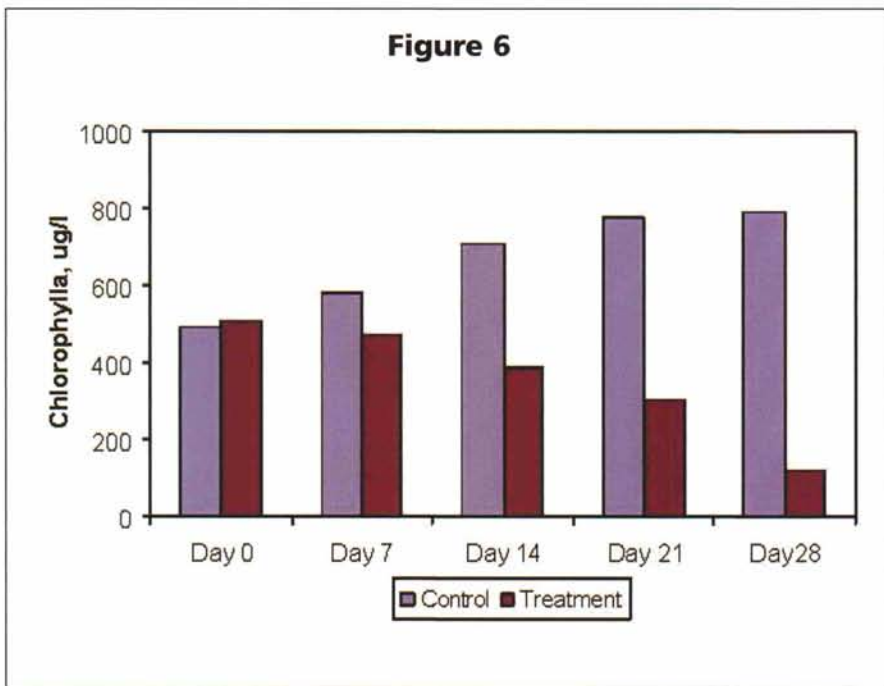
The damage to the cell structure is correlated with a decrease in the chlorophyll *a* concentration in the treated tanks. In contrast, in the control tank, chlorophyll *a* continues to increase. This can be seen clearly in Figure 6 below

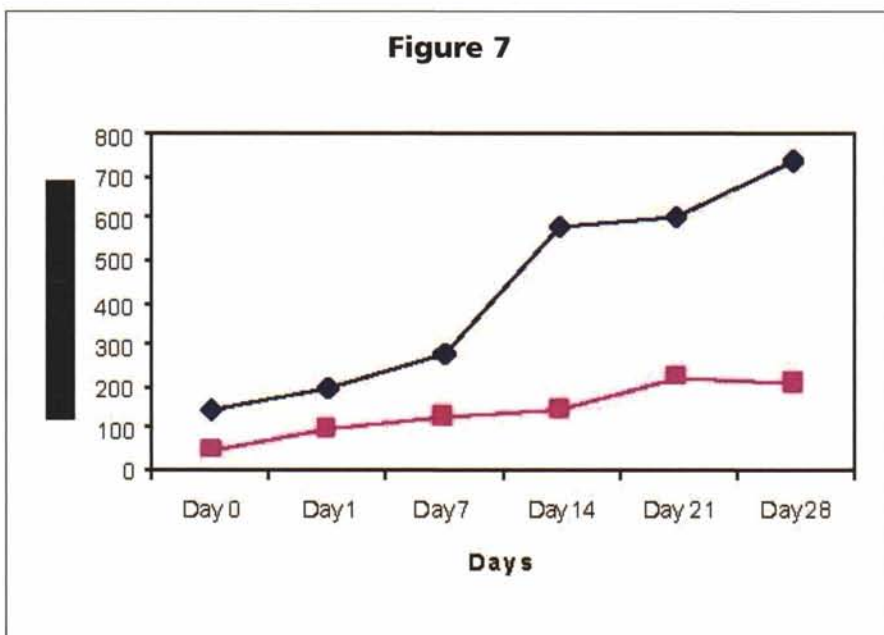
In a 28-day regrowth experiment, the chlorophyll concentration continued to increase from day 1. However, the increase in the ultrasonic-treated

*Spirogyra* was significantly less than in the control treatment. See Figure 7. This indicates significant structural damage is associated with cell death in *Spirogyra*.
