Ted Soenksen, Wilmette Golf Club

10 Year Old John Deere 3215A Fairway Mower

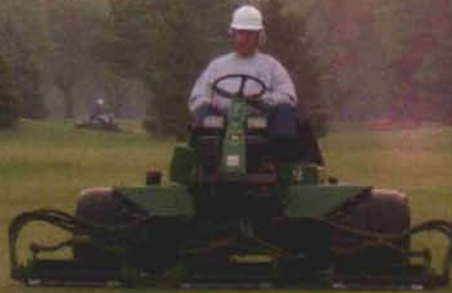
Operator stipulates the rear cutting units do not come on consistently. Once they are "on" and cutting they stay "on." Next swath cutting units may or may not come "on."

After inspecting the wiring around the rear mow valve, I found a break in the power supplied to the solenoid. Upon further inspection, I discovered the wiring was faulty where the wiring harness was zip-tied to the adjacent hydraulic hose, (see image: blue wire being split to supply both solenoids). After stripping back the insulation and the rubber sealed shrink-wrap, I found that corrosion from 10 years of moisture was trapped in this area. The actual break was pinpointed at the factory spliced connection that supplies voltage to both the mow solenoid and the back lap circuit.

Simply, properly splice the wire and protect it with weatherproof connectors and seal with fusion tape.
