Toro GM3500D Fuel Line

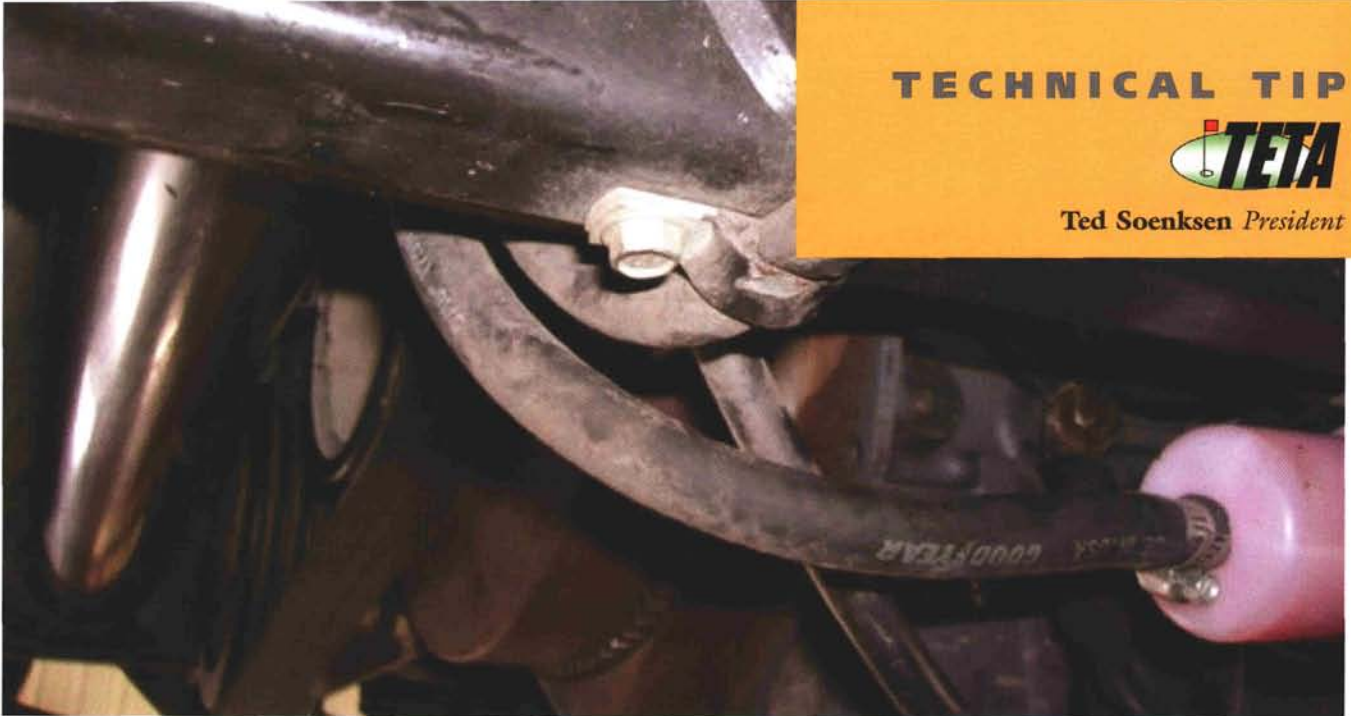
Last season I experienced a problem with the Toro GM3500D. The operator drove the machine to the shop and showed me that one of the fuel lines and the sealing grommet had come out of the fuel tank. I replaced the grommet with a new one. The machine went back out again, trouble free, for the rest of the day. The same thing happened the next day. I then thought that the operator might be stepping on the fuel tank with the tank full of diesel. The pressure, I thought, was forcing the fuel line and grommet to pop out, or that the fuel tank was over filled. On the third occurrence, I realized it was the fuel-tank vent line that was popping out. After two calls to Toro, I learned that there were no bulletins pertaining to this problem on this machine. After discussion with the Toro service personnel, we decided to apply adhesive to the grommet and see what would happen. The problem stopped. I was still not confident I had

found a solution. Keep in mind that the summer was very warm and we experienced a cool down after the last repair was made. For the rest of the season, though, I was not concerned as you “can’t fix what aint broke.”

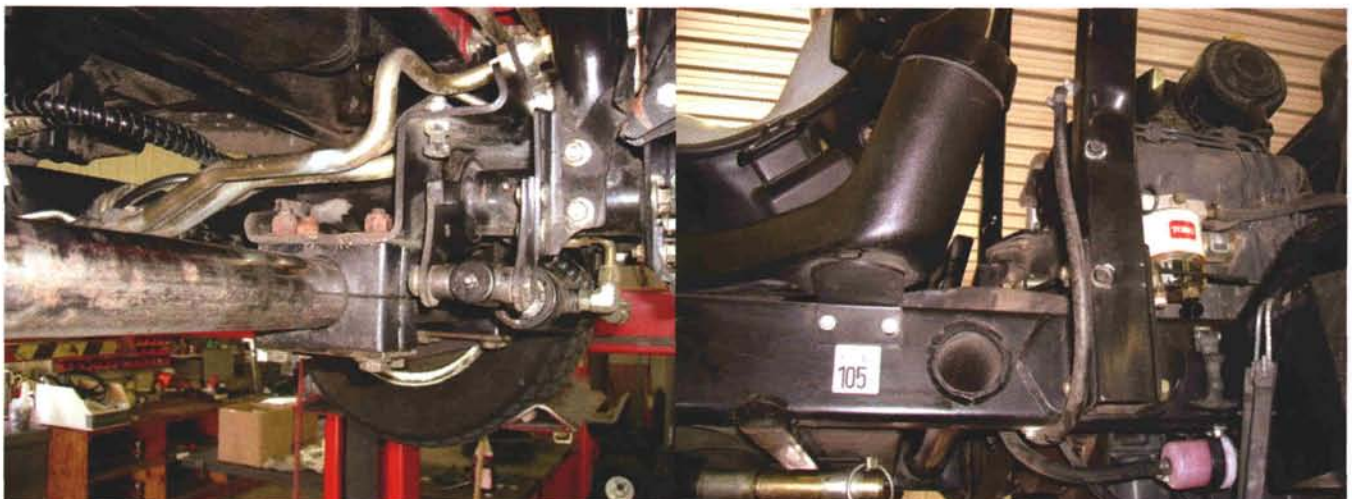
During the winter tear down with the machine up on the lift, I found these...(pictures). The fuel line that goes to the vent side of the fuel tank is connected to a steel tube that travels up the ROP frame. The fuel line had been crushed shut by the mounting-loop that is bolted to the frame. The center deck must have been bumped up high enough to hit the hold-down loop. After correcting this minor glitch, I am confident that the problem is now solved.
