BY STEVE STARRETT, YUNSHENG SU, TRAVIS HEIER, JAMIE KLEIN, JEFF HOLSTE AND MONICA PALOMA

## Surface water quality

Long-term monitoring determines the magnitude of nutrient loss in runoff related to development

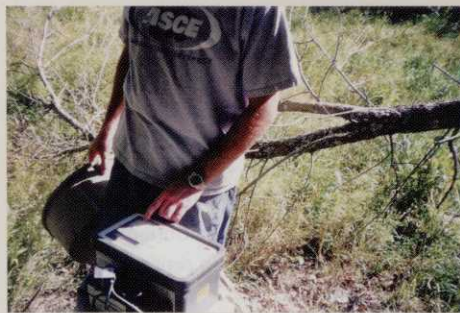
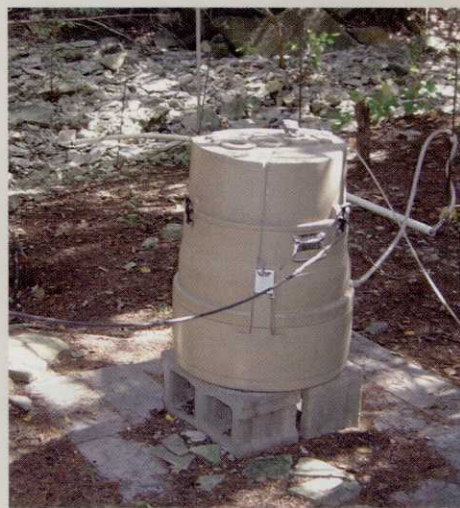
ISCO 3700 portable samplers (top photo) and a sampling station.

ISCO 3700 portable samplers were set up at each of the three stations to collect water samples during runoff events (top photo above). Liquid detectors actuated the samplers at the beginning of a runoff event, and the samplers collected grab samples at a predetermined time interval of one or two hours (bottom photo above). Field sampling conditions didn't allow inclusion of sample replicates as part of the study. Collecting runoff samples from almost all storms would produce higher constituent concentrations than a sampling method that collected samples every three months, for example. Thus, these sampling methods would capture the periods with the highest concentrations.
