A STREAM runs through it

A suburban Philadelphia course looks to stream restoration to solve flooding and erosion problems and enhance course value.

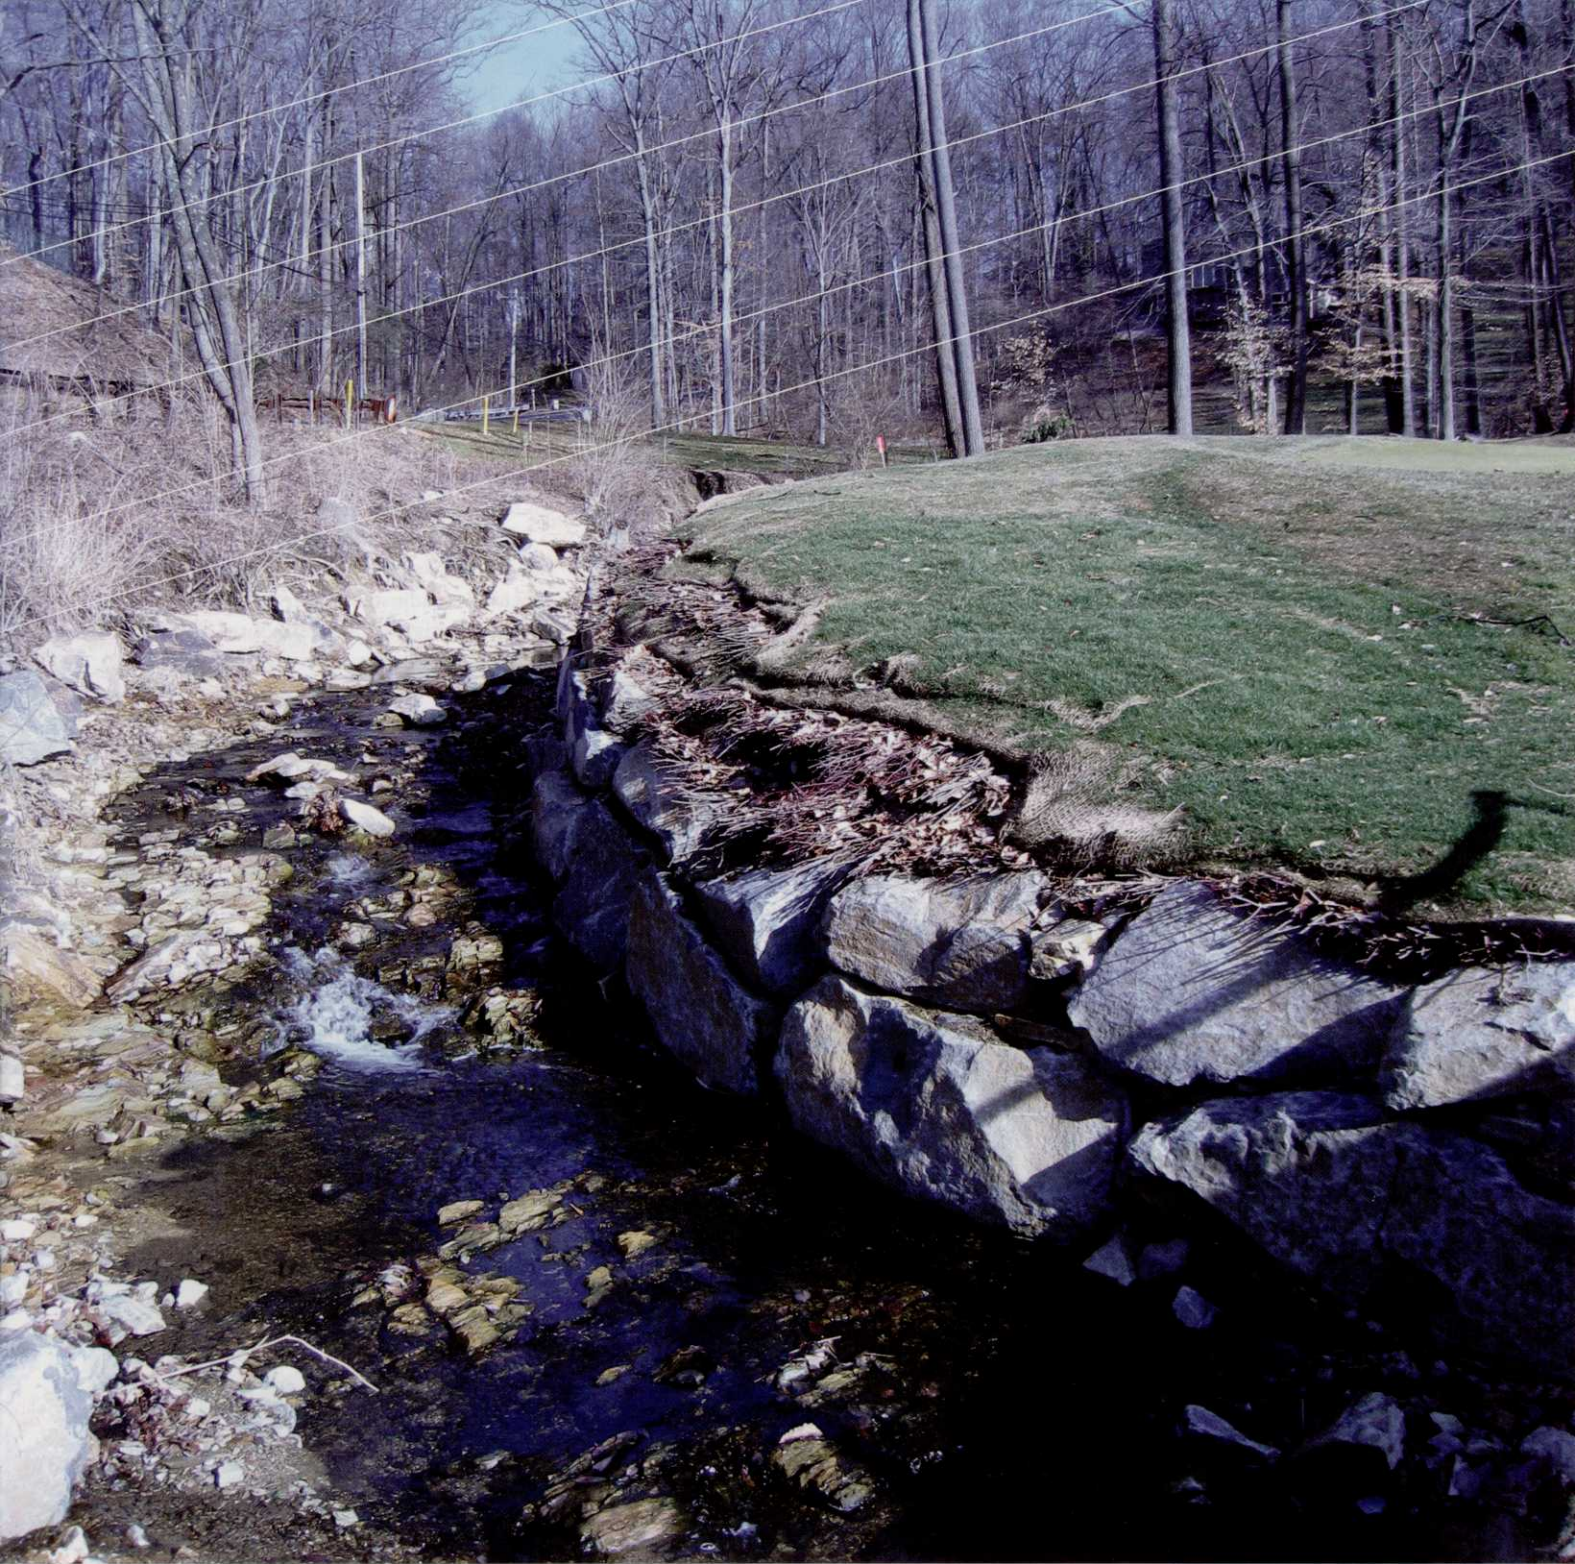
Boulder toe stabilization was implemented around the 4th green to prevent additional erosion, while enhancing the aesthetics of the hole.

In addition to reducing flooding and erosion, the redesigned stream channel has also added interest and challenge to several holes, for instance bringing water into play on the approach to the 6th green and enhancing the 4th green with boulder walls. "The project has enhanced the overall feel of the golf course," says general manager Ron Rottman
