A New Irrigation System Improves Playing Conditions

Rockland Country Club
Matthew Ceplo, CGCS, superintendent

Sparkill, N.Y. 10976

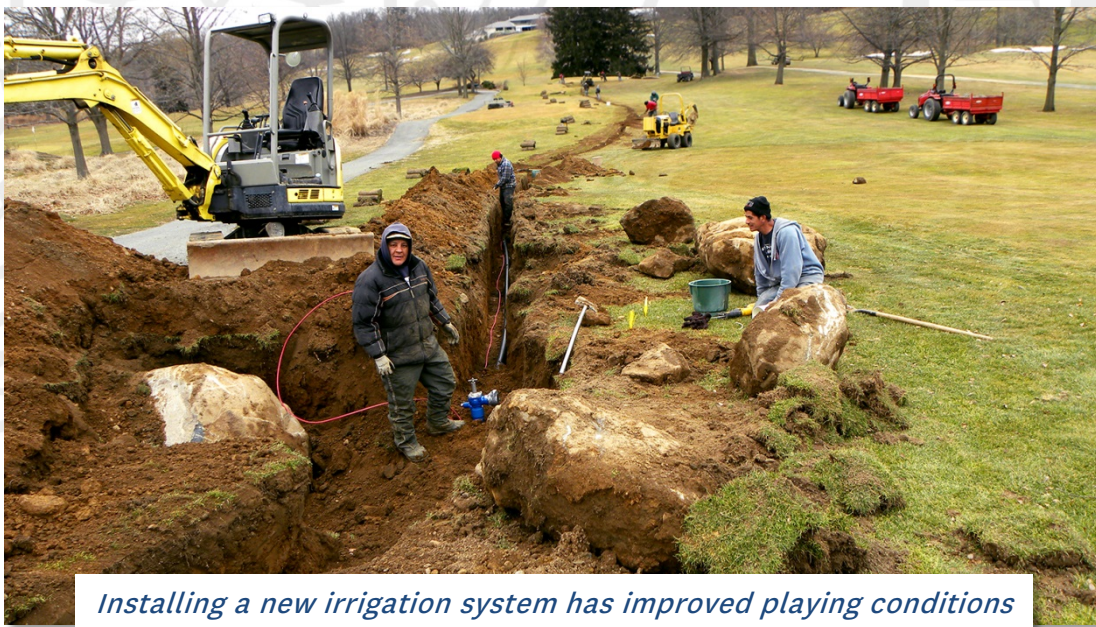
Installing a new irrigation system has improved playing conditions and turf health and has reduced maintenance costs.
