DOLLAR-WISE

new maintenance facility construction

Plan your construction well and refurbish what you can to make the new facility a project you look forward to. A contingency fund will help pay for it.

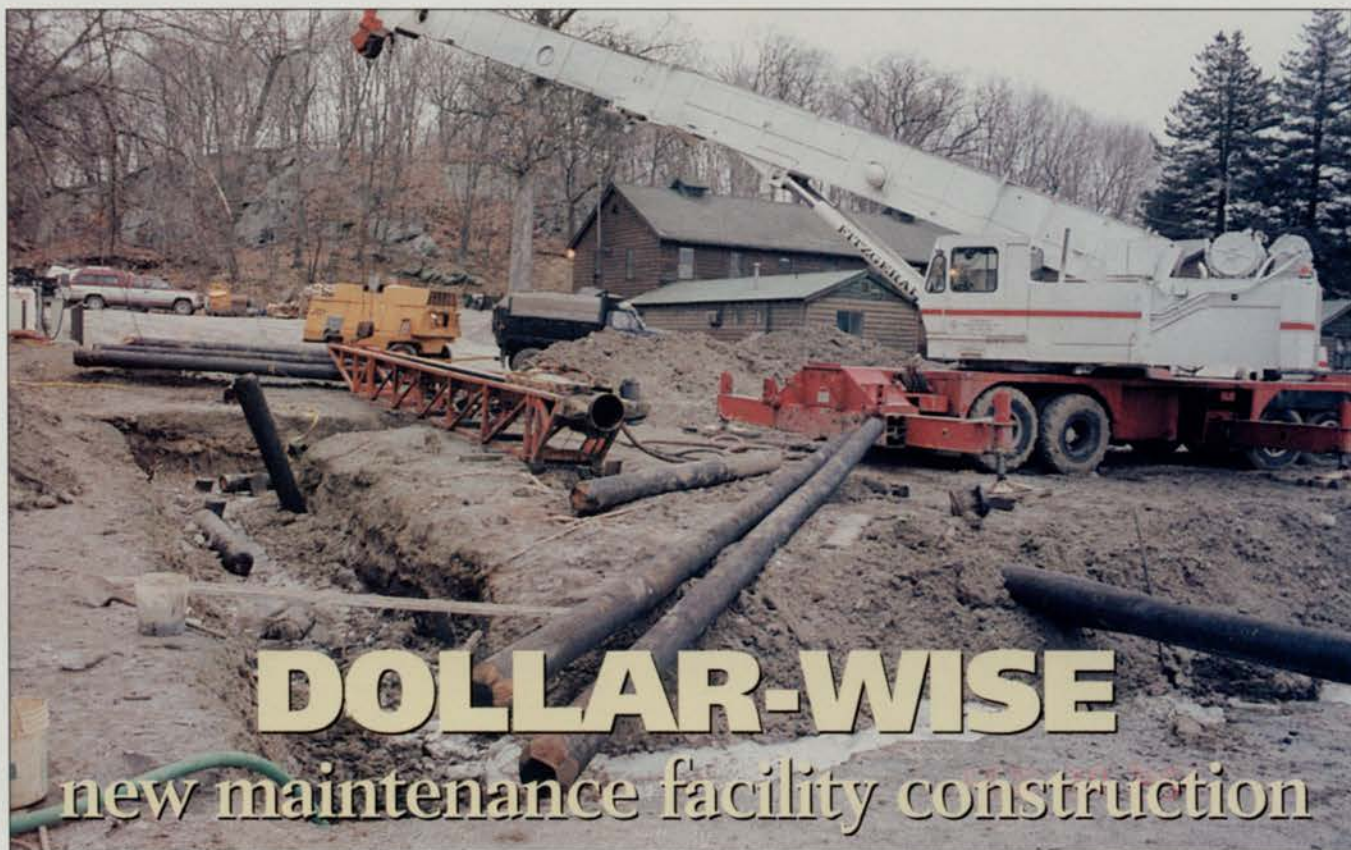
▲ Piles were driven to reinforce footings.

"The first problem was unacceptable soils—rock, muck and peat—during excavation," Alonzi remembers. "Construction was stopped after four days and we had to hire an engineer to oversee a new slab and new footings that ended up taking two months." Piles, a pile driver and cranes cost an additional \$50,000.

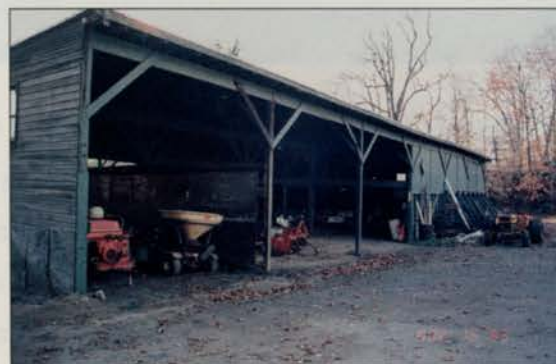
Before...

▼ The old storage area was due to be replaced.

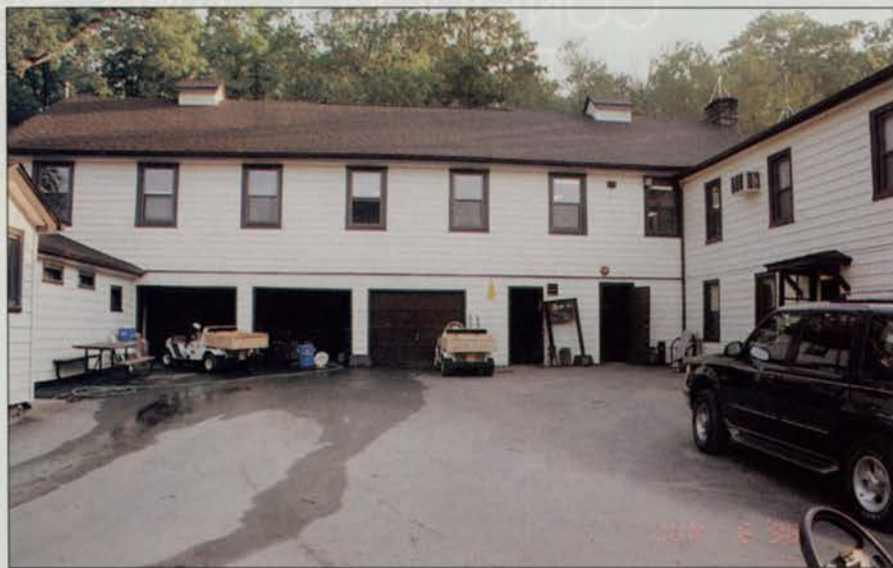
The original building was remodeled to be used as an administrative building. That project included a new roof, new gutters, vinyl siding, new windows and interior work.

4) Alonzi decided to repair the existing structure, to be used as an administrative building. That project included a new roof, new gutters, vinyl siding, new windows and remodeling the interior. Cost: \$75,000; total cost now at \$682,800.

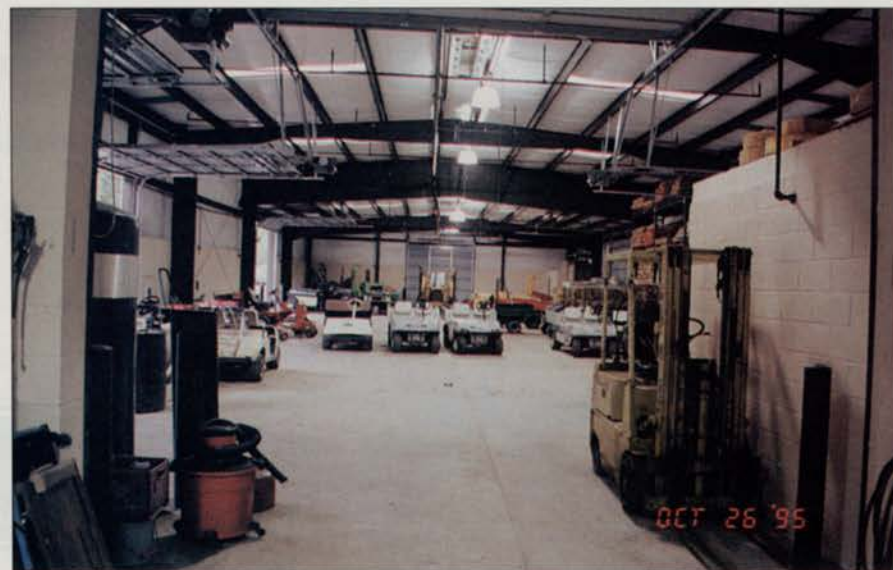
...and after

Finished. The new facility at Westchester includes a 2500 sq. ft. repair shop and a 6500 sq. ft. equipment storage area.

2) The project was separated into three distinct parts: the 50-by-180-foot maintenance facility, a 2500 sq. ft. repair shop and a 6500 sq. ft. equipment storage area. The design included seven concrete storage bins and a wash station.

Finally, in March of last year, a "floating" concrete slab was poured in 25-foot sections to eliminate its cracking as the ground would settle and heave. Coarse asphalt was poured May 16th.
