Correcting Windburn Injury Without Interrupting Play

by O. J. NOER

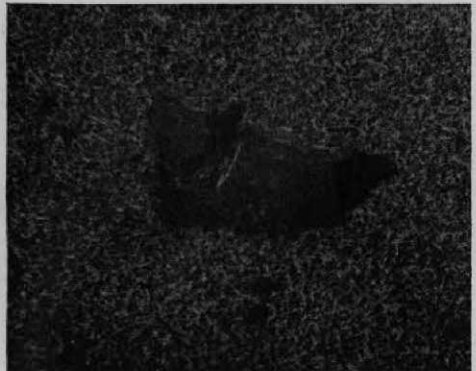
1. Injured spots in spring on a windburned green, due to shallow rooted turf. The high spots were affected most. 2. The greens were drilled promptly in spring, and holes were left open to encourage deep root formation. 3. The green surfaces looked like this after drilling. 4. The small amount of soil around each drill hole was removed with a dandelion-type rake. 5. New white roots started to develop immediately. By midsummer they extended beyond the depth of the drill hole.
