Get Pumped!

Case Studies in Pump-Station Replacement

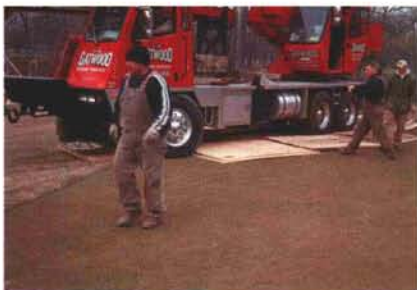
Crane on no. 18 at Shoreacres.

A flagged pathway was set in the rough for trucks to follow, creating a haul road to the construction site. The road area incurred very little damage; most of it could be repaired with a roller. The exception was at the area surrounding the pump house, where most of the turning occurred with equipment. Plywood came into use in some areas when necessary; for example, a crane sitting on no. 18 lifted the pumps off the truck down a ravine and into the building.

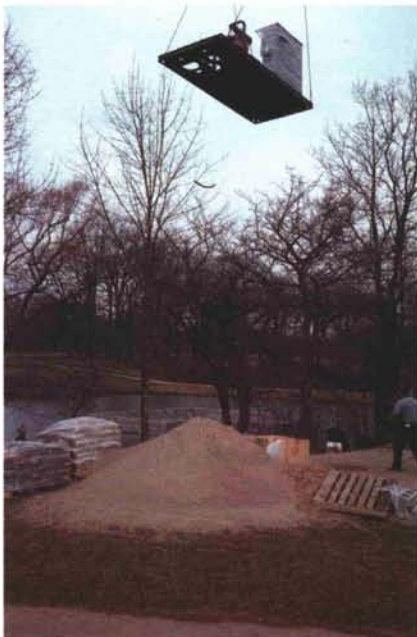
Lifting pump station into pump building at Shoreacres.

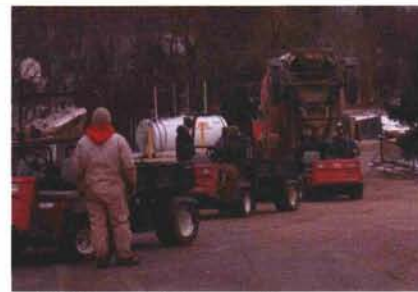
Utility vehicles used to transport cement at CGC.

On Tuesday, February 26, tear-down of the building began. Footings for the new building were poured on Thursday, February 28. At this point, the ground had become soft. We set plywood across the fairways and utility vehicles were used to transport the cement for the footings from the trucks.

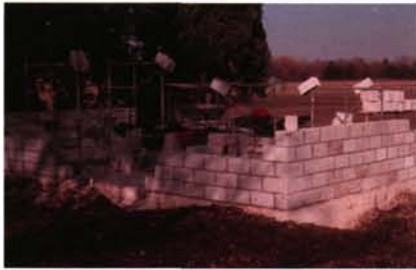
Erecting building at CGC.

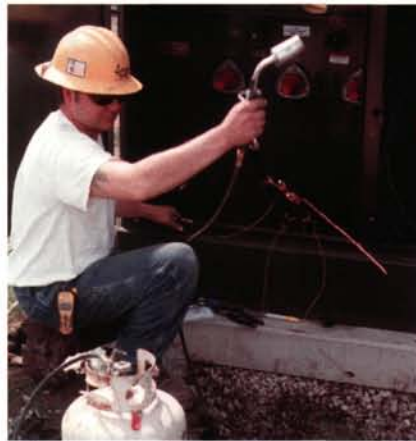
Working on the transformer at CGC.

The most important element of planning for a pump-station installation is making sure all of your permits are in order, well in advance. Contact the utility company and research your existing service and what will be required of the future station. If a transformer change-out or wire connection needs to be made, it may be up to 12 weeks before it will happen.

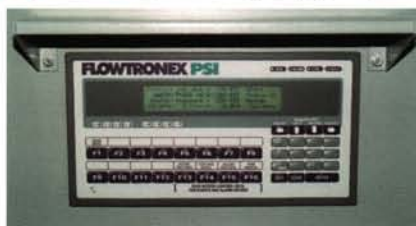
Data control pad for pump station.

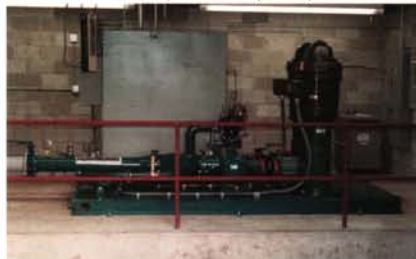
Inside of new pump station at CGC.

The same results have been evident at Chicago Golf Club. Integrated with pipe looping and nozzle change-outs, the coverage and performance of the irrigation system is much improved. The new pumps run very smoothly. The building offers an abundance of light and space, making work and access very easy. Evaluating the status of the system and diagnosing problems is very straightforward. Touch-screens provide an array of information to correct even the most complicated issues.
