2016-30-600

Evaluating the Performance of Four Subsurface Drip Irrigation Systems Used on Creeping Bentgrass Tee Boxes at the Las Campanas Golf Course (Santa Fe, NM)

PROJECT DESCRIPTION

An irrigation trial was conducted at the Las Campanas Golf Course (Santa Fe, NM) to evaluate the effect of different subsurface drip irrigation systems (SDI) on turf quality, stress and water usage of creeping bentgrass tee boxes.

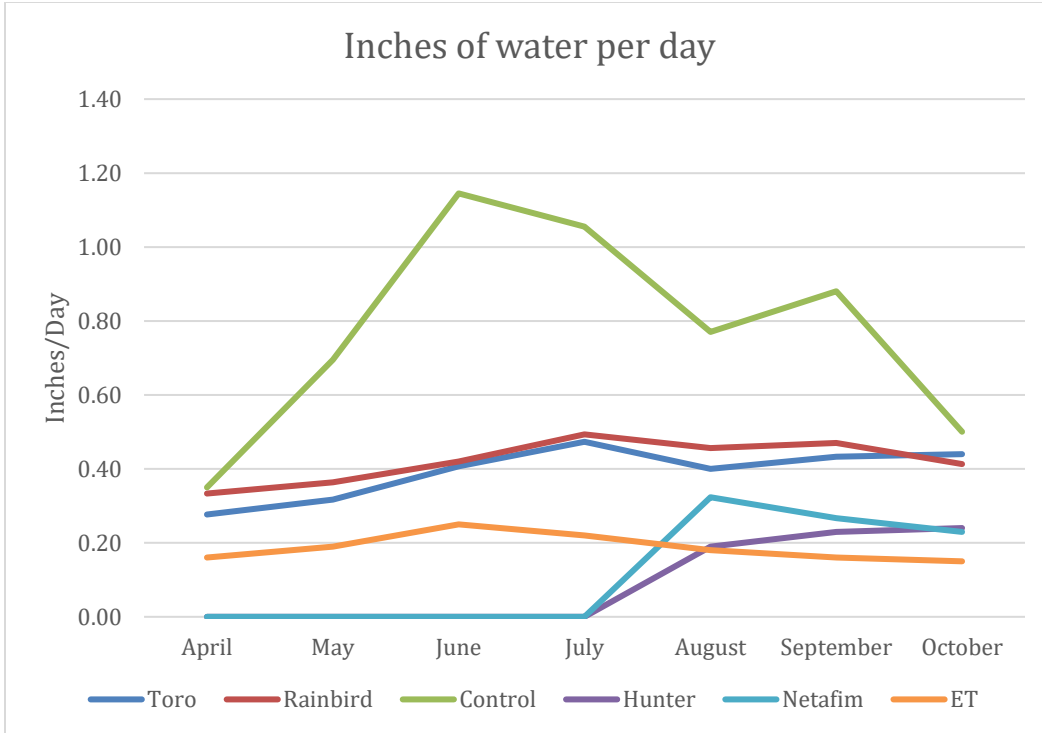
Figure 1. Amount of water distributed by each irrigation system.

- The irrigation amounts used by SDI-irrigated tee boxes were remarkably lower from those used by the control tee boxes. Sprinkler-irrigated tee boxes received 3 to 5 times more water compared to the SDI-irrigated tee boxes. It appears that the higher irrigation amounts used by sprinkler systems were due in part to overspray. Pop-up heads irrigated beyond the tee box area and ended up irrigating the surrounding native vegetation. In contrast, the SDI systems delivered the water only to the designated area.

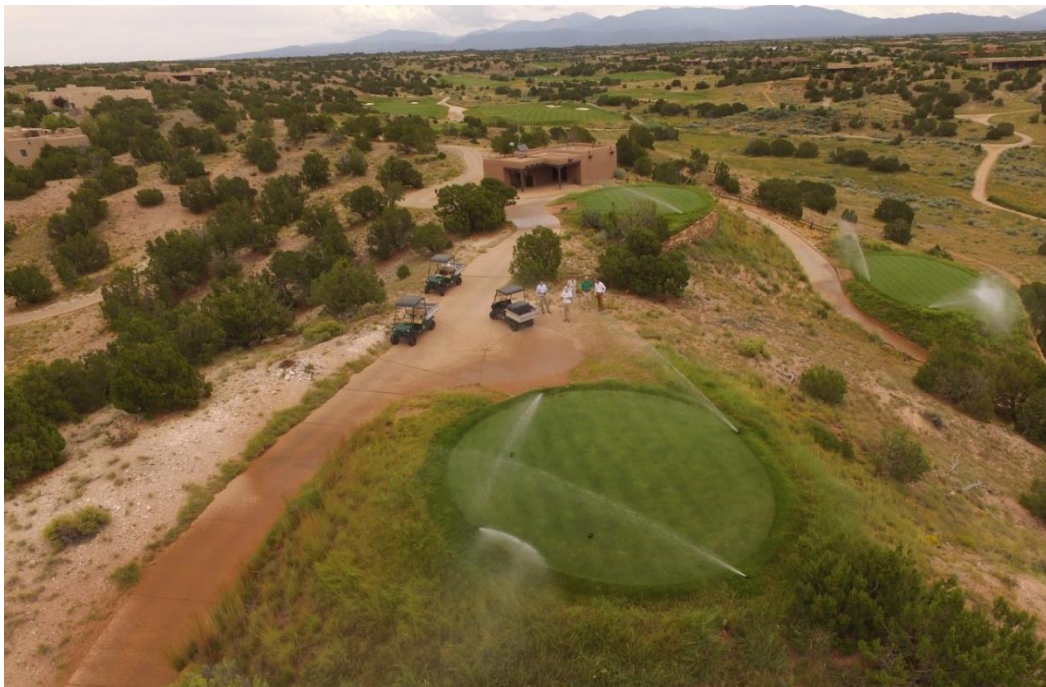
Figure 2. Watering pattern typical of sprinkler irrigation, with water being distributed outside the tee area.

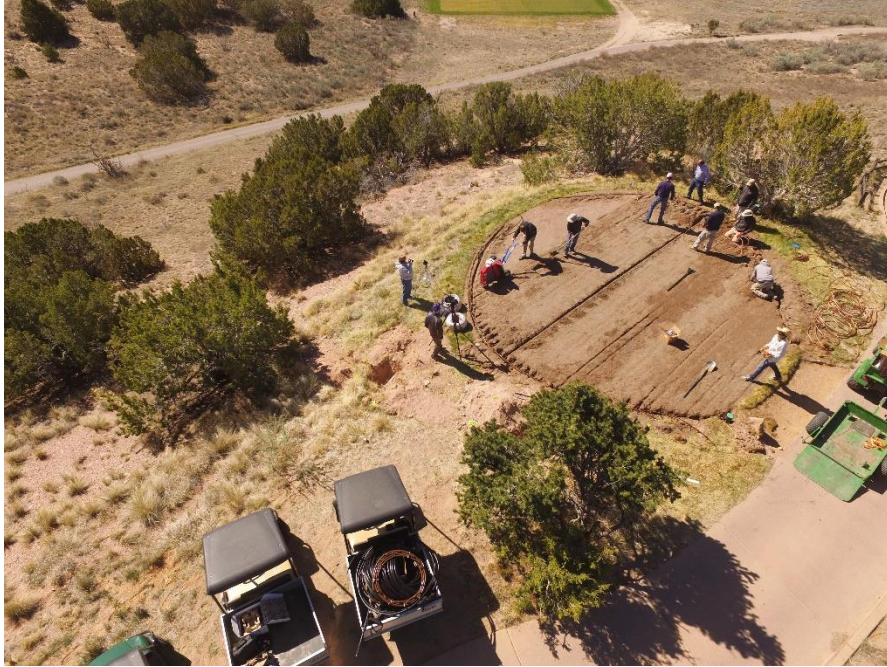
Figure 3. Process of installation with the existing turfgrass removed.

The subsurface drip systems were installed in May of 2016 and consisted initially of two brands. One of them was the Toro Rootguard® DL2000™ (The Toro Co., Riverside, CA) delivering 2.0 l hr⁻¹ (0.48 gal h⁻¹) and operating at 241 kPa (35psi). The other system was the Rainbird XSF with copper shield Technology (Rainbird®, Azusa, CA), delivering 2.0 l hr⁻¹ (0.6 gal h⁻¹) and operating at 241 kPa (35psi). Both systems were installed at a depth of 10 cm (4 inches). Each system was installed in three tee boxes, one set at 23 cm (9 inches) of spacing between lines, and two tee boxes with 30 cm (12 inches) spacing. This decision was based on the lack of information on installation and performance of SDI on sand based profiles, and the team suspected that 30 cm spacing might be too far apart. Both systems were installed according to manufacture specifications. A filter and a pressure regulator were installed on each tee box before the main valve, in addition to an air release valve and an automatic flush valve. The team choose two approaches to install the SDI systems under pre-existing turfgrass. The first strategy was to remove the sod, and using a disk trencher, cut into the sand profile. After the system was installed, the sod was laid back into place, followed by topdressing and irrigation using the overhead sprinkler system. The second approach was to trench directly into the existing

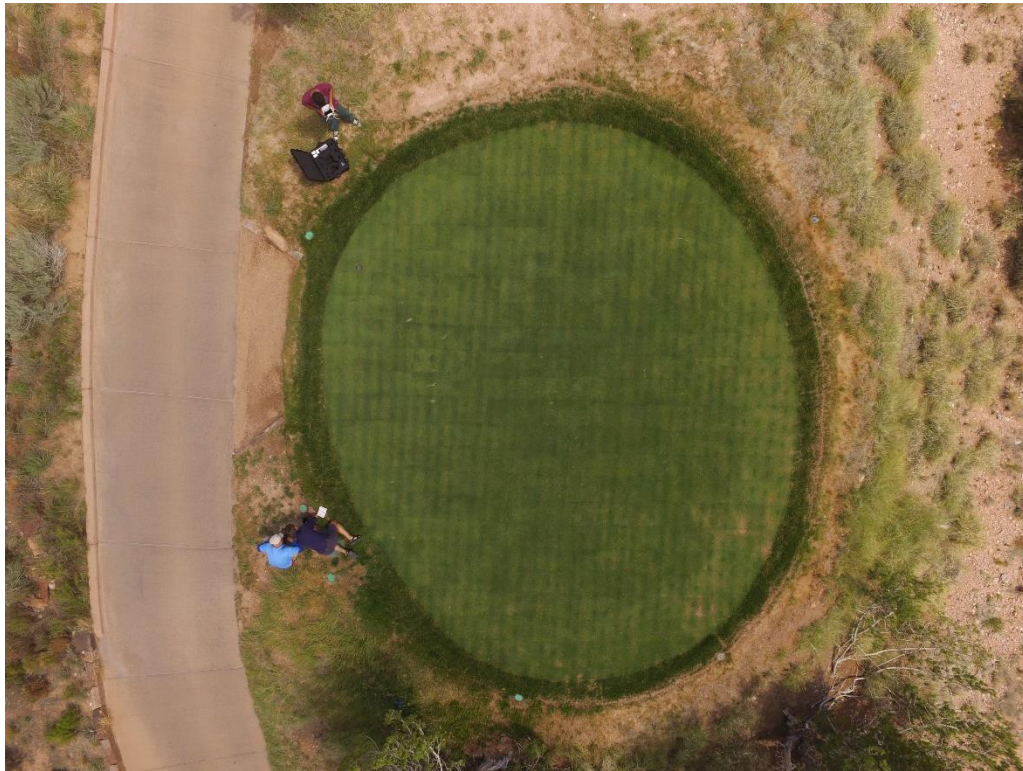
Figure 4. Recovery of turfgrass 4 months after sod removal installation.

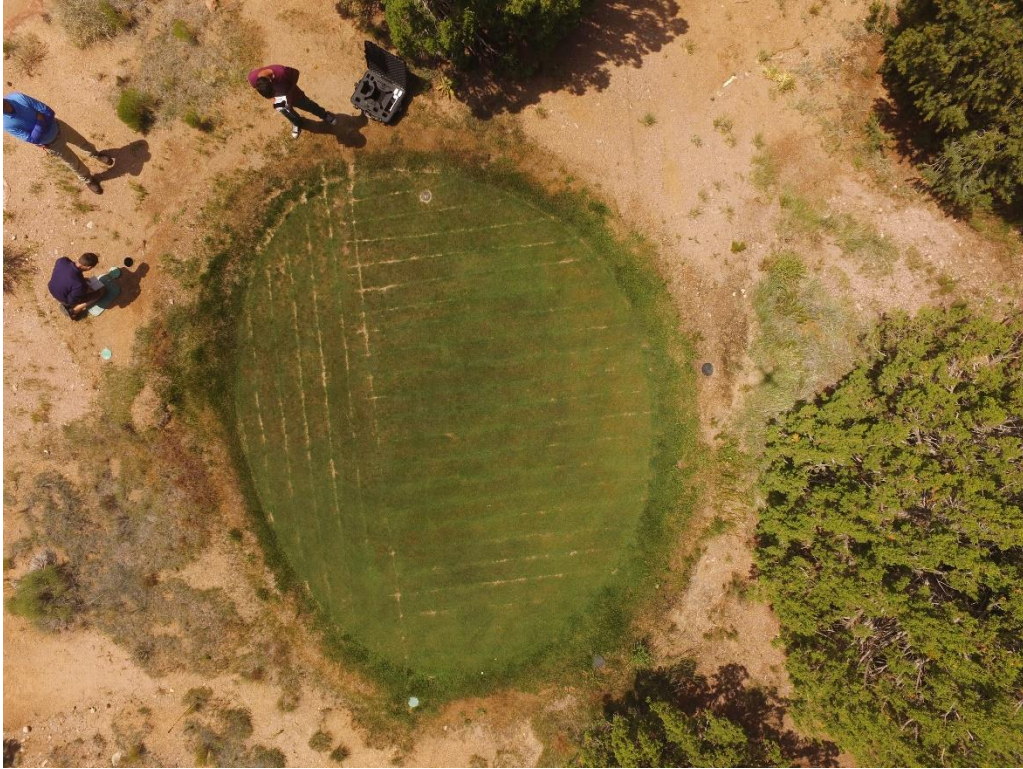
Figure 5. Recovery of turfgrass 4 months after trenching into existing turfgrass.

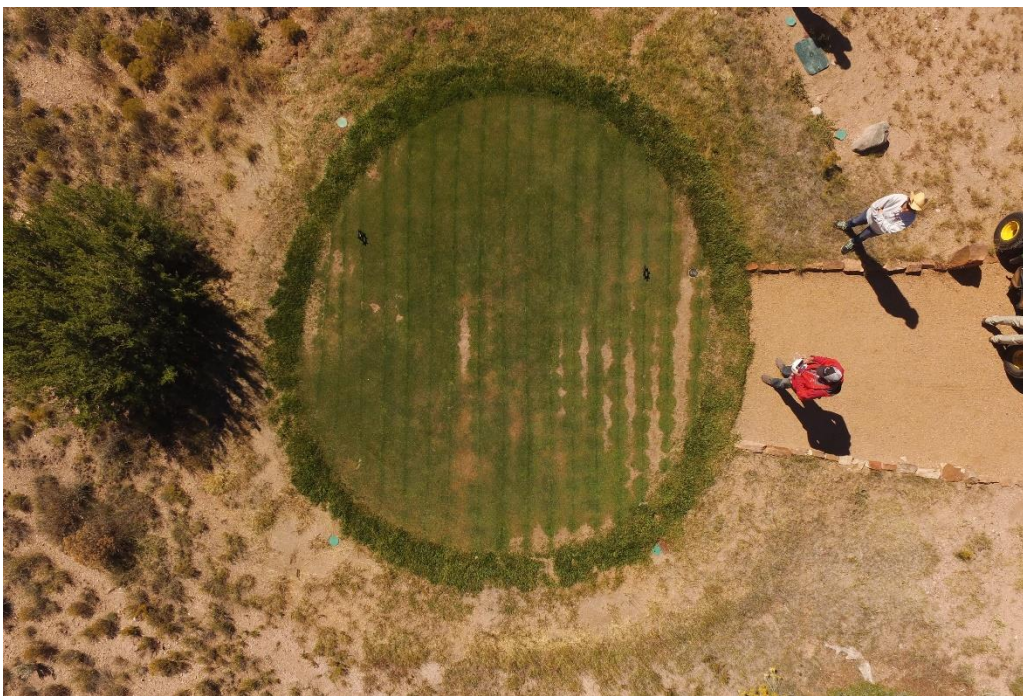
Figure 6. Incorrectly installed subsurface drip irrigation.
