Baker National Golf Course Leachate Study

FINAL REPORT
DECEMBER 17, 1992

John M. Barten

Water Quality Manager, Hennepin Parks

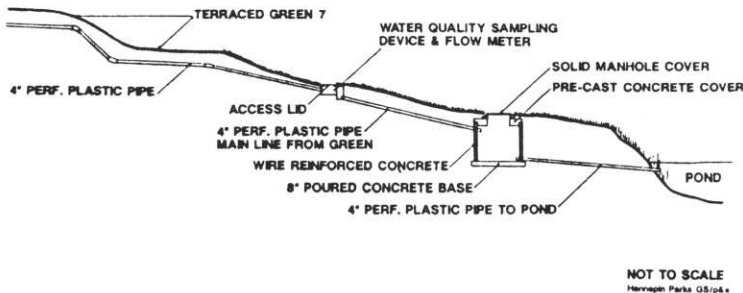
FIGURE 1
GREEN 7 LEACHATE COLLECTION AND SAMPLING SYSTEM

During the renovation of the golf course in 1989, an underdrain tile system was installed in the 7,182 square-foot green on the 7th hole. The underdrain system was designed by the Hurdzan Design Group. Leachate from the green is collected by the underdrain system and discharged into an adjacent manhole (Figure 1). The manhole was constructed to act as a trap for pollutants in the leachate water. Outflow from the manhole flows into a small pond which discharges into Spurzem Lake. Leachate from the green was collected immediately upstream of the manhole.

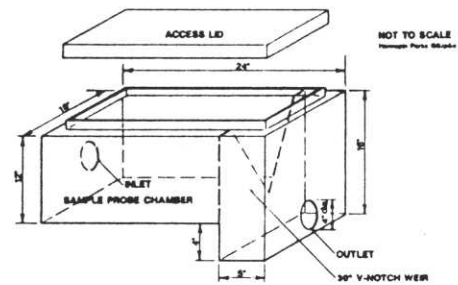
FIGURE 2
GREEN 7 WATER QUALITY SAMPLING CHAMBER AND
PRIMARY FLOW MEASURING DEVICE

A stainless steel box equipped with an adjustable 30-degree, v-notch weir was fabricated for the project to facilitate sample and flow data collection (Figure 2). The box was installed between the green and the manhole. The sample box was constructed with attachments to connect the drainage tile line to the inlet and outlet ends of the box. Flow monitoring and water sample collection devices were installed in the box.

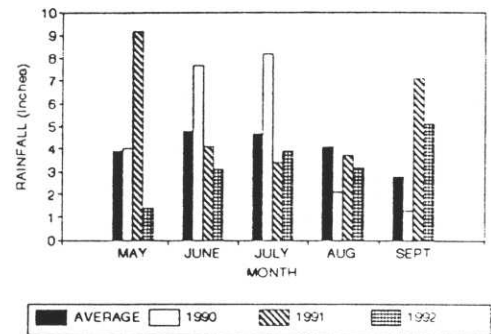
BAKER GOLF PRECIPITATION
GROWING SEASON - 1990 TO 1992

Figure 3. Baker Golf Precipitation 1990 to 1992

Rainfall on Green 7 during the study season (May through September) was above average in 1990 and 1991, and below average in 1992 (Figure 3). A total of 23.3, 27.5, and 16.2 inches of rain fell on the Baker Golf Course in 1990, 1991, and 1992 respectively, as compared to the average of 20.3 inches.

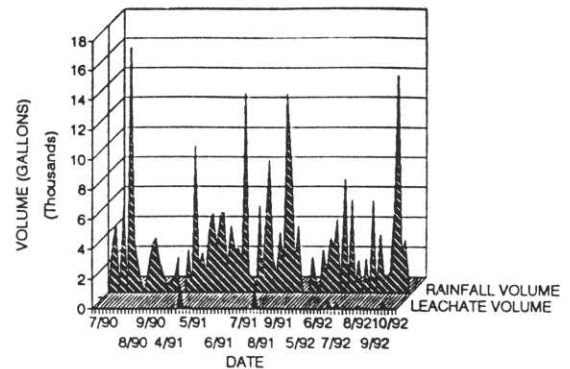
BAKER GOLF COURSE - GREEN 7
RAINFALL VS LEACHATE

Figure 4. Total Rainfall and Resulting Leachate at Green 7 Baker Golf Course

As shown on Figure 4, only 14 of 63 monitored rainfall events which occurred during the three-year study period produced leachate. Rainfall events less than 0.50 inches did not produce leachate, and larger events produced only small quantities. The amount of water passing through green 7 was less than 5 percent of the rainfall on the green for all but two events.
