USGA CASE STUDY

Regrassing Greens to Creeping Bentgrass

Shaker Ridge Country Club Mr. James Seaman, superintendent Loudonville, N.Y.

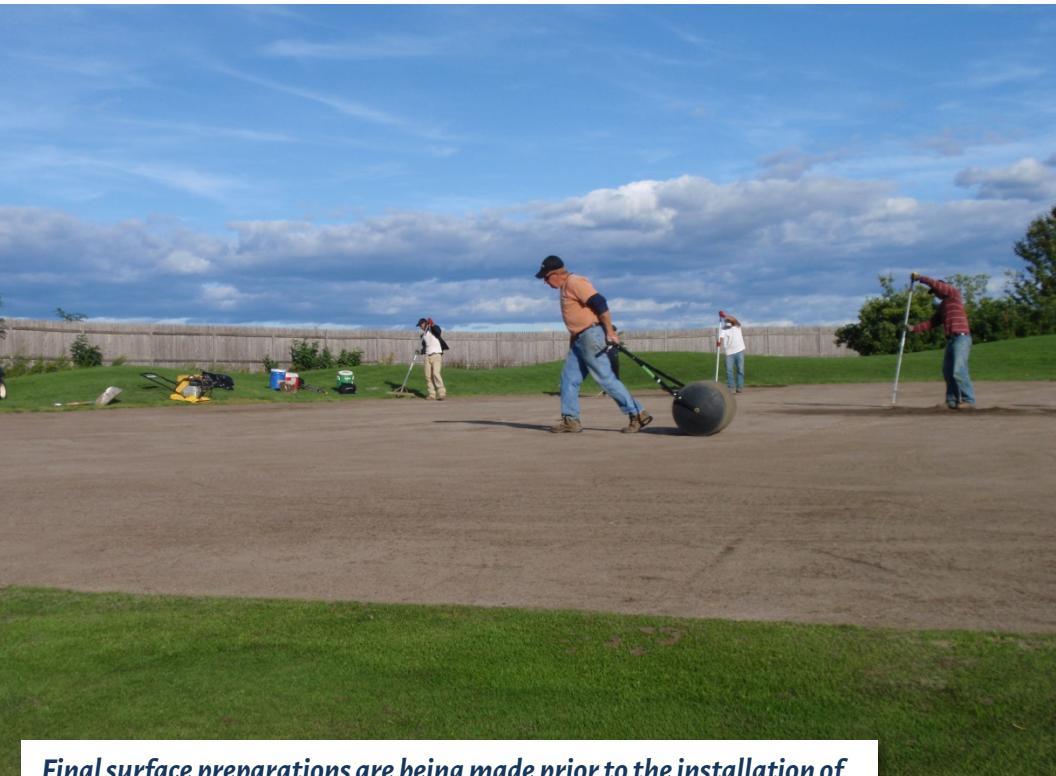
Final surface preparations are being made prior to the installation of new, washed, A1/A4 sod on a green at Shaker Ridge Country Club.

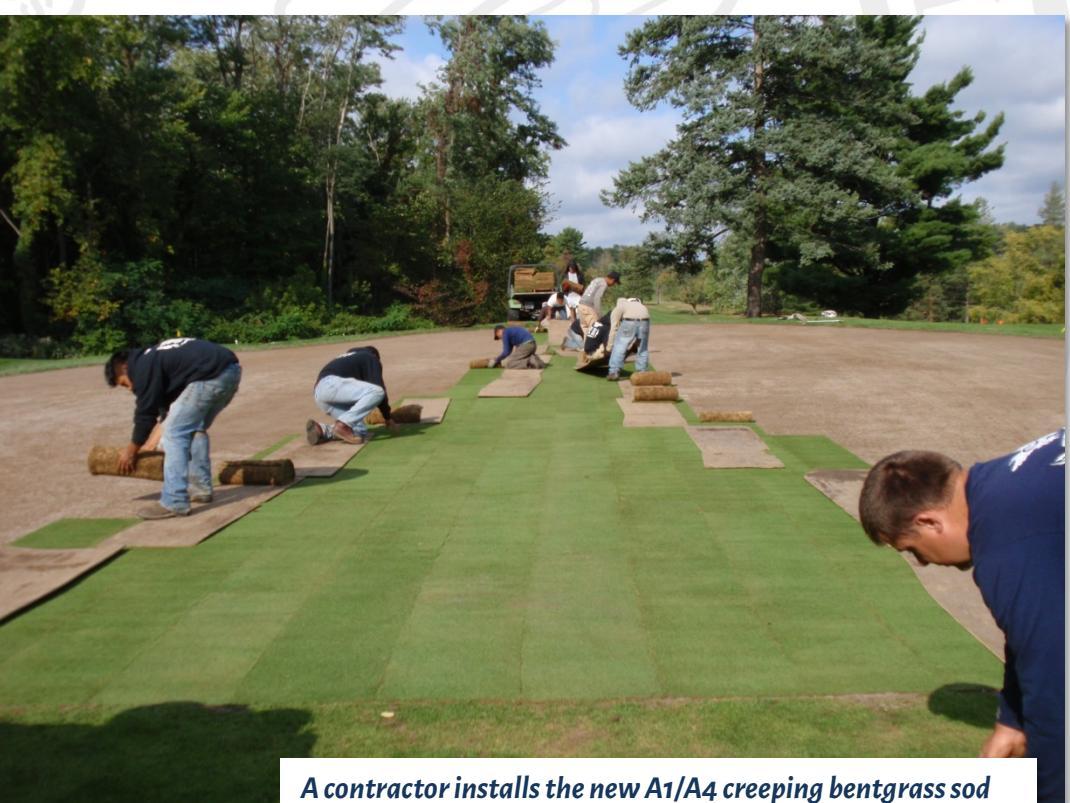
A contractor installs the new A1/A4 creeping bentgrass sod to greens at Shaker Ridge Country Club in Loundonville, N.Y.
