COURSE RENOVATION

A subsurface air and drainage system and a ceramic soil mix improve greens at a Chicagoland club

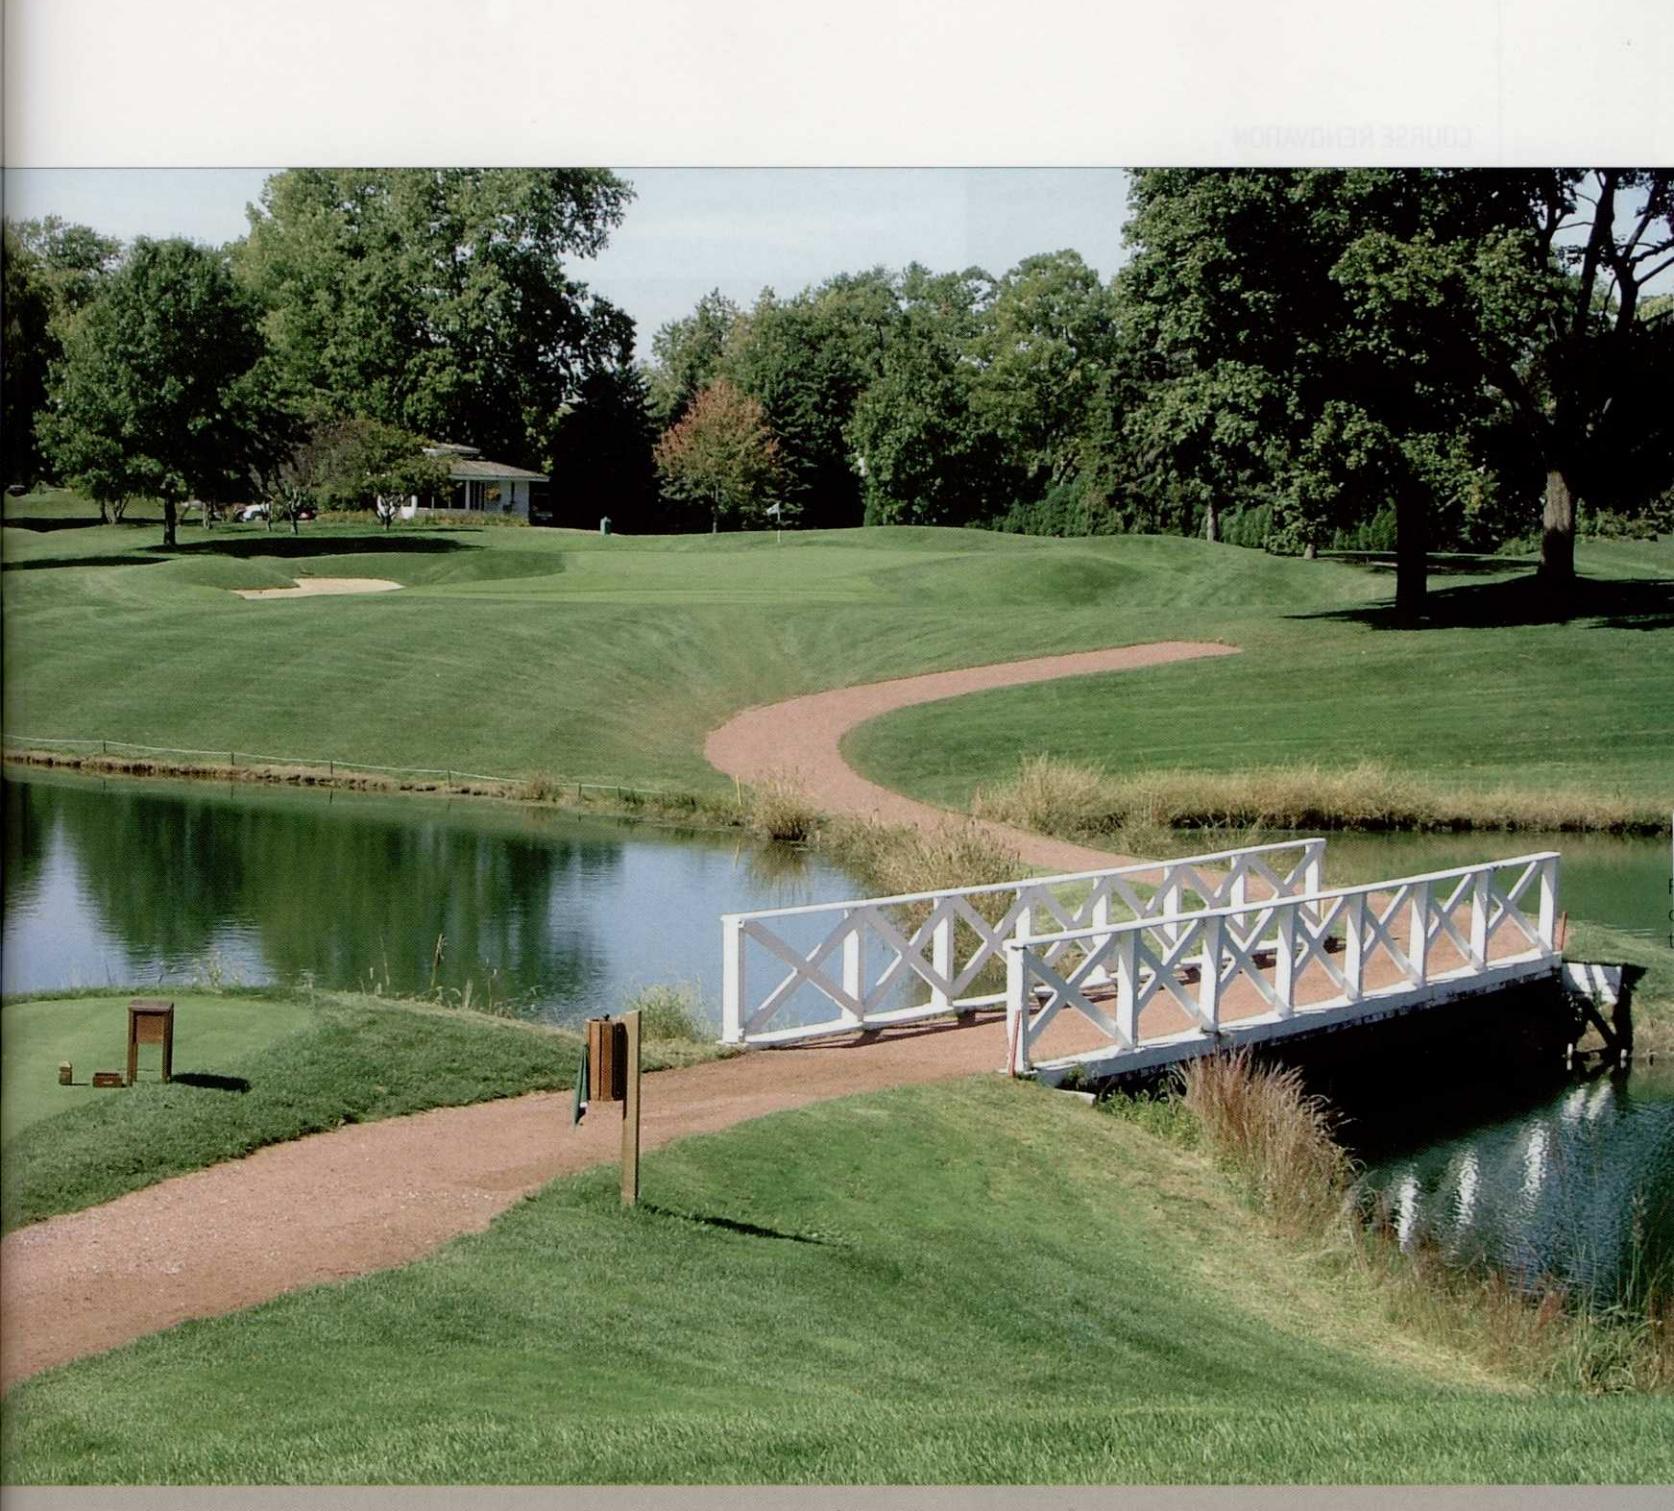
The goal of the recently completed renovation at Westmoreland Country Club was to change how the greens are played and maintained. Photo: Westmoreland Country Club

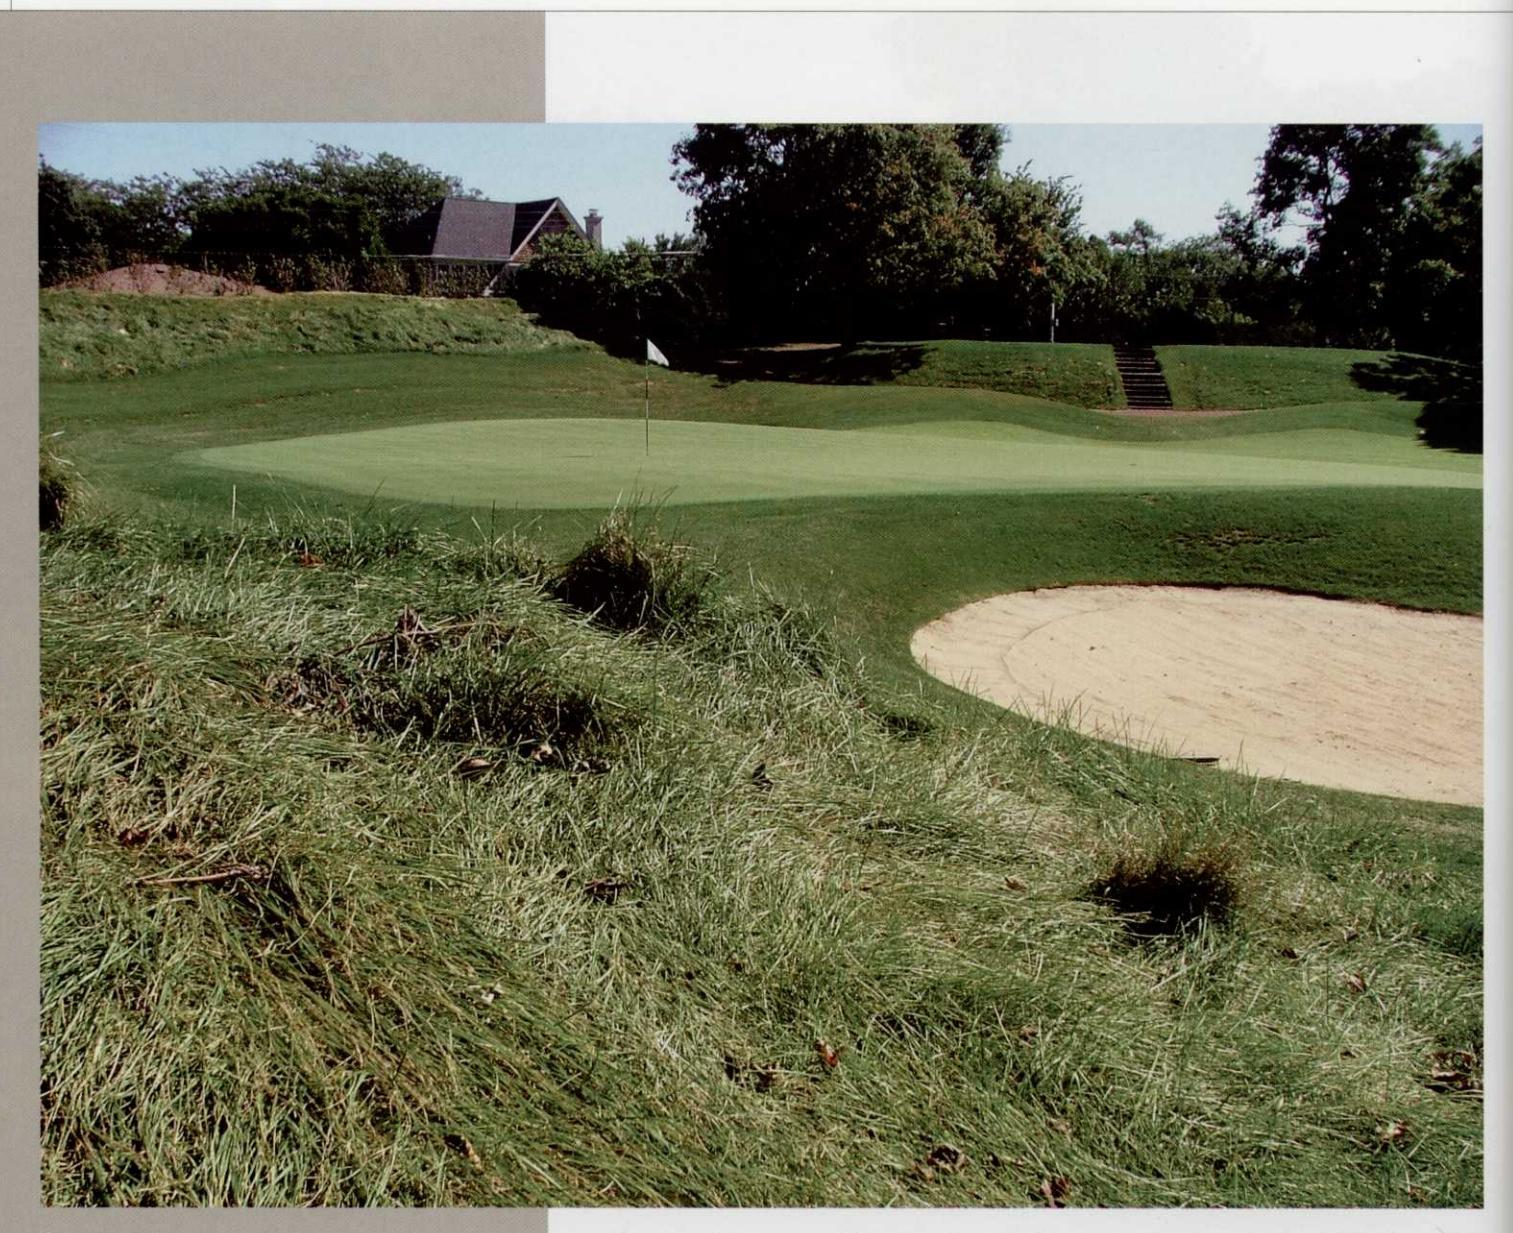
The renovation included a system that blows air underneath the greens, providing oxygen to roots, cooling them in the summer and warming them in the winter. Photo: Westmoreland Country Club

The subsurface air system consists of 6-inch main pipe down the middle of each green and a herringbone system of 4-inch tile off the main pipe on 10-foot centers. A loop system around the outside of the green connects the 4-inch pipe and the main pipe to another 4-inch pipe that encircles the green. Photo: Westmoreland Country Club 12 inches down, we couldn't drench it in. The root structure was too established. But that proved to be our bread and butter to get the greens back. Soon, the disease stopped working, and they came right back."

The subsurface air system at Westmoreland is different than others. Instead of drain tile on 15-foot centers, Golf Creations and subcontractor Leibold Construction installed a 6-inch main pipe down the middle of each green and a herringbone system of 4-inch tile off the main pipe on 10-foot centers. A loop system around the outside of the green connects the 4-inch pipe and the main pipe to another 4-inch pipe that encircles the green.

"Normally on a USGA green, the tile lines are laid 15 feet apart, but on the Westmoreland project we laid these tile lines 10 feet apart and ran perimeter tile all the way around each green, too," says Kevin Stieneke, operations manager for Golf Creations. "A normal green would take 600 feet of tile. We did 1,300 feet for each green. The more tile, the more spots where the air is pushing up into the soil profile, and the more air the better."

What the construction team basically has done is create a true manifold that ties into the drainage to blow warm and cold air underneath the greens, Heery says.

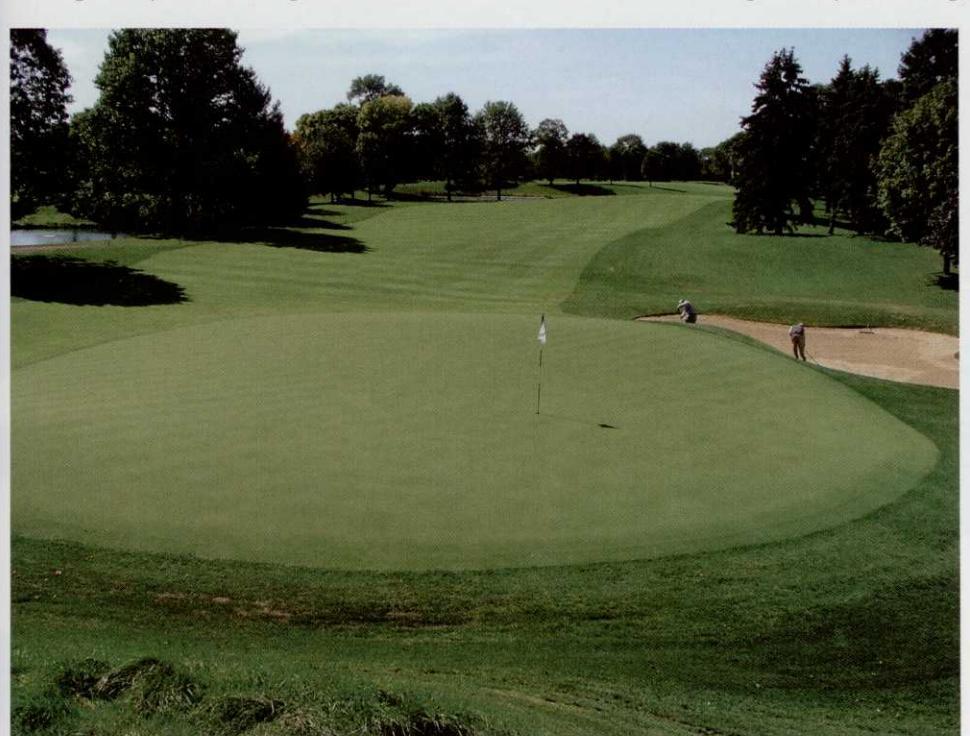
Ceramic soil mix was used in greens construction instead of peat. The mix is designed to hold more water in the profile during times of drought. Photo: Westmoreland Country Club

Heery was sold on the use of ceramic soil mix in greens construction by Paul R. Latshaw, who he worked for at Congressional, and Paul B. Latshaw, who he worked for at Merion Golf Club in Pennsylvania. Golf Creations rebuilt the soil profiles using a ceramic mix called Perma Pore instead of peat. The mix, tested in a nursery Heery maintains at Westmoreland, is designed to hold more water in the profile during times of drought. It also can be sized to the same gradation as the greens sand.

With the ceramics, the greens percolate at just less than 30 inches per hour. Mills has consulted on several new courses and used ceramics in all of them, which was one of the reasons he was brought in as a consultant at Westmoreland.

"You have to change your thinking as a superintendent when using ceramics instead of peat," Heery says. "Ceramics absorb water and retain soluble nutrients. You use less water and nutrients than on a traditional green with peat."
