The McFarland Park Golf Course lies on a floodplain separating the business and residential section of Florence, Ala.

18 Greens In The Air

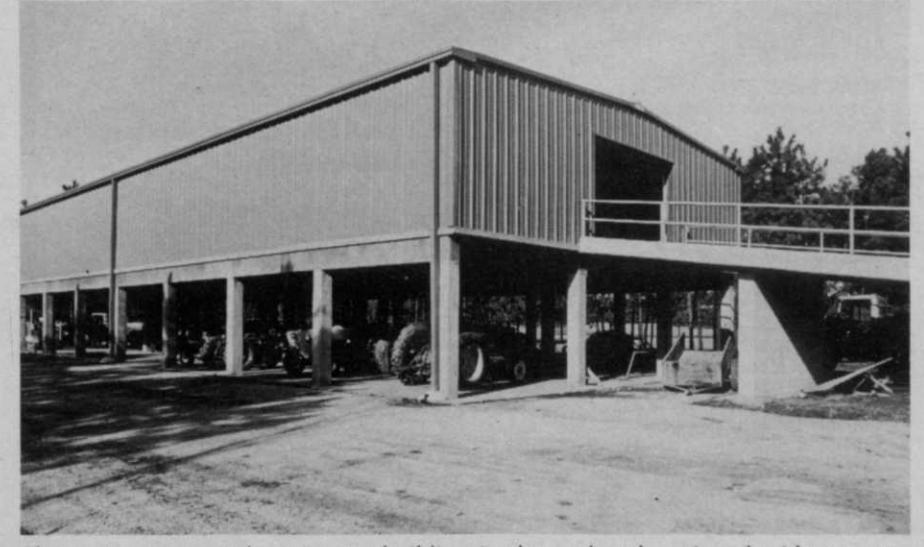
The maintenance and equipment building is elevated and equipped with a ramp. During high water, tools are moved from below to the upper part of the building.

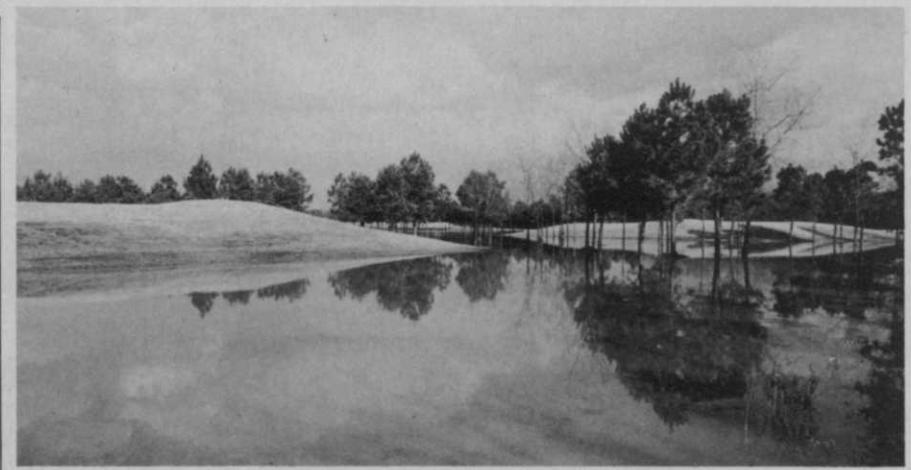
The 15th (1) and 17th greens stay high and dry as nearly five feet of flood water covers fairways and rough.

nessee quickly rose to its highest level in 7 years and by December 10, the course was under water. The flooding lasted for two weeks. Some of the course was covered with as much as 5 feet of water for three weeks. A few days later, the area was sheathed in ice by an ice storm and hit by the coldest weather of the winter. "But," says Green, "everything passed the test, including our ryegrass winter greens."

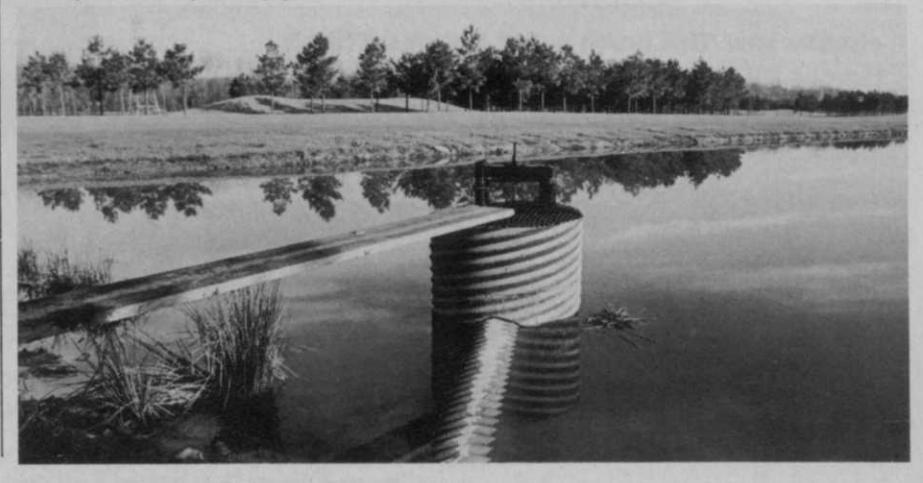
Here's the type of apparatus used to control water level on the course's 10 lakes. Two lakes separating fairways 11 and 12 and 9 and 11 have yielded over 300 balls put there by erring golfers.

Water levels in the lakes are controlled by valves equipped with trickle tubes to allow water to flow (continued on page 32)

both ways. Seven of the lakes are interconnected by drain pipe and are served by one valved outlet to the river. Two more form a similar network. The 10th is connected to the river by its own valve. As the river level rises, water floods the course gradually by spreading out from the lakes which receive water through the valves. During times of heavy rainfall, surface water drains from the course in reverse — from the lakes to the river. Clever. Yes.

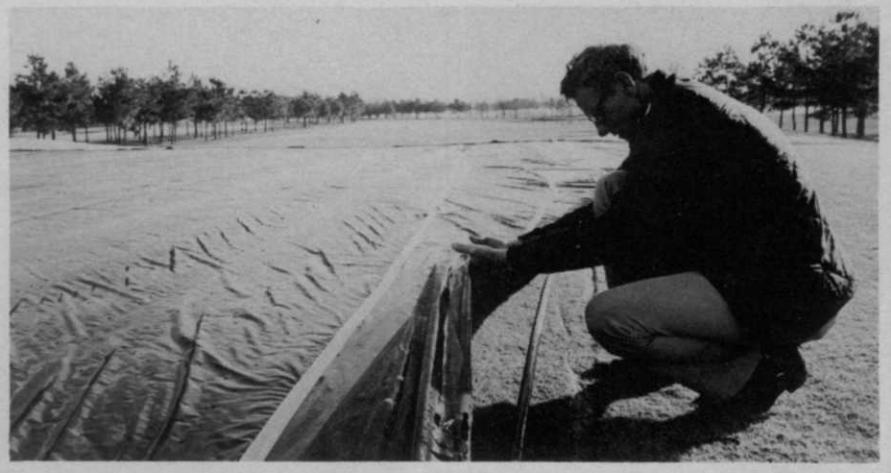
Jack Green, superintendent of the McFarland Park Golf Course, checks one of his elevated permanent greens protected by plastic during the winter.
