# JOBTALK

# New drainage technology solves field woes

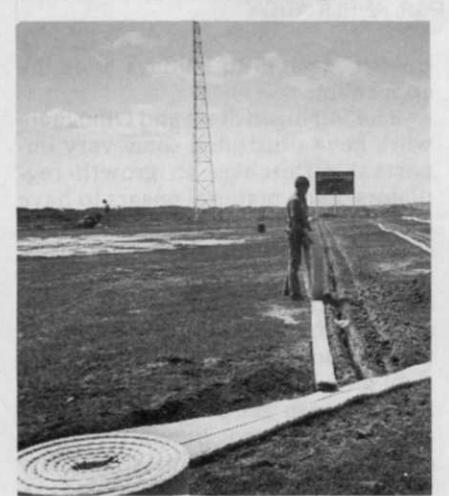
Installing the TerraFlow system laterals. The white areas are where turf was not able to survive because of high salt.

The TerraFlow Drainage System was installed in a herringbone pattern down the length of the field. Because of an 18-inch crown, the TerraFlow merely followed the slope of the field from the crown to the sidelines. All trenches were backfilled to within two inches of the surface with coarse washed sand to facilitate rapid water draw-down from the surface.

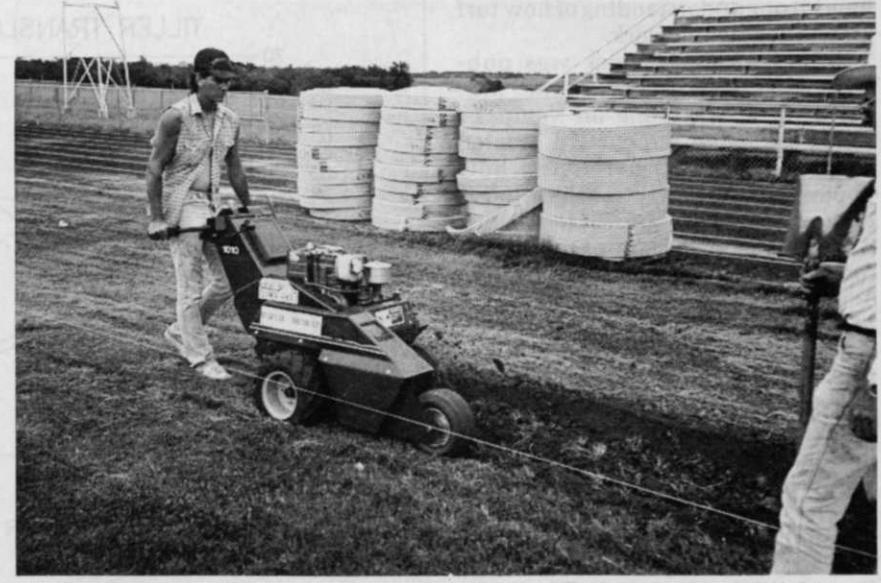
Digging the trench for the 12-inch TerraFlow trunk line along one sideline using the Ditch Witch 1010 trencher.

Trenching using a Ditch Witch 1010 trencher took 45 man/hours. TerraFlow installation took 100 manhours. Sand backfilling took 60 man/ hours. The trenching spoils were bladed with a tractor into the remaining two inches of the trenches, requiring six hours of tractor/operator time. The excess soil was removed from the site using a front-end loader and 20 man/hours.
