Alternative Water Sources

'Horizontal Well' Taps Surficial Aquifer, Returns Investment

Club Taps Surficial, Floridan Aquifers, Processes in Own RO Plant

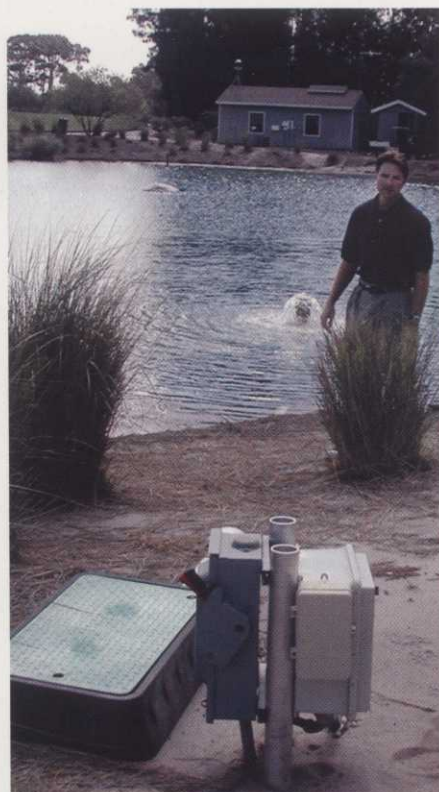
Tom Trammell, CGCS, stands in front of the horizontal well installed more than one year ago. The well provides more than 300,000 gallons of water per day for irrigation usage. Trammell notes that he has made sizeable savings over the last year due to improved water quality and reduced electrical cost for pumping from the shallow source. Hawk's Nest is scheduled to add one more well in the summer of 2002.

I am writing this article in March of 2002 and, here in Florida, we were still in the midst of a drought. The horizontal well not only has provided ample, good quality water (and continues to do so), I am using less electricity because the well is only 18 feet deep. Additionally, I am applying fewer soil supplements because of the quality of the water, and I am recycling anything that is unused. I was able to make a presentation to my green committee that demonstrated our horizontal well would pay for itself in 10 years.

The horizontal well taps the water that lies near the surface and directly beneath the golf course in a surficial water zone. This technology has the ability to recover water from this resource and deliver it in sufficient quantity to satisfy irrigation and lake augmentation needs. Surplus water that is not used in actual irrigation is returned to the surficial aquifer to be reused later. The system can be permitted to be used as a stand-alone water supply source or to supplement existing water supplies.
