Elevate to Irrigate Temporary Nursery

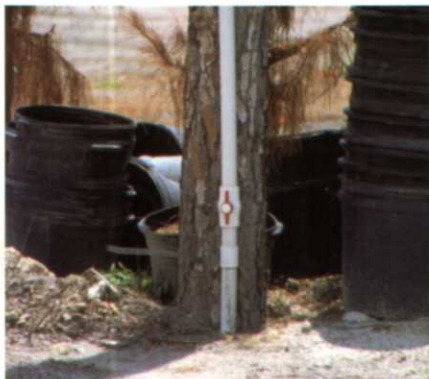
A simple, inexpensive quarter-turn ball valve controls water flow to each sprinkler. Total cost of temporary irrigation system was less than \$100 to protect huge investment in plant material. Photo by Darren Davis.

a temporary overhead irrigation system was installed. To accomplish this, six pine trees that recently had been discarded from the golf course clearing process were limbed up and cut to a length of approximately 35 feet. These straight tree trunks were then buried to a depth of ten feet, leaving approximately 25 feet of exposed trunk. A two-inch PVC line was attached on the side of each trunk leading to the top where a full circle Toro 670 irrigation head was secured. Each head can be isolated at the base of the trunk with a quarter turn ball valve. The trunks were placed in a grid, three per side and approximately 60 feet apart.

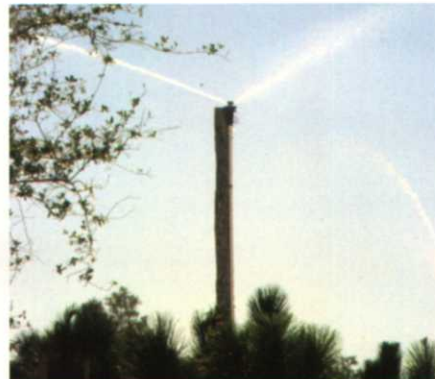
Toro 670 heads were mounted on trimmed pine tree trunks to cover nursery holding area. Elevated position insured all plant material received adequate watering. Photo by Darren Davis.

Being overhead, it was easy for von Hofen and his staff to see from a distance and know that it was in operation which gave them peace of mind knowing their concentration could be given to other necessary tasks. The end cost of the entire system was less than \$100 due to the fact that the six irrigation heads went into inventory for future use on the golf course leaving the only true cost being the discarded PVC pipe and PVC quarter turn ball valves.
