Design case study

A longer, more difficult Isleworth

ARCHITECT STEVE SMYERS UPDATES THE ARNOLD PALMER-DESIGNED COURSE IN FLORIDA WITH ADDITIONAL CONTOURS, AN IMPROVED IRRIGATION SYSTEM AND HILLSIDE BUNKERS

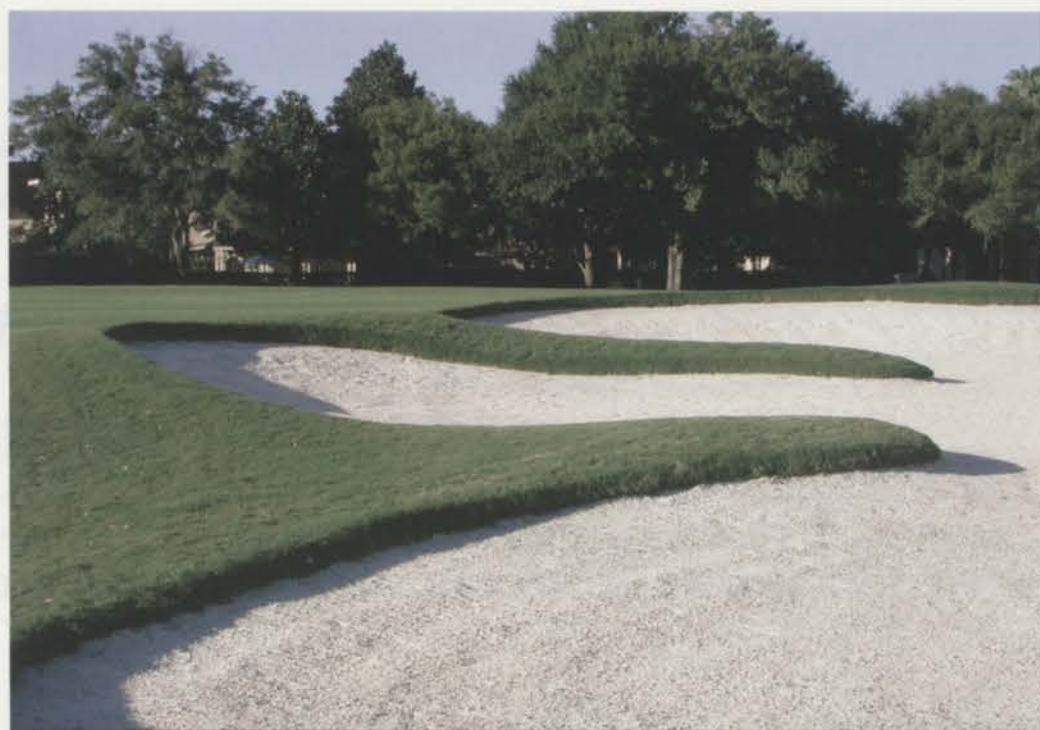
Golf course architect Steve Smyers constructed the bunkers at Isleworth to catch the eye, accentuating hilltops and hollows.

Smyers didn't construct his trademark bunkers on every hole, but where he did use them, he did so to catch the eye – to accentuate hilltops and hollows – as a contrast to help golfers read the course and to set up playing strategy.

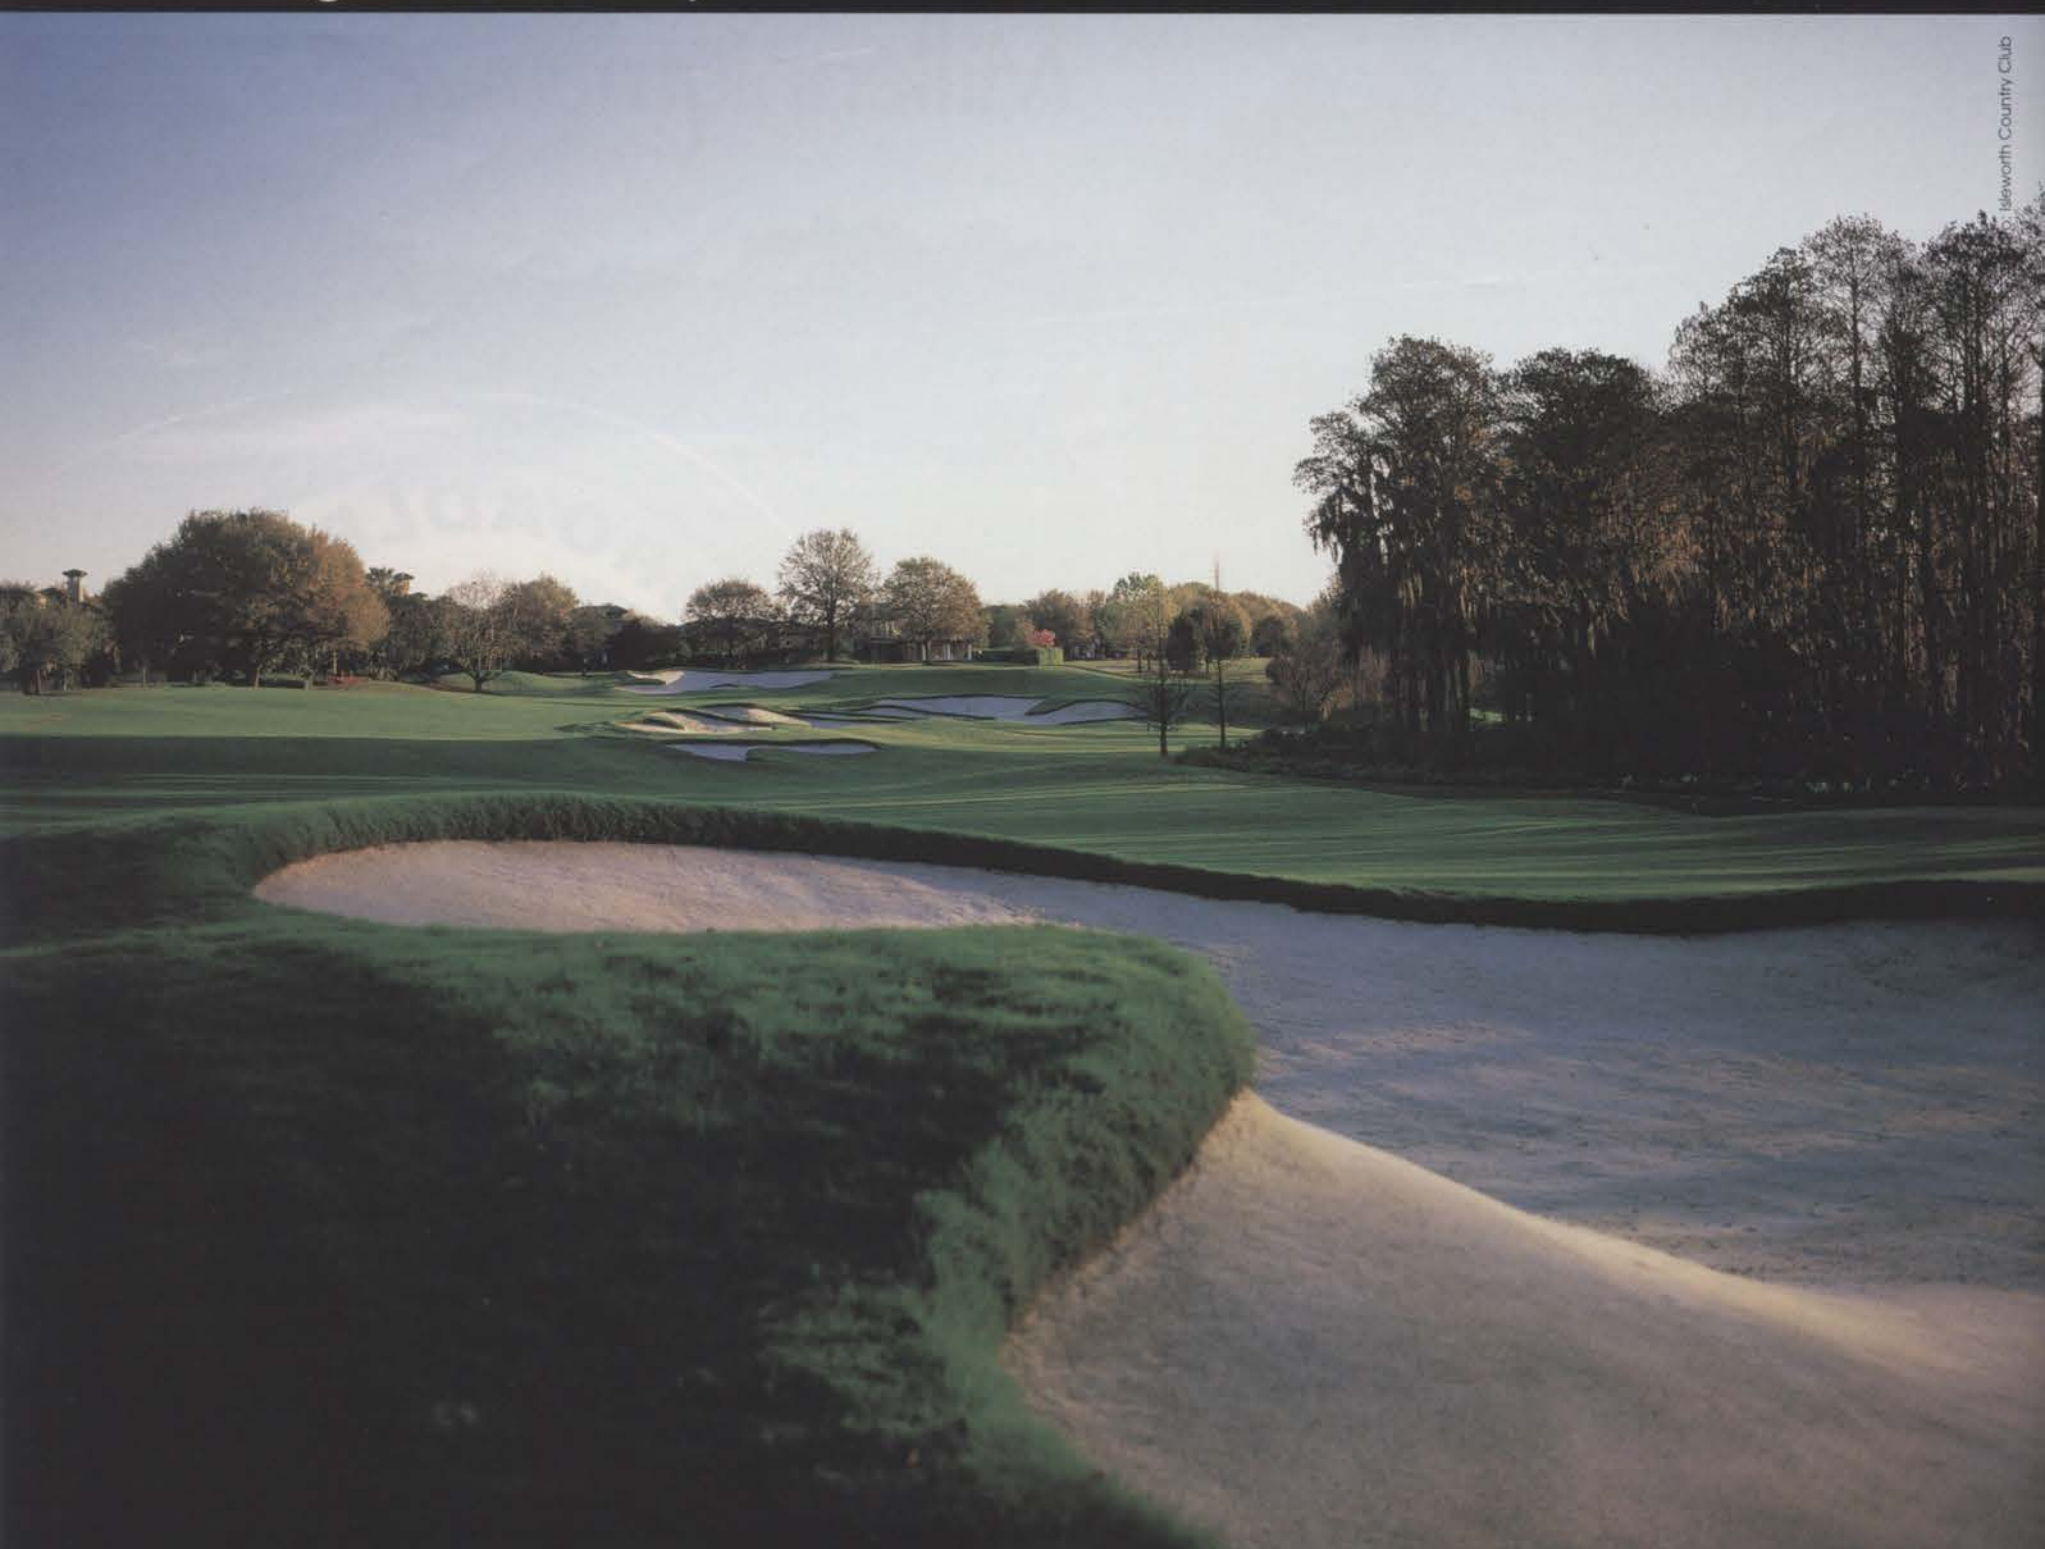
The course at Isleworth Country Club was regraded, creating swells and swales of movement and a range of depth where it was previously flat.

That resulted in changing everything. The course was regraded, creating swells and swales of movement and a range of depth where it was previously flat. Trees were cut down and others planted. Before Steel left the project, Smyers worked closely with him on slopes and contours that might impact mowing.
