Globetrotting consulting agronomist Terry Buchen visits many golf courses annually with his digital camera in-hand. He will share helpful ideas relating to maintenance equipment from the golf course superintendents he visits – as well as a few ideas of his own – with timely photos and captions that explore the changing world of golf course management.

travels with TERRY

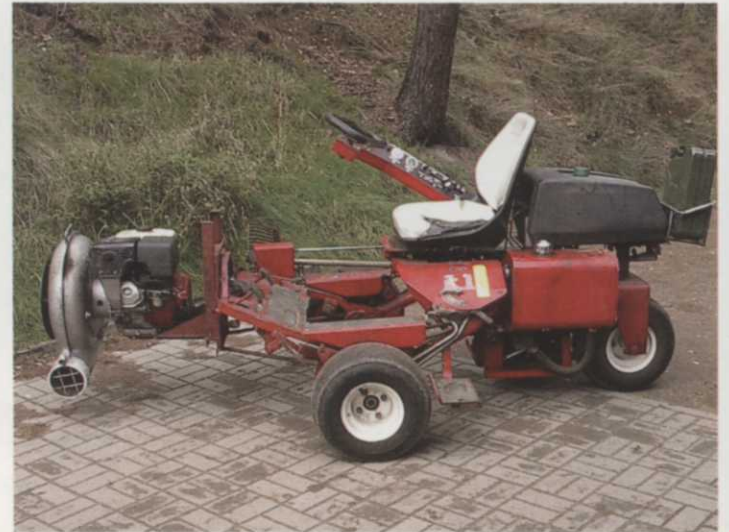
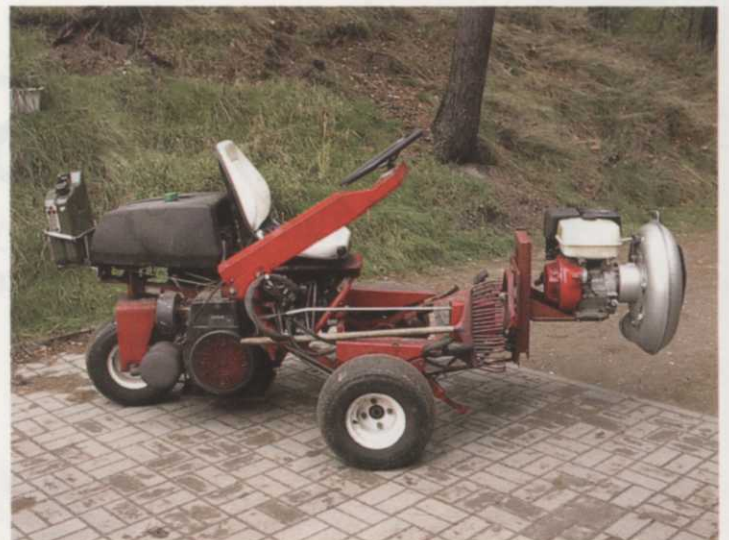
The piece of equipment shown at the right originally was a 1988 Toro Greens Master 3000 triplex greens mower before the cutting units were removed. The self-contained leaf blower is attached to a 14-inch-by-9-inch metal platform and has angled steel plates on either side for added strength. The pieces were cut and welded together. The blower rests on rubber pieces that are about 2-inches thick to dampen the vibration from the air-cooled engine. To help support it, the platform also has diameter rods welded to it and bolted to the greens mower's frame. The engine is bolted to the metal platform. Quick disconnects on the metal framework platform are used to remove or install the leaf blower as required when servicing either machine. The cost to build the platform, including materials and labor, was \$1,290. The piece of equipment is solely used for blowing leaves and debris.

The leaf blower is moved up and down with the hydraulic system that was used to previously operate the cutting units. The mow and lift pedals are used to move the blower up and down to the desired level. The leaf blower is used mostly on greens, tees and approaches where it can be driven without damaging the turf. A 2.6-gallon portable gasoline can is attached to the rear of the unit with a light-weight frame to help balance the machine because of the weight of the leaf blower. The gas can is never below one-half full so the weight balance is maintained. The machine can be driven using a transport speed when going from one place to another because of its good front-to-back weight balance.

Norbert Lischka, master greenkeeper and course manager at The Hamburger Golf Club in Hamburg, Germany, and his greenkeeping team developed this idea.

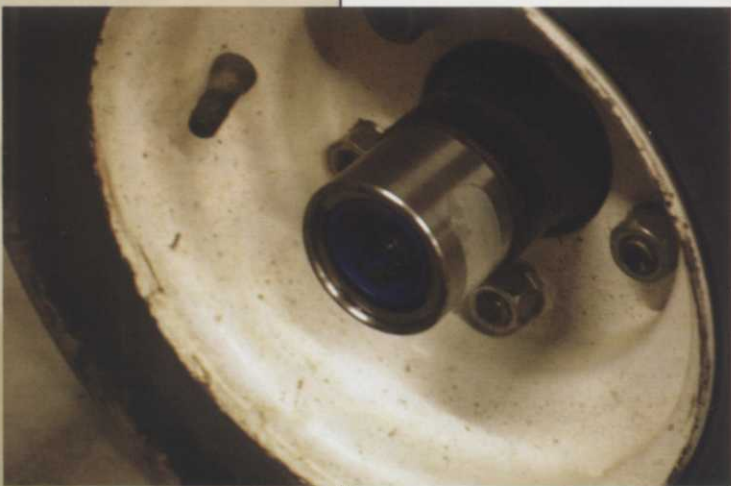
Corrosion of wheel hubs can be caused when pressure washers or steam cleaners are used to clean maintenance equipment. The Bearing Buddy helps prevent moisture-forming corrosion from prematurely wearing out wheel hubs. The outer barrel of the Bearing Buddy is made of triple-chrome-plated steel, and the internal parts are made of stainless steel. The axle hub is filled with waterproof grease until the grease forces the Bearing Buddy piston outward about 1/8 of an inch. Because the piston is spring loaded, it exerts a slight 3-psi pressure against the grease, which maintains a slight pressure between the inside of the hub and the outside environment. When the hub is submerged, water can't enter the hub because of the pressure. An automatic pressure relief feature prevents grease overfills and overpressurization. The inner seal will be damaged without this feature. Grease can be added to the hub through an easily accessible grease fitting located in the center of the piston. The

lubricant level (and pressure) can be checked quickly and easily by pressing on the edge of the moveable piston. If the piston can be moved or rocked, it's properly filled with grease. A vinyl cover can be fitted over the Bearing Buddy to contain excess grease and to keep it off wheels and tires.

The Bearing Buddy can be used on the turning wheels of golf course maintenance equipment that turns a lot because the spring loading forces grease the other way when turning. It can't be used on any of the drive wheels. It can be used on any maintenance equipment wheel bearings that have dust covers.

The Bearing Buddy costs \$14.95 a pair, and a pair of vinyl covers cost about \$2. The total cost depends on the model and size.
