Irrigation conquers coral on the Keys

On the Ocean Reef Club's golf courses on Key Largo, the northern-most of the Florida Keys, golfers play on coral — but they would never know it from the way the ball behaves. The gently undulating fairways are lush with grass, and the greens are smooth and true.

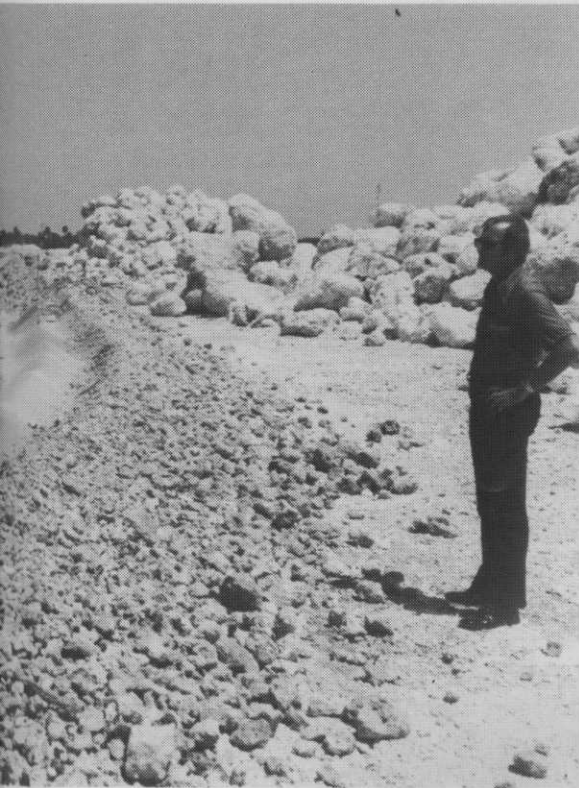
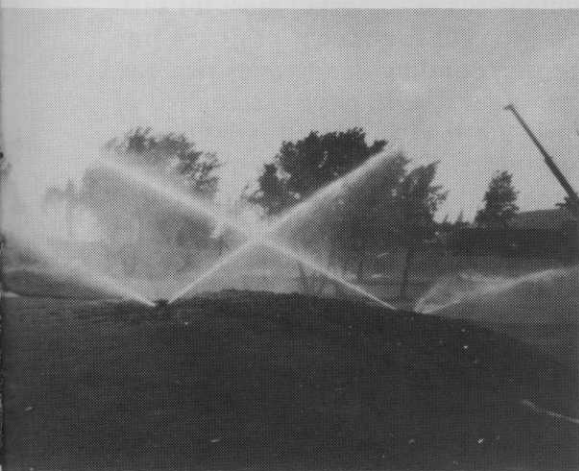
TOP PHOTO shows typical difficulty encountered in trenching coral rock in the Florida Keys. It's not hard to imagine the work necessary to turn that rock pile into a lush looking golf course. BOTTOM PHOTO gives a look at the results of all that hard work, as well as illustrating one of the main reasons for the courses' beautiful appearance: automatically controlled sprinkler rotors. Turf gets very thirsty off the tip of Florida, but automatic irrigation takes good care of its needs.

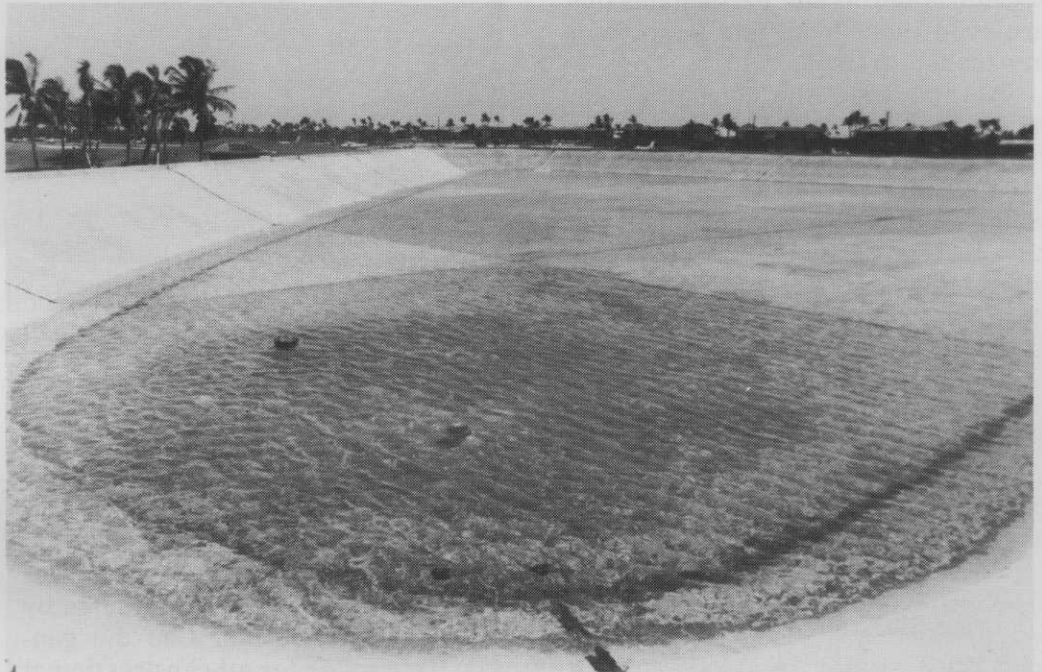
ABOVE: Getting enough water to feed a golf course — let alone three of them — can be even a bigger problem than distributing it. The Ocean Reef Club had plenty of water available, but it all had salt in it. So a desalinization plant was built, complete with the million-gallon-capacity holding pond shown.

When construction began in 1973 on the second 18 holes, the 6,600-yard Barracuda Golf Course, a seep well was drilled and a desalinization plant was built that has a capacity of 900,000 gallons a day. A million-gallon water tank was assembled beside it. The desalted water is mixed in the big tank with fresh water from Homestead. The combination provides the entire Ocean Reef complex, not alone the Barracuda Golf Course. The well water contains up to 15,000 parts per million of salt, but the reverse-osmosis desalinization plant takes this salt content way down.

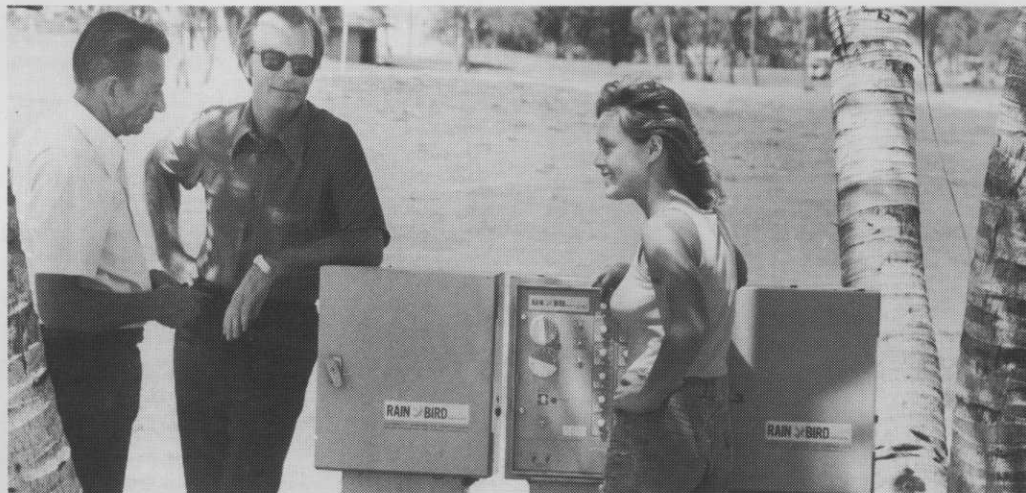
Ocean Reef Superintendent Tom Grondski, course designer Karl Litten, and maintenance crew foreman Kathy Austin discuss operation of the programmable sprinkler controller.

Superintendent Grondski finds that because of the versatility of the controllers and the uniformity of distribution of water by the rotary pop-up sprinklers, he is able to make maximum use of his limited water supply. In addition, his assistant finds the system easy to understand and simple to program. The sprinklers are all operated automatically and electrically from field controllers located strategically throughout the course.
