## Dealing With Drought: Turf Removal And Increased Water Storage

**Barona Creek Golf Club**  
**Sandy Clark, CGCS, superintendent**

Lakeside, Calif. 92040

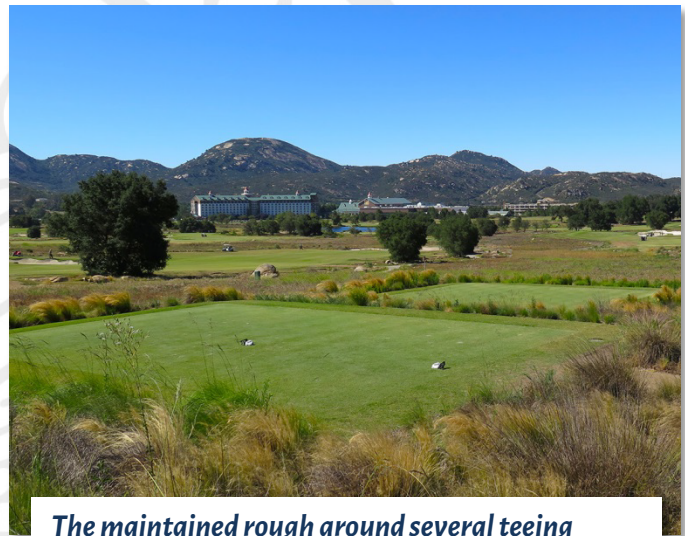
*The maintained rough around several teeing grounds was converted to drought-tolerant plants that blend well with the existing landscape and require less water and maintenance.*

- Eliminated perennial ryegrass overseeding
- Removed 2 acres of bermudagrass from an alternate fairway
- Removed 12 alternate teeing grounds
- Added waste areas
- Replaced maintained turf around teeing grounds with native plants

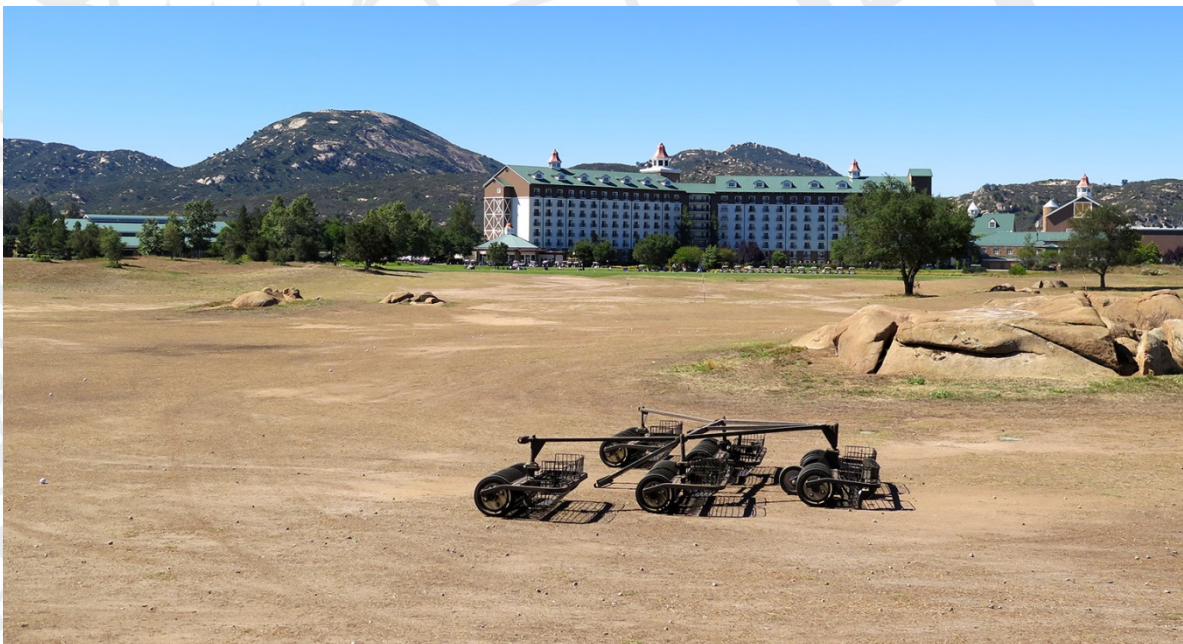
*As demonstrated by Barona Creek, the driving range is an excellent location to reduce water use.*
