Equipment Wash Water Recycling

Maple Leaf Golf and Country Club
Nancy Miller, CGCS, superintendent

Port Charlotte, Fla. 33980

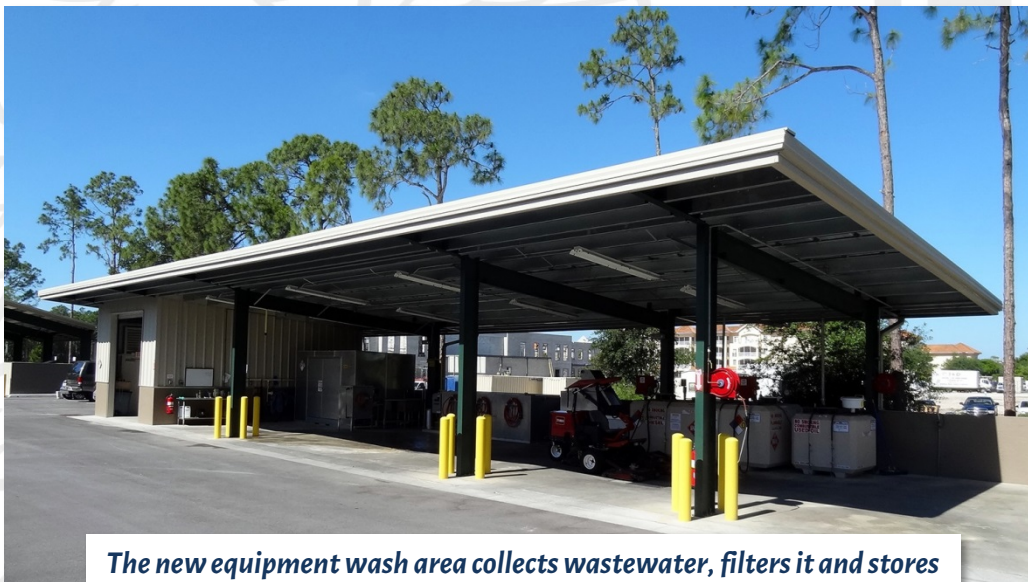
The new equipment wash area collects wastewater, filters it and stores it for future use. Covering the facility protects staff and equipment from the elements, improving morale and washing quality.

A new equipment washing facility that matched the club's environmental and resource management goals was constructed in October 2014. It included a shelter over both the equipment wash area and refueling area, compressed air hoses for blowing debris off equipment, and an ESD Waste2Water recycling unit. Before equipment is washed, most of the clippings are blown off and collected. As a piece of equipment is being washed, the recycling unit collects the wastewater, filters it, and stores it for future use.
