Leveling Sprinkler Heads Conserves Water And Improves Playing Quality

Country Club of Detroit
Ross Miller, CGCS, superintendent

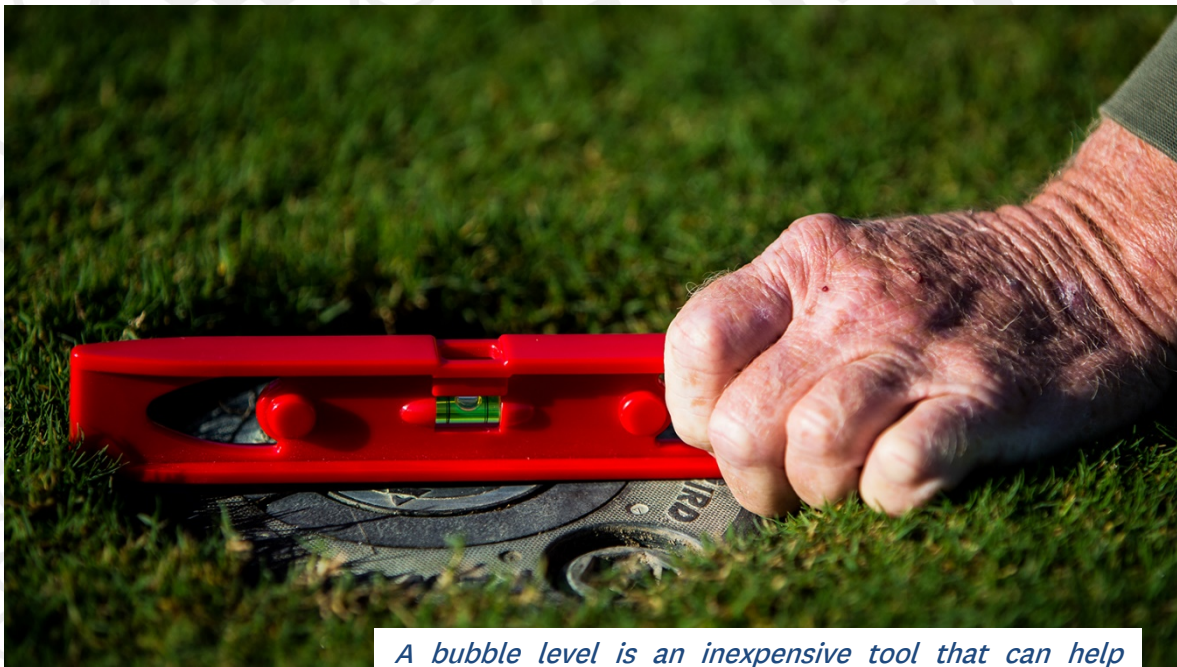
A bubble level is an inexpensive tool that can help confirm whether or not a sprinkler head is properly set.

Mr. Miller developed a plan to assess and correct underperforming sprinkler heads that were wasting water and compromising playing conditions. The first step was to evaluate individual sprinklers and prioritize them for repair. Heads around putting greens were given first priority, next came fairways, then tees and other areas. Once these priorities were established, crew members began the task of visually inspecting each sprinkler body and nozzle for any signs of cracks, leaks or damage and parts were replaced as necessary. The next step was trimming any excess turfgrass from around the head and removing any soil that could interfere with the spray pattern. Any sunken or tilted sprinklers were made level with the surrounding grade and confirmed using a small bubble level.
