Native Grasses Yield Water Savings

Camelback Golf Club – Ambiente Golf Course
Aaron Thomas, director of grounds operations

Scottsdale, Ariz. 85253

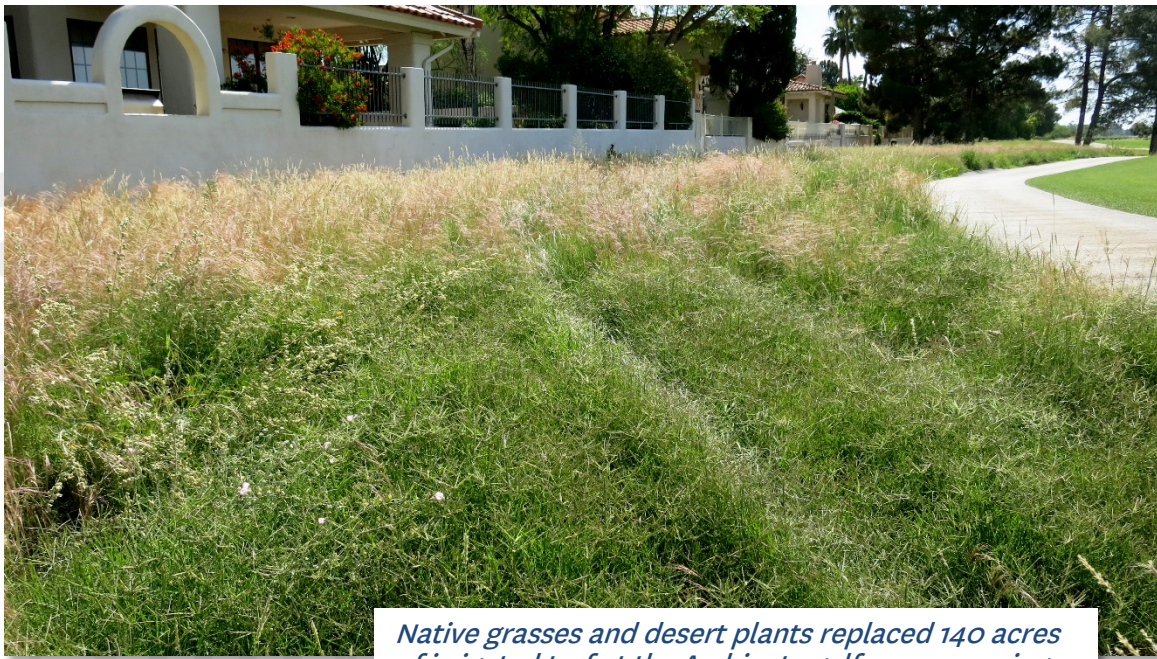
Native grasses and desert plants replaced 140 acres of irrigated turf at the Ambiente golf course, saving more than 43 million gallons of water annually.

The golf course architects completely renovated the golf course and removed most of the trees. In addition, the course now had only 80 acres of irrigated turf. The remaining 140 acres were hydroseeded with a mixture of native grasses, desert plants and wildflowers. During establishment, the hydroseeded areas received about 60 percent of the total water that would have been applied if the areas remained bermudagrass. The long-term goal was to irrigate the naturalized areas at 30-40 percent of what would be required to maintain bermudagrass. Irrigating at this rate should sustain healthy, but not overly dense native grasses.

Approximately 43 million gallons of water per year are being saved on the renovated golf course. In 2014, the agronomic staff applied only 13 inches of irrigation to the naturalized areas. This is just 22 percent of the water that would be required to maintain bermudagrass and overseeded ryegrass. Aaron Thomas, director of grounds operations at Camelback Golf Club, is quick to point out that the new naturalized areas require as much, if not more, maintenance than turf areas. However, the water inputs are much less and as the naturalized areas mature water use should decrease even further.
