Grabbing A Tiger By The Tail

By Larry Gilhuly, agronomist, West Region

June 25, 2014

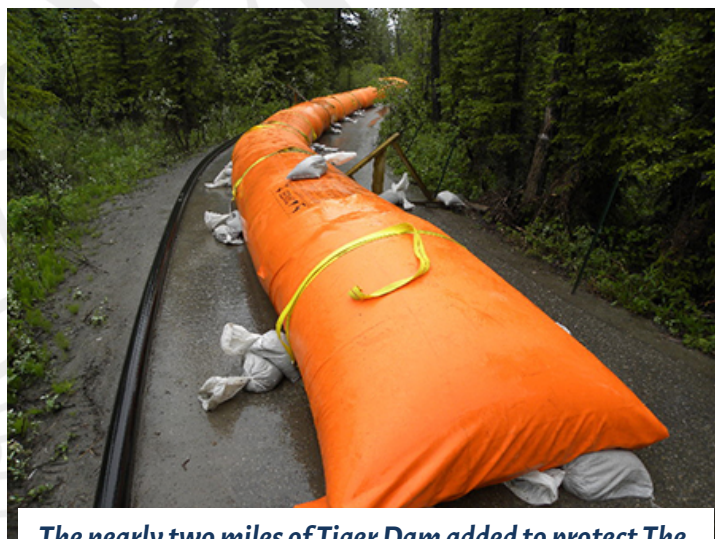
The nearly two miles of Tiger Dam added to protect The Glencoe Golf & Country Club was definitely good insurance. Note: the white mark on the tree to the right which shows the height of the river the year before.

the same site. However, measures had been taken to minimize the potential for flooding by installing nearly two miles of a material called Tiger Dam. This water-filled material was bolted to an asphalt path along the perimeter of the golf course and, when combined with over 500 feet of concrete road dividers, it offered an additional three feet of protection in case the river crested. Despite the cost of nearly \$1 million (\$475,000 to purchase the Tiger Dam tubes, \$200,000 in materials, and \$100,000 to set up and take down) this club was not going to let nature win again.
