Improving on perfection at Shipley

John Lelean visits the Yorkshire Course where the staff rebuilt a green in thirty days

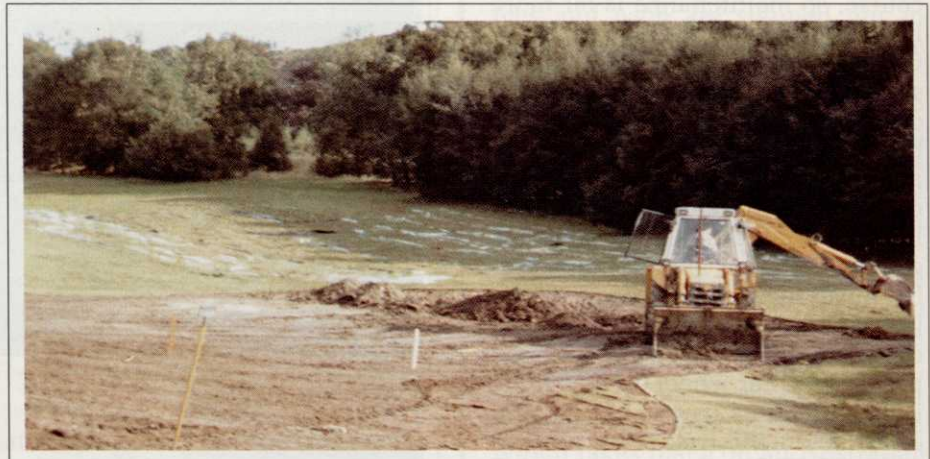
Excavation starts on the fifth green. Lifted turf laid out on polythene sheeting on edge of the fairway.

The method of operation was first to cut a temporary green in front of the work area so play could continue throughout September. Then all the turf was lifted and laid out on

the polythene sheeting, grass side up on the bank overlooking the working area.

The plastic sheeting prevented roots growing down, but kept the turf moist and had it required watering it was easy to hose over.

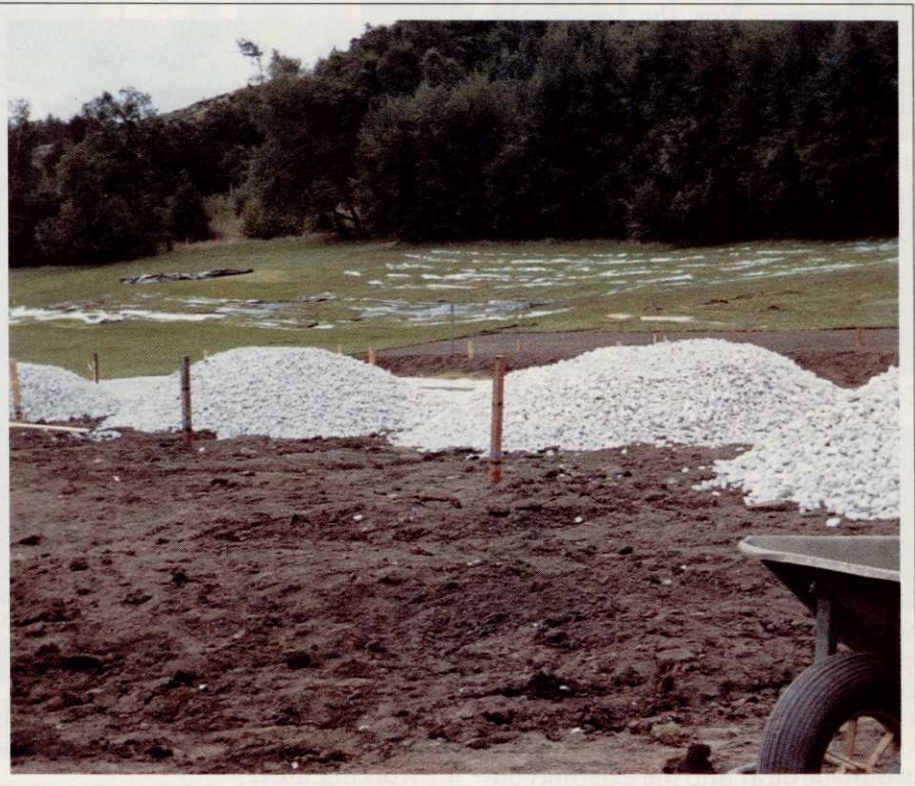
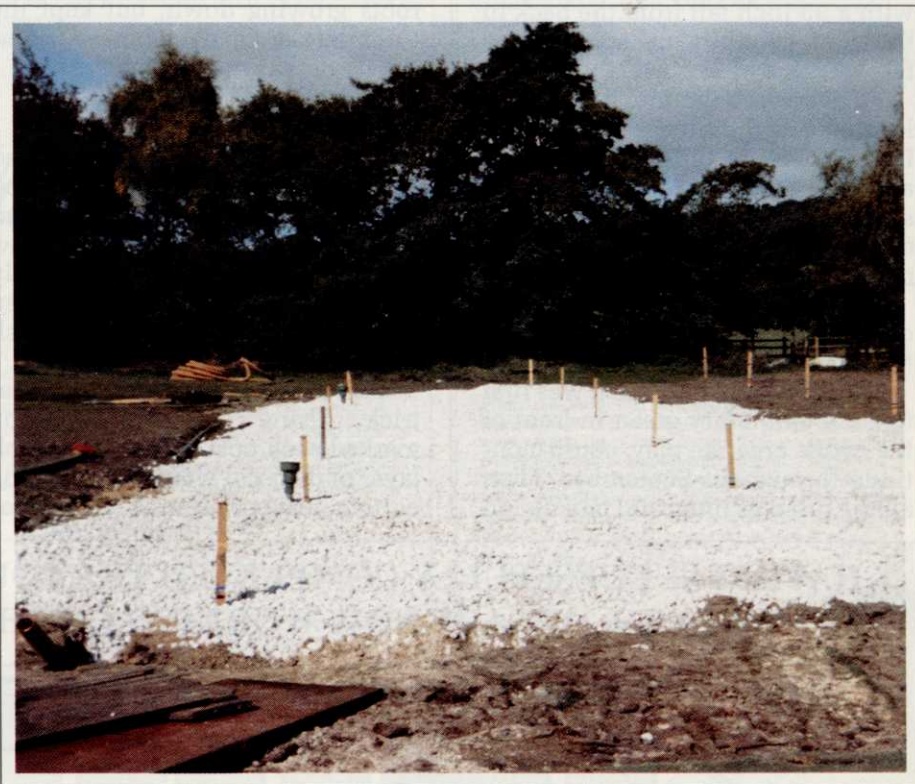
Hard limestone used in the re-construction of the fifth green at Shipley.

size large hard limestone about an inch and a half across. A type obtainable locally that has proved not to break up, which was laid to a depth of about 4 inches.

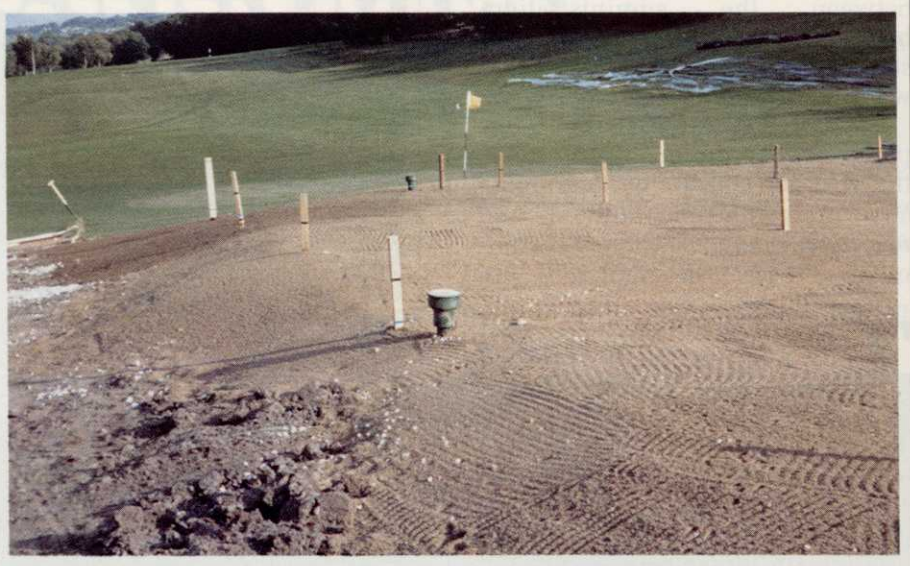
Drains and stone carpet completed. Sharp sand laid to a depth of two inches, ready for the nine inches of top mix. Note the marker posts at 12 foot centres with coloured bands showing the level to be achieved. The flag post for the temporary green can be seen in front of the workings to allow play to continue throughout the month.

Once the site was excavated the drains were installed covered by around half an inch of stone above and below. Marking stakes were put in exactly 12 feet apart to 12 foot centres, so working from back to front each stake was precisely 12 feet apart.

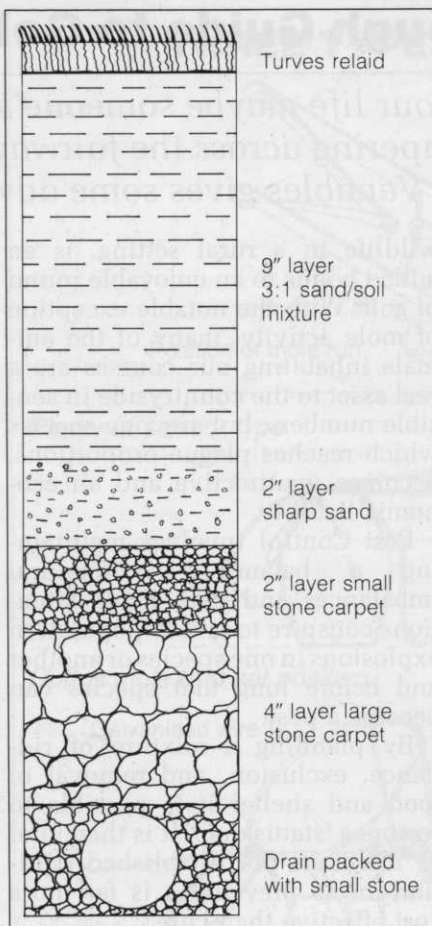
Fig. 2

Here Patrick used another neat trick. Using coloured tape he marked each post to the depth each layer of material would be laid. The bottom mark was at 4 inches for

large stone, the second up 2 inches for small stone, the third up a further 2 inches for the sand layer and the fourth at 9 inches for the sand/soil growing medium. (Fig 2).

Each level allowing for the 5 inch fall every 12 feet, keeping the side to side measurements level. To achieve accuracy he placed the first stakes in the centre of the construction.

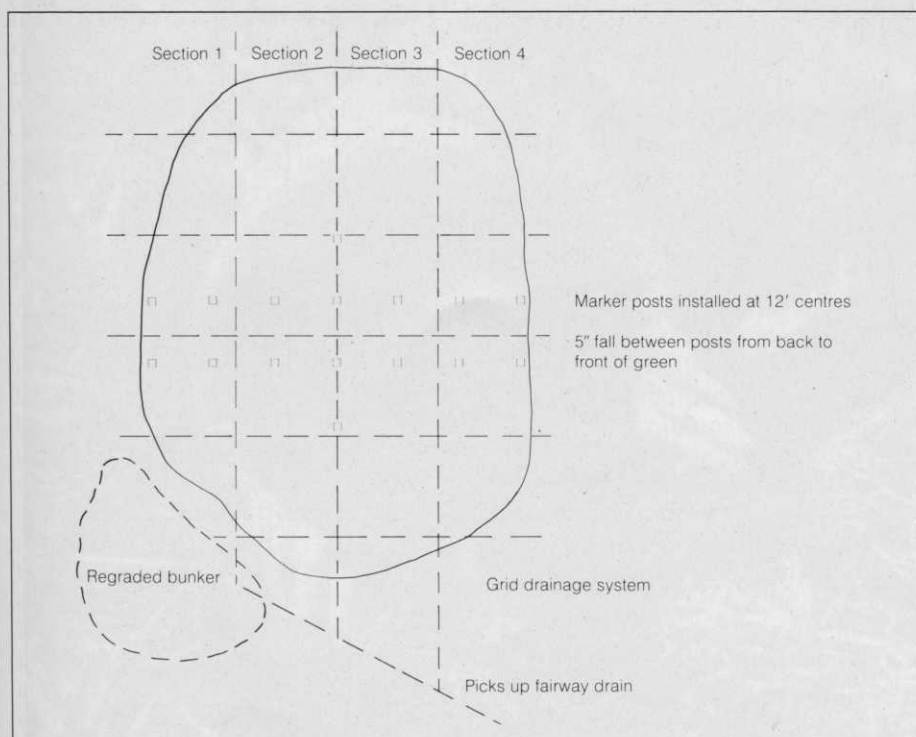
Fig. 3

Once the two lateral drains were dug and laid, the method of operation was to divide the working area into four sections taking a line from the back of the green to the front. Starting at section one, the levels were built up from the drain to stone carpet, small stone, sand and then sand/soil mix. (Fig 3).

When completed the second section was treated in similar fashion and so on until all four areas were built up in similar fashion.

The reason behind this method of operation was to avoid machinery churning up the various levels whilst working on the next. It also avoided potential damage to the drains.
