Arne van Amerongen describes his work on a course where nose bleeds are an occupational hazard...

Once in a lifetime

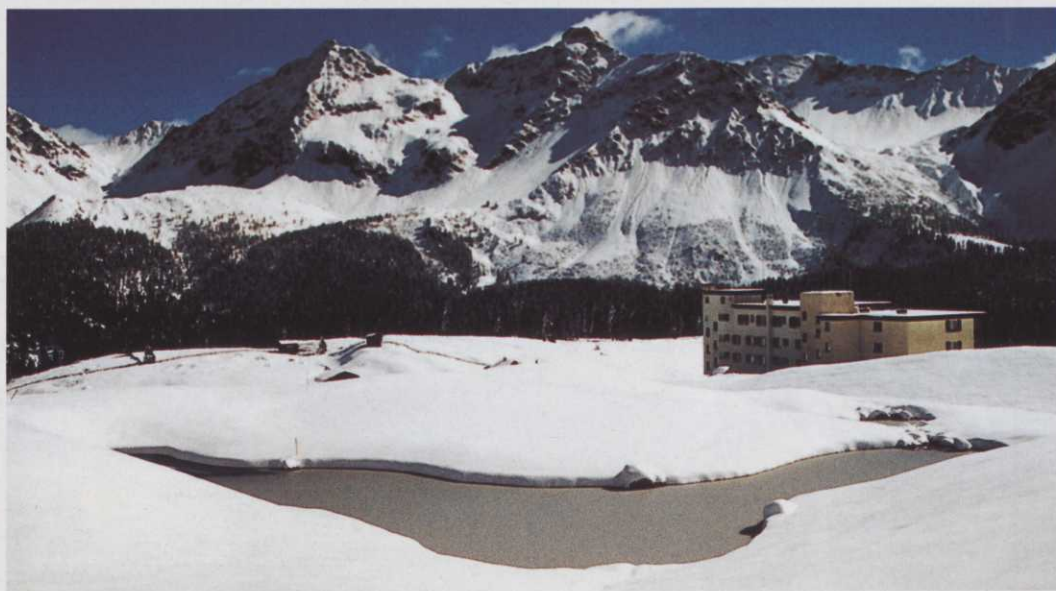
Snow stopped construction in October, last year

A major problem in these mountains is, naturally, the weather. Even in summer (June until September) you can expect at least one day of snow in every month. However, during this construction, rain, rather than snow, was our major problem. We had suffered 237 mm in August and 270 mm in September! We had only four to five months for construction so such heavy rain was a considerable hindrance and, over and above this, snow started in earnest in the first week of October.

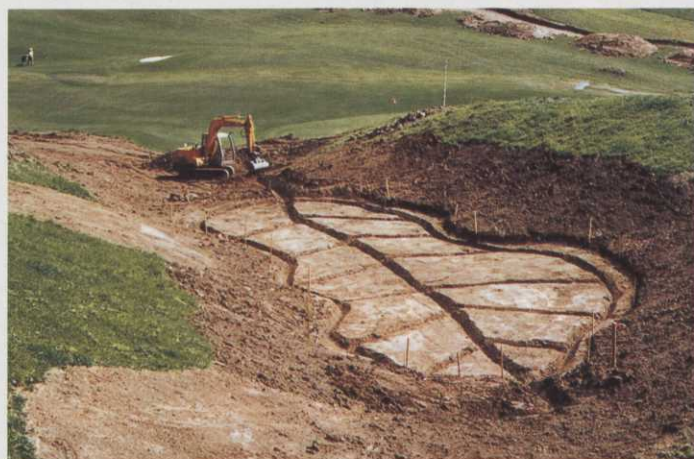
The new 18th green showing herring-bone and perimeter drain lines

tory under these testing conditions. Construction was to full perched water table standards, with particular attention to intercept drains on the perimeter of greens to intercept both surface flow from surrounding steep slopes and also sub-surface lateral drainage, as well as a conventional herringbone system.
